# REPORT of SURVEY for REPAIRS, &c.

No. in Survey held at London Date, First Survey 22.5 Oct. Last Survey 24.5 Oct 1936  
Leg. Book. 87219 on the ~~Wood, Iron or Steel~~ N.V. "ARTHUR TOWN" (No. of Visits 4)

REPAIRS, OR EXAMINATION AS PER RULE, FOR Steering Gear (Hand operated)

M.V. "ARTHUR TOWN"

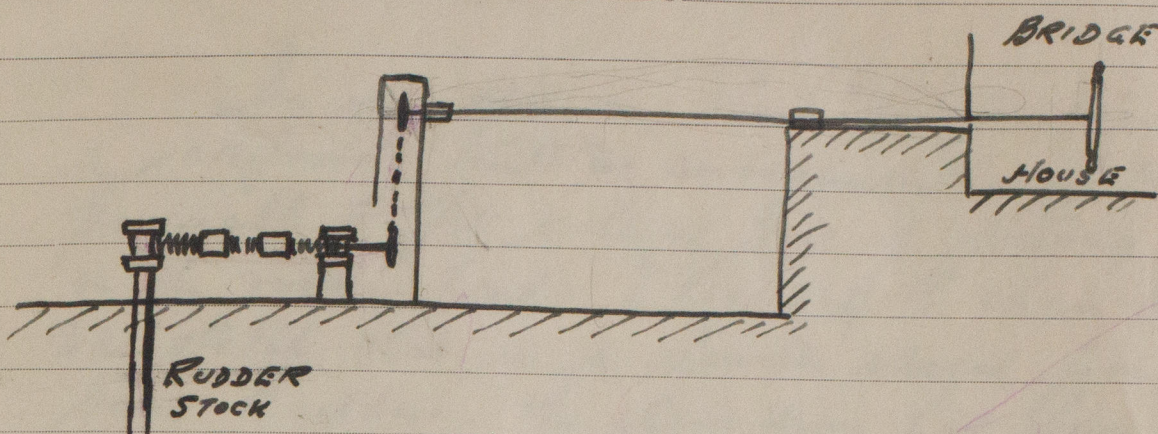
The steering unit fitted on the rudder head is the ordinary hand gear — right and left handed single thread screw shaft — operated from the Bridge (distant about 20'0) through a line of shafting and intermediate chain drive. A sketch

of the arrangement is shown:-

- (a) The rudder in addition to being free laterally was undesirably buoyant - rising and falling about  $\frac{1}{2}$ " on passing waves - in itself sufficient to create some distortion in the gear, the forward end of which is carried on a pedestal. (This buoyancy has now been eliminated by drilling holes top and bottom in the hollow rudder)
- (b) Whilst complete freedom of movement existed in most parts of the gear, some binding was suspected in the after carrier block of the screw shaft. (This has now been eased)
- (c) There was evidence of chafing on the face of the upper chain sprocket due apparently to faulty meshing with the chain when considerable force was applied to get the rudder over. (An additional bearing has been fitted on the extreme after end of overhead shafting to prevent the sprocket being pulled out of alignment)

On completion of these modifications, little effort was required to operate the rudder whilst the vessel was manoeuvring slowly but quite considerable effort is still required when the vessel is fully under way. It would appear for easy operation that the mechanical advantage provided is insufficient for the size of rudder and it is proposed to effect further modifications at Antwerp to which port the vessel has now proceeded. These modifications are:-

1. Fitting the maximum size of hand wheel

- in the Bridge House.
- 2 Fitting an enlarged size of lower sprocket in the intermediate chain drive.

In our opinion, these modifications form a satisfactory tentative arrangement - it might be preferable to fit a larger size of steering unit on the rudder head. (Regarding the chain drive it was stated that in a similar vessel from the same Builders, the chain drive had been replaced by a vertical shaft and bevel pinions).
