19713 on the ~~Wood~~ ~~Iron~~ or Steel ANGLO SAXON

REPAIRS, OR EXAMINATION AS PER RULE, FOR *Condition & Alterations*

"ANGLO SAXON"Repairs W & T Cont.

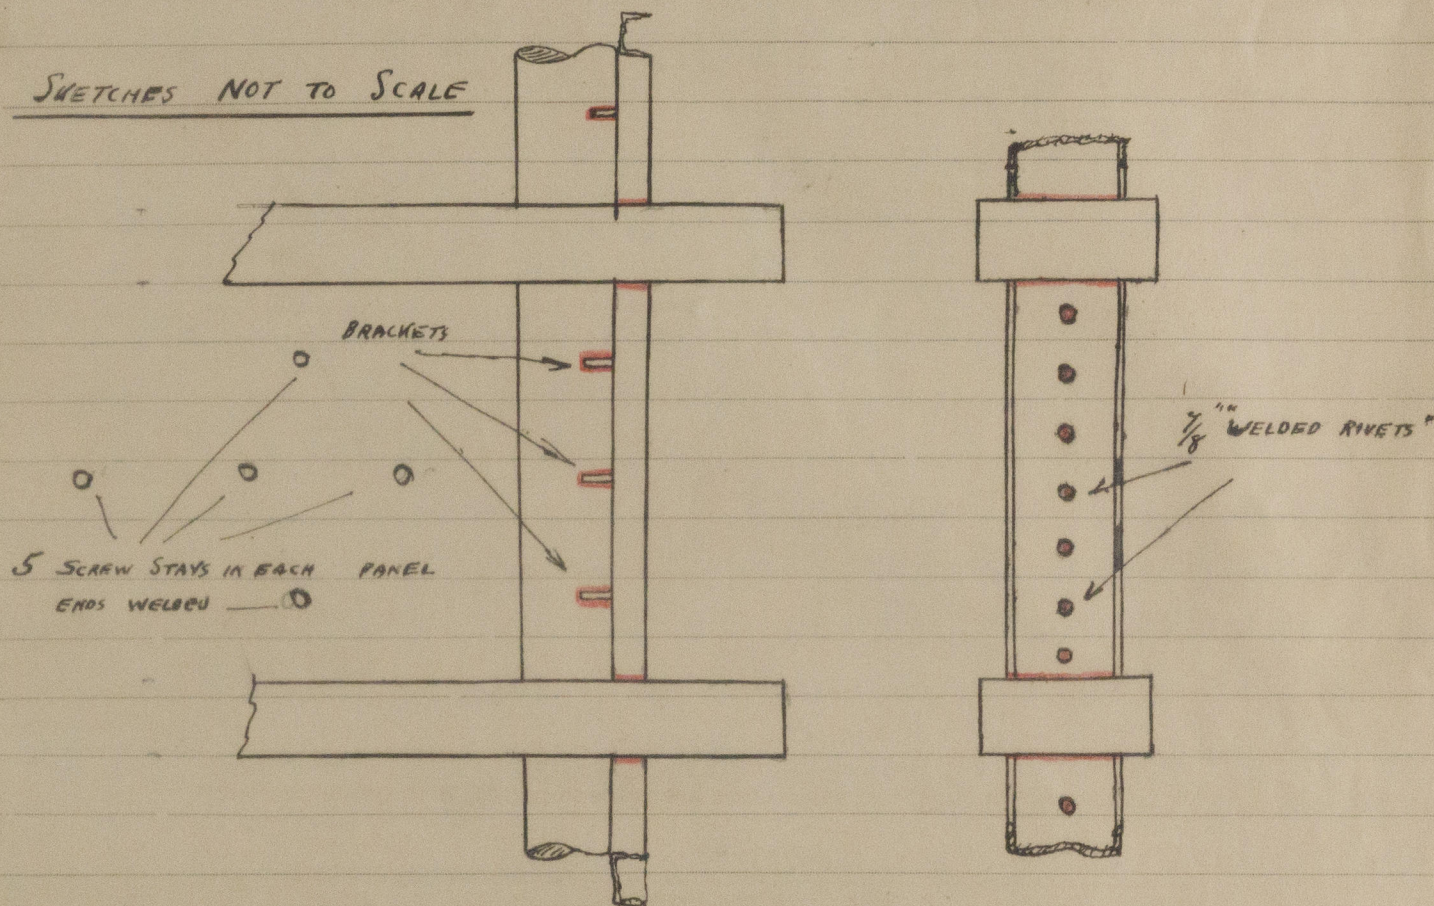
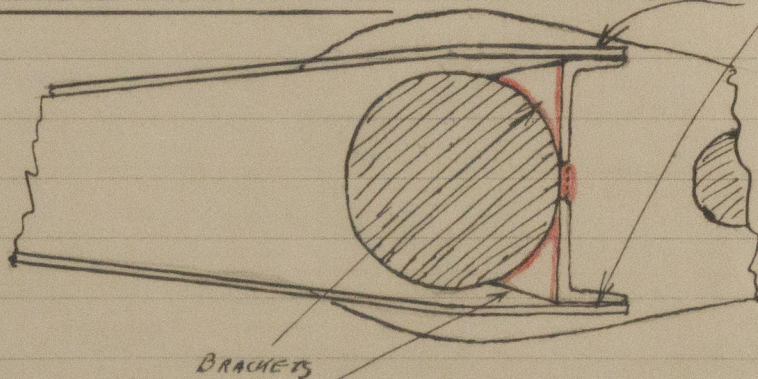
SKETCHES NOT TO SCALE

The rudder plates each side were now found torn away between & the bottom & adjoining arm, meeting

RED INDICATES ELECTRIC WELDING.

PLATES RIVETED TO CHANNEL PIECES

Rudder now removed ashore & plates renewed in heavier material. The channel pieces ^{forward of main piece} between arms have been renewed & attached to main piece by "welded rivets" & welded brackets fitted between arms as indicated in sketch & as proposed by Owner's Superintendent.

Screwed stays (1 1/2" dia) have been fitted joining plates between arms to prevent parting of plates between arms.

Fudgens rebushed. On completion, rudder replaced, tried & found to work freely.
