REPORT OF SURVEY FOR REPAIRS, &c.

Port of Baltimore, Maryland

Reg. Book. 25125 on the ~~Wood, Iron or Steel~~ M. V. "GRENA"

REPAIRS, OR EXAMINATION AS PER RULE, FOR Drydocking, S.S. No.2, Renewal Load Line and Damage Repairs.

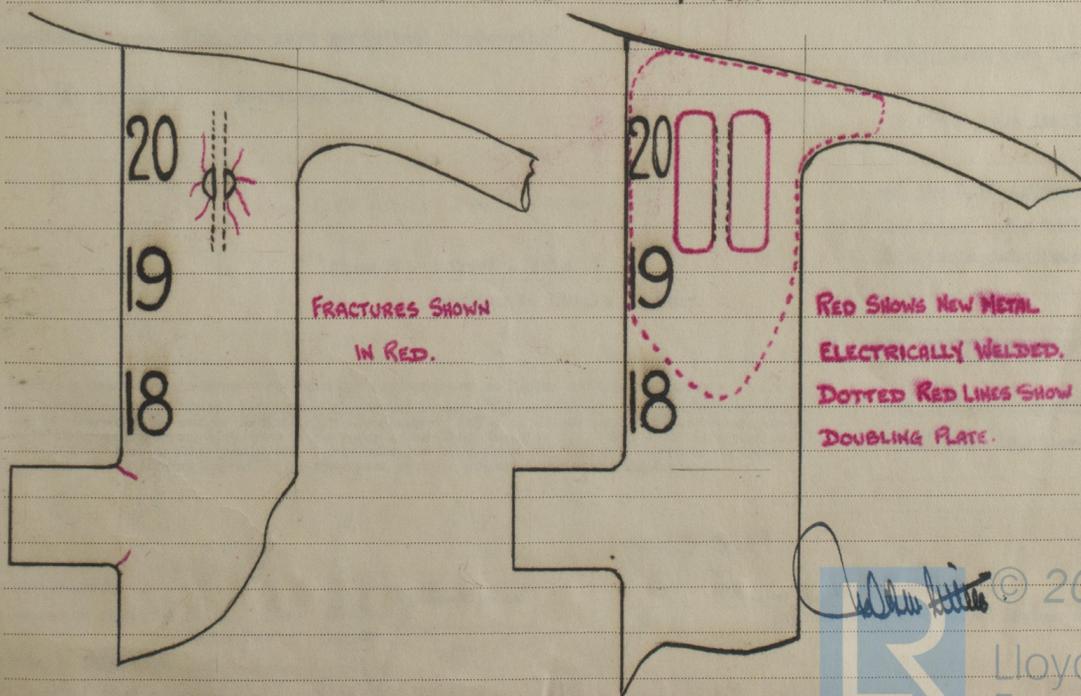
RUDDER POST OF STERN FRAME- STARB. SIDE ONLY - PORT SIDE SIMILAR.

S. R. List:- Indented keel plate No. 4 from aft and bottom plating and plates A 3 and 4 and B 3 (P.S.). Rudder post of stern frame (E.W. 6,36; reinforced 1-37; rewelded 6,40; E.W. 10,41 and 7,42 at 20 - 21 ft. draught mark (s.s.) and solepiece (s.s.) E.W. reinforced 10,41 specially to examine next docking. Permanent repairs to sheerstrake slightly indented forward in way No. 1 cargo tank and amidship in way No. 3 cargo tank at Owners' convenience and to forward bunker bulkhead (P.S.) next docking. Indented No. 1 plate 3rd strake below sheer (p & s) and etc. Drydocking and repairs (grounding).

stern frame carefully examined, the fractured and badly fused sections of rudder post plating between 19' 6" and 20' 6" marks cut out (see sketch) new sections of plate cut to fit and electrically welded in place. A number of minor fractures in rudder post at the root of gudgeons cut out

and electrically welded. The welding on stern frame solepiece cut out for examination, the solepiece built up by electric welding and reinforcing bars of 1 1/2" x 4" section fitted and electrically welded port and starboard sides of the solepiece for the full length, the alignment of the gudgeons again checked upon completion of repairs and found good. The rudder replaced, tried out and found satisfactory. All hatch covers reconditioned and packing renewed. Steering engine crankshaft journals and thrust collars machined true, new main and thrust bearings fitted. Other minor repairs carried out.
