Lloyd's Register. Calcutta.

S. S. "Sangu"

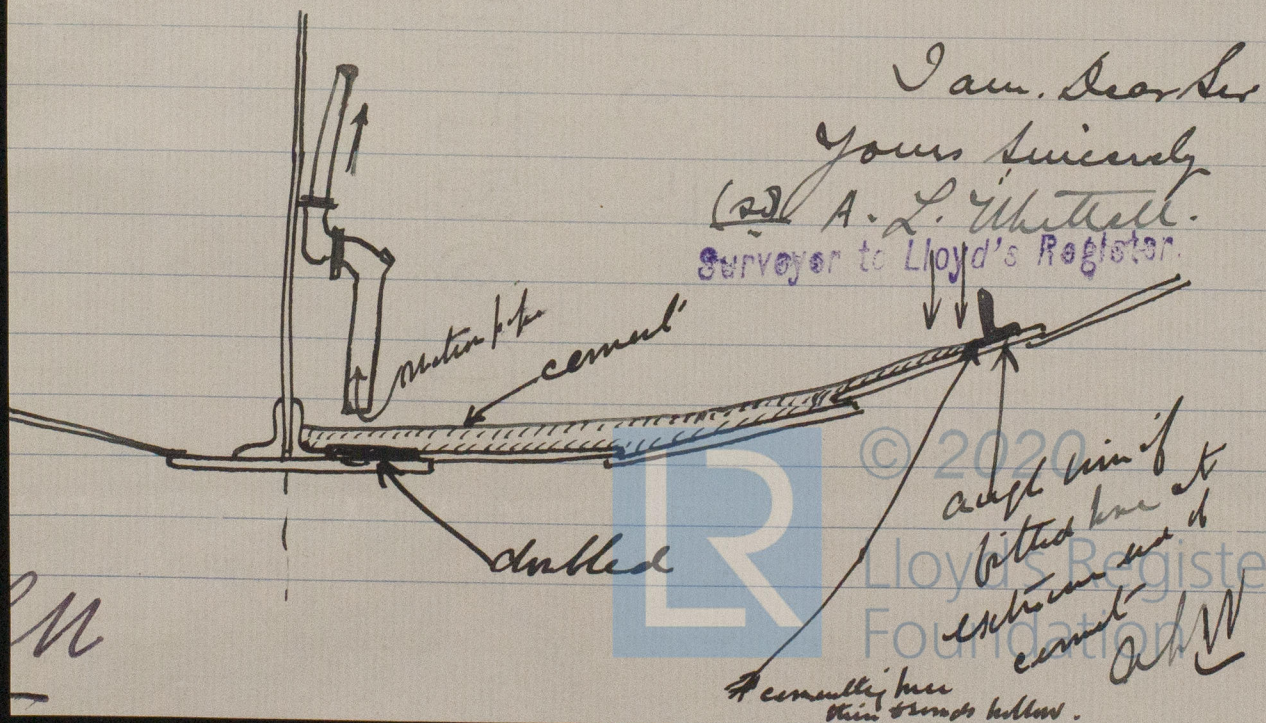
I found the iron pitted more or less some of the pit holes being say $\frac{1}{4}$ " deep and covering an area about the size of a man's hand.

Regarding the cementing of the bottom (internally) of the oil tanks the idea is good enough provided absolute soundness can be depended upon, but unfortunately the cement at times shrinks and cracks and, even though the cracks be trifling still, sooner or later the oil or water which may be in it gets below and the remedy is worse than the evil.

I sounded the cement in many places and all appeared sound enough excepting just at the turn of the bilge of the extreme ends of the cement, here, on

account of the cement being tapered to a fine edge, the sound when tapped with a hammer was hollow & drumming.

In my opinion had it been possible to fit fore & aft angle irons between floors at these extreme ends of cement the cementing would be a complete success but as it now stands I am inclined to think that, on account of the vertical height of the oil, the vibration of the hull through the water, and the thinness of the cement at the extreme edges, the oil will sooner or later find its way behind the cement and gradually work down.

Over the worst pitted places I had doubling plates varying in size from 12" to 20" inches square $\frac{1}{2}$ " thick fitted and riveted on and then cemented over.

This doubling was done in Tanks 2, 3 & 5 the others I simply recemented over again mixing the cement with crude brown sugar (which from experience I found to be a capital thing to give gripping power to the

The hole which was eaten through the hull bottom in No 2 tank I fitted with a screwed rivet and over this part a doubling plate similar to the others.
