## REPORT of SURVEY for REPAIRS, &amp;c.

Survey held at Bombay

on the Wood, Iron or Steel S.S. "Singu"

REPAIRS, OR EXAMINATION AS PER RULE, FOR I surveyed this vessel afloat and in dry dock at the request of the Captain to have the temporary repairs to the hull bottom in No 2 tank permanently repaired—see Report No 1362 of 5-10-08.

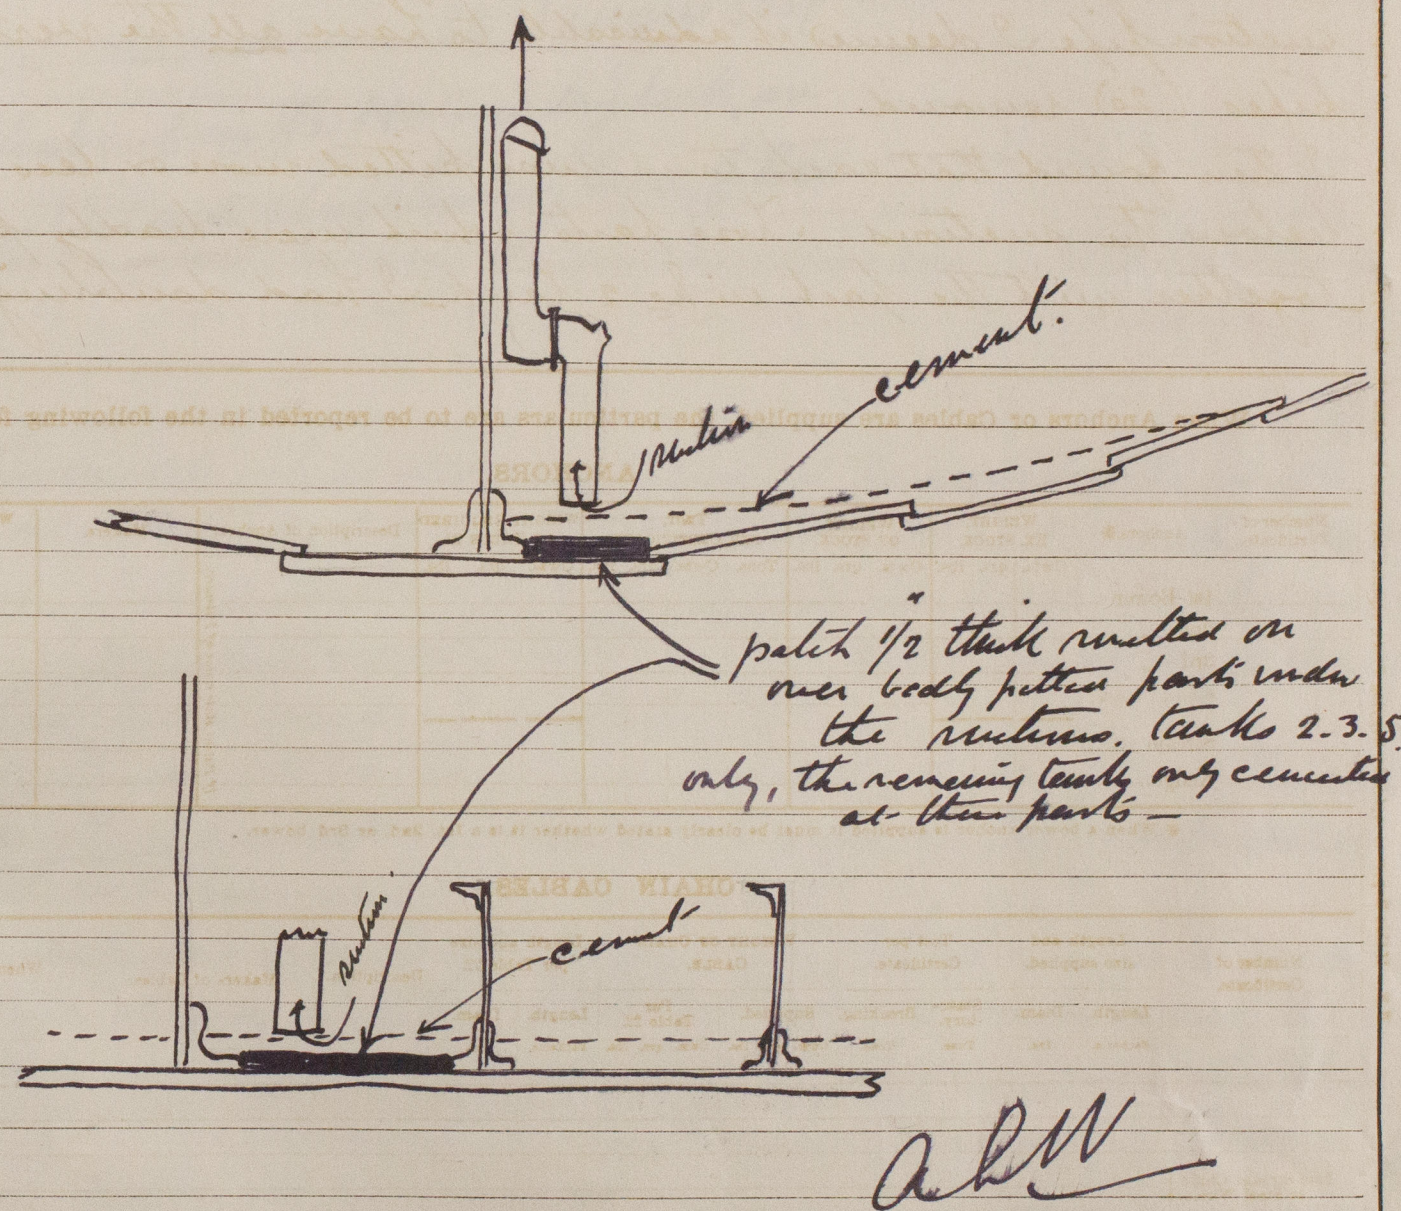
no 2 tank. After all the oil was taken out and the temporary repairs removed I made a careful examination of the hull internally at this part and found that the hole which had been eaten through had a bell mouth appearance see sketch.

Observing this to be the condition of the inside plating at this suction pipe I deemed it advisable to have all the vertical suction pipes (20) removed.

$\frac{1}{2}$ " thick fitted over and riveted on, the area of the doubling plates varying according to the extent of pitting, and then over these doubling plates cement-mixed with country crude brown sugar - was placed about 2" thick.

The ends of each suction pipe (20) were then cut to suit the new conditions leaving a space of  $5/8"$  for the oil to enter - see sketch
