Screw shaft sea connections examined.

The screw shaft replaced by the new spare shaft owing to wear of brass liner.

It is submitted that this vessel is eligible to remain as CLASSED.

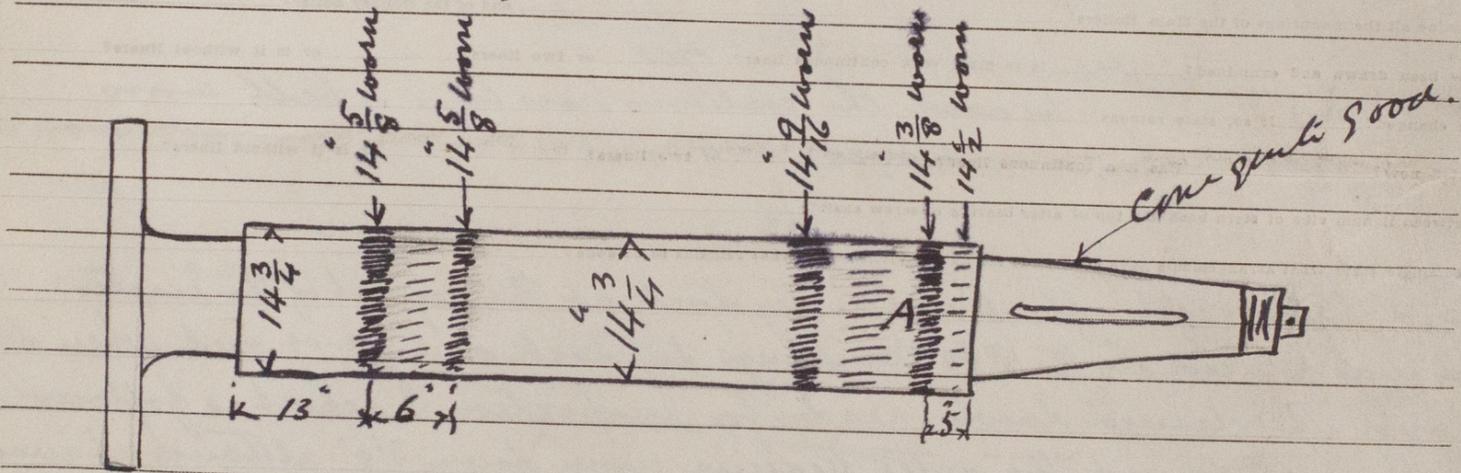
condition, the wearing having taken place only at the liner of the shaft.

The spindle end of the main injection valve has this time been repaired, the solid end having broken off (see sketch)

This shaft badly worn away at A from $14 \frac{3}{4}$ to $14 \frac{3}{8}$ on brass liner, otherwise good. Kept on board as spare.

new end screwed into spindle of main injection valve

I condemned the shaft for use in its present state and condition and recommends the spare new shaft which was on board to be fitted to the existing propeller.

The old shaft has been kept on board and in my opinion as soon as it has been placed in lathe and turned parallel it will be fit for further use as otherwise it is in good condition.
