Report of Survey for Repairs, &c., of Engines and Boilers.

No. 10953

Survey Report 29th Oct. 1936 When handed in at Local Office 31st Oct. 1936 Port of Gothenburg
Survey held at Gothenburg Date, First Survey 11th May Last Survey 13th Oct. 1936
on the Machinery of the Wood, Iron or Steel 5/5 "FRATERNITAS" (No. of Visits 44)

Port of GothenburgContinuation of Report No. 10953 dated 31st October, 1936 on theSS 'FRATERNITAS' No 75343 in the Register Book

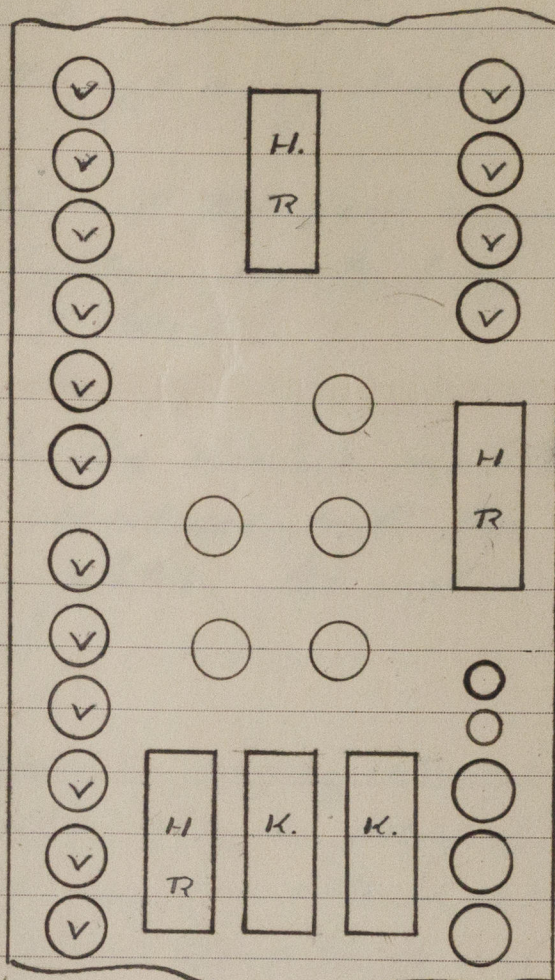
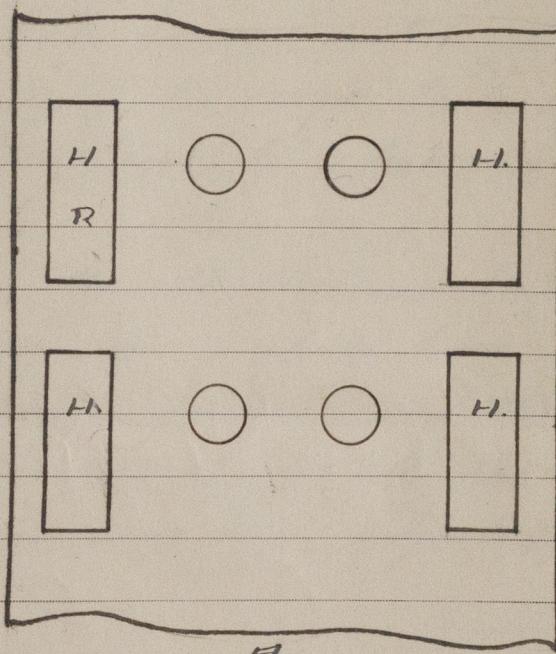
General arrangement for the press-boilers.

V - Vertical boilers. 16 @ 60 lb.

HR - Rebuilt Hartman boilers. 1 @ 43.

H - Hartman boilers. 3 @ 43.

K - New Kraemer boilers. 2 @ 43.

The safety valves of all vertical press-boilers adjusted under steam to 60 lbs/sq" (16 off) of the new Kraemer boilers to 60 lbs/sq" (23 off) and of the Hartman boilers to 43 lbs/sq" (7 off.)
