REPORT OF SURVEY FOR REPAIRS, &c.

Reg. Book. 2607 on the Wood, Iron or Steel M.V. "BRITISH COURAGE" (No. of Visits 35)

REPAIRS, OR EXAMINATION AS PER RULE, FOR ALTERATIONS, DOCKING, & S.S. No. 3

ALTERATION TO TANK TOP & ENGINE SEATING TO SUIT NEW TYPE DIESEL ENGINE.

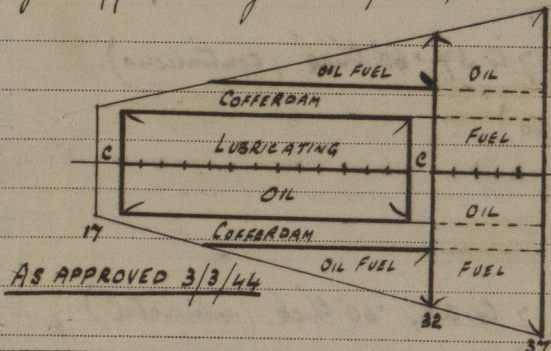
Note—After approval of above plan, arrangement of D.B. tanks in way of Engine Seating was modified as per sketch.

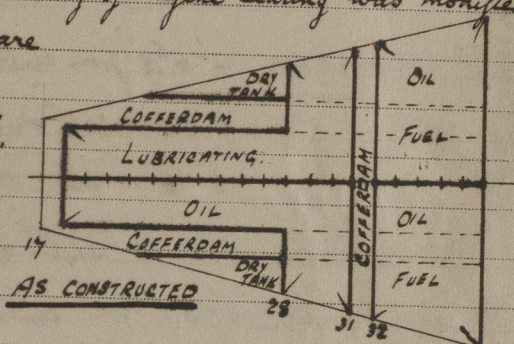
These modifications are marked in Red on approved plan herewith.
