## REPORT OF SURVEY FOR REPAIRS, &amp;c.

Date of writing Report 29.8.1940 When handed in at Local Office 29.8.1940 Port of Middlesbrough  
No. in Survey held at MIDDLESBROUGH. Date, First Survey 18th June. Last Survey 15th Aug. 1940.  
Reg. Book. on the Wood, Iron or Steel SS. "EMPIRE ENDURANCE" ex "ALSTER"

s.s. "EMPIRE ENDURANCE" ex s.s. "ALSTER"

# EMPIRE ENDURANCE Ex ALSTER

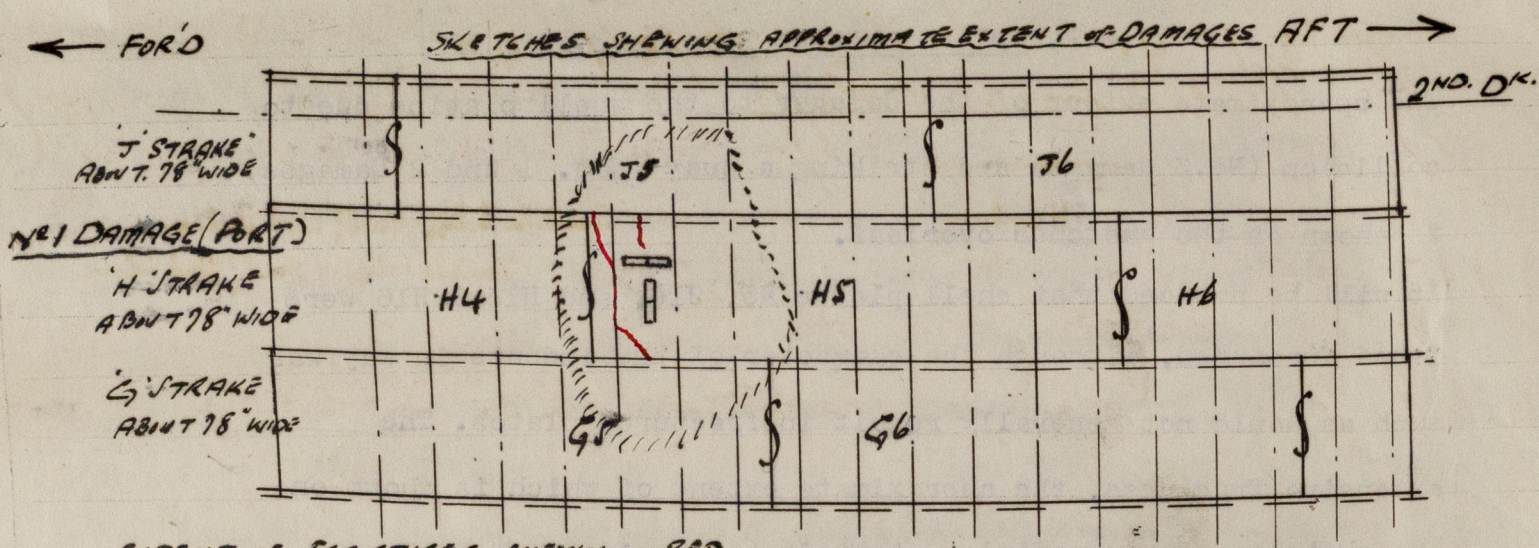
It will be noticed that shell plates H5, J16, and H15 & H16 were found fractured, although the character of the indents in way was such as would not generally result in fractured plates. The extensive fractures, the approximate extent of which is shown on the sketches, in our opinion started at the rivet holes. There were also some minor fractures which had definitely started at rivet holes.

EXTENT OF FRACTURES SHOWN IN RED.  
MAXIMUM INDENT ABOUT 4" CLEAR OF FRACTURES.

TEST PIECES ARE SHOWN TRUE

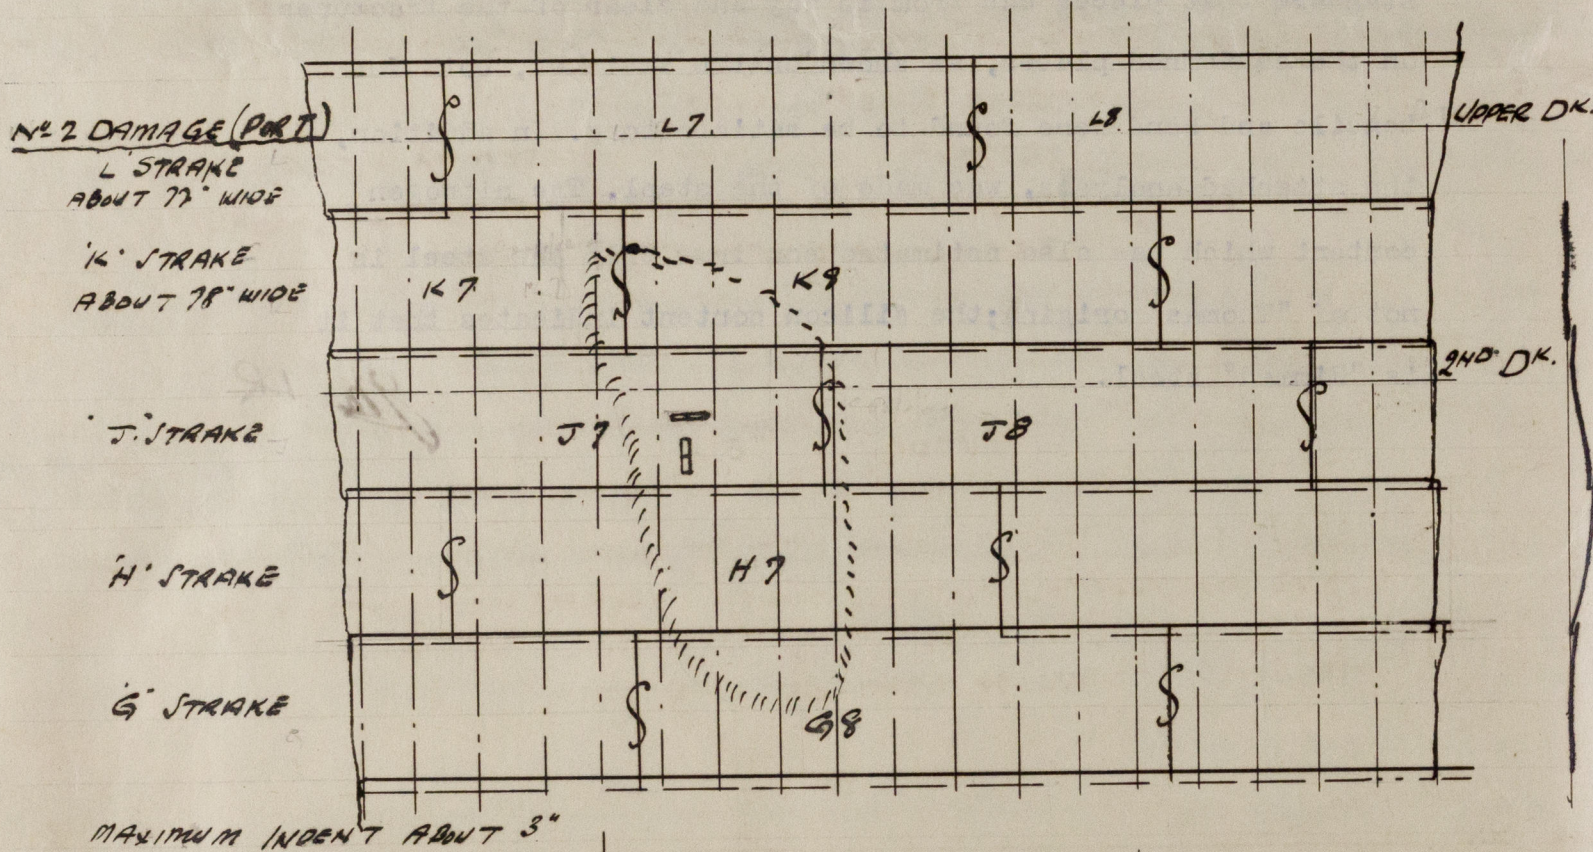
MAXIMUM INDENT ABOUT 3"

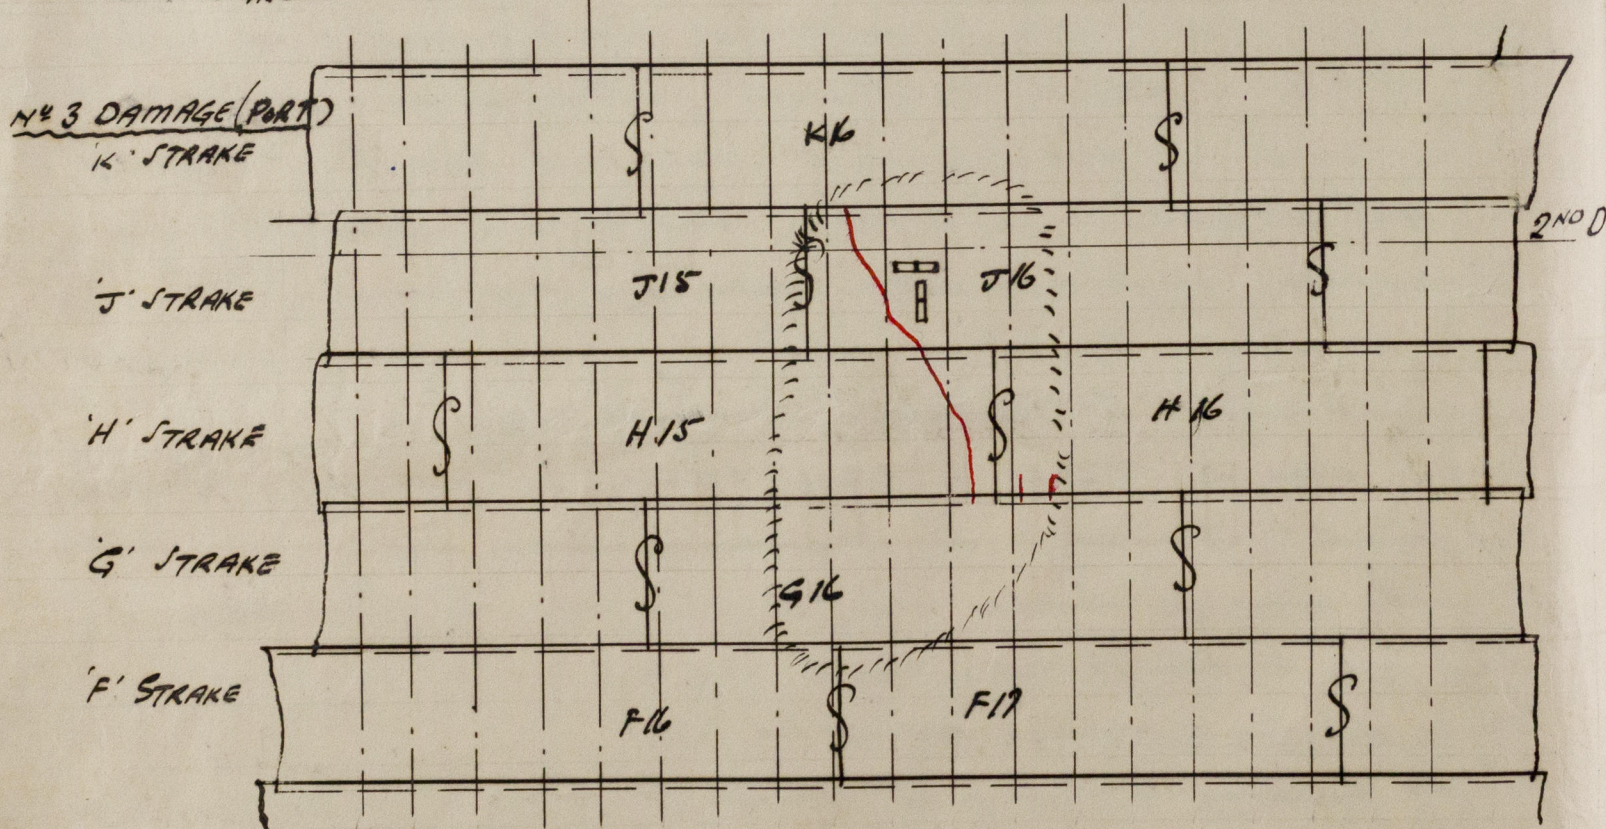
EXTENT OF FRACTURES SHOWN IN RED.

MAXIMUM INDENT ABOUT 5" IN WAY OF FRACTURES
