# REPORT OF SURVEY FOR REPAIRS, &c., OF ENGINES AND BOILERS

on the Machinery of the Wood, Iron or Steel S.S. "VACPORT"

S.S. "VACPORT"

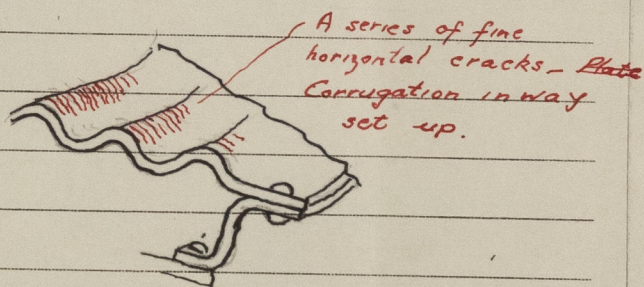
SKETCH SHOWING FATIGUED FURNACES

Centre furnace found fatigued at bottom sector of the 2<sup>nd</sup> & 3<sup>rd</sup> corrugations from the F.E.P. (See Sketch) & heavily cracked on S. side of the 3<sup>rd</sup> corrugation - this crack now veed out & welded.

Starboard furnace found fatigued at bottom sector of the 1<sup>st</sup> & 2<sup>nd</sup> corrugations from the F.E.P. & deeply cracked on P. side of the 2<sup>nd</sup> corrugation - this crack now veed out & welded.

Port boiler:- Centre furnace found fatigued at bottom sector of the 2<sup>nd</sup> & 3<sup>rd</sup> corrugations from the F.E.P. & heavily cracked at the S. side of the 3<sup>rd</sup> corrugation - this crack now veed out & welded.

Port furnace shows slight fatigue cracks at the bottom sector of the 2<sup>nd</sup> corrugation from the F.E.P.

It would appear from the above that the oil fuel burners of the boilers are not adjusted correctly & the greatest heat transfer is taking place in way of the first three corrugations; the position is being investigated & it is stated a new type of burner tip will be fitted.

On completion of repairs the boiler was hydraulically tested & found satisfactory. It is recommended that the centre & starboard furnaces of this boiler be specially examined at next B.S.

It is recommended that the centre furnace of this boiler be specially examined at next B.S.
