S.S. "GRETASTON"

Dimensions .....401.54 x 52.73 x 30 feet.

This vessel, which has been constructed in accordance with the requirements of the Revised Rules by Messrs. R. Duncan & Co. Ltd., Port Glasgow, was completed in February 1924.

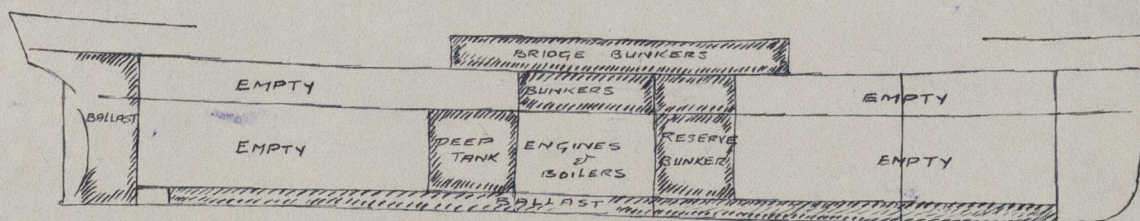
While on her first voyage from Glasgow to Bahia Blanca buckling of the bridge deck plating was reported to have taken place in the vicinity of the machinery casing. The vessel sailed in ballast condition, the double bottom, after peak tank, and the deep tank amidships which holds 860 tons of water, being full. The reserve bunker forward of the machinery space contained 944 tons of coal, an additional coal reserve of about 990 tons being carried in the bridge and 'tween decks amidships. The cargo hold spaces were empty.

The total load placed on board the vessel on leaving Glasgow was 4016 tons, 3274 tons of which was concentrated over a length of 135 feet amidships. The total deadweight of the vessel in the load condition is 8700 tons disposed over the full length of the vessel.
