Continuation of Report No. 4929 dated

March 1946 on the

১৫. "Maute Isabela"

SS. "Monte Isabela" List of drillings of the outside Plating

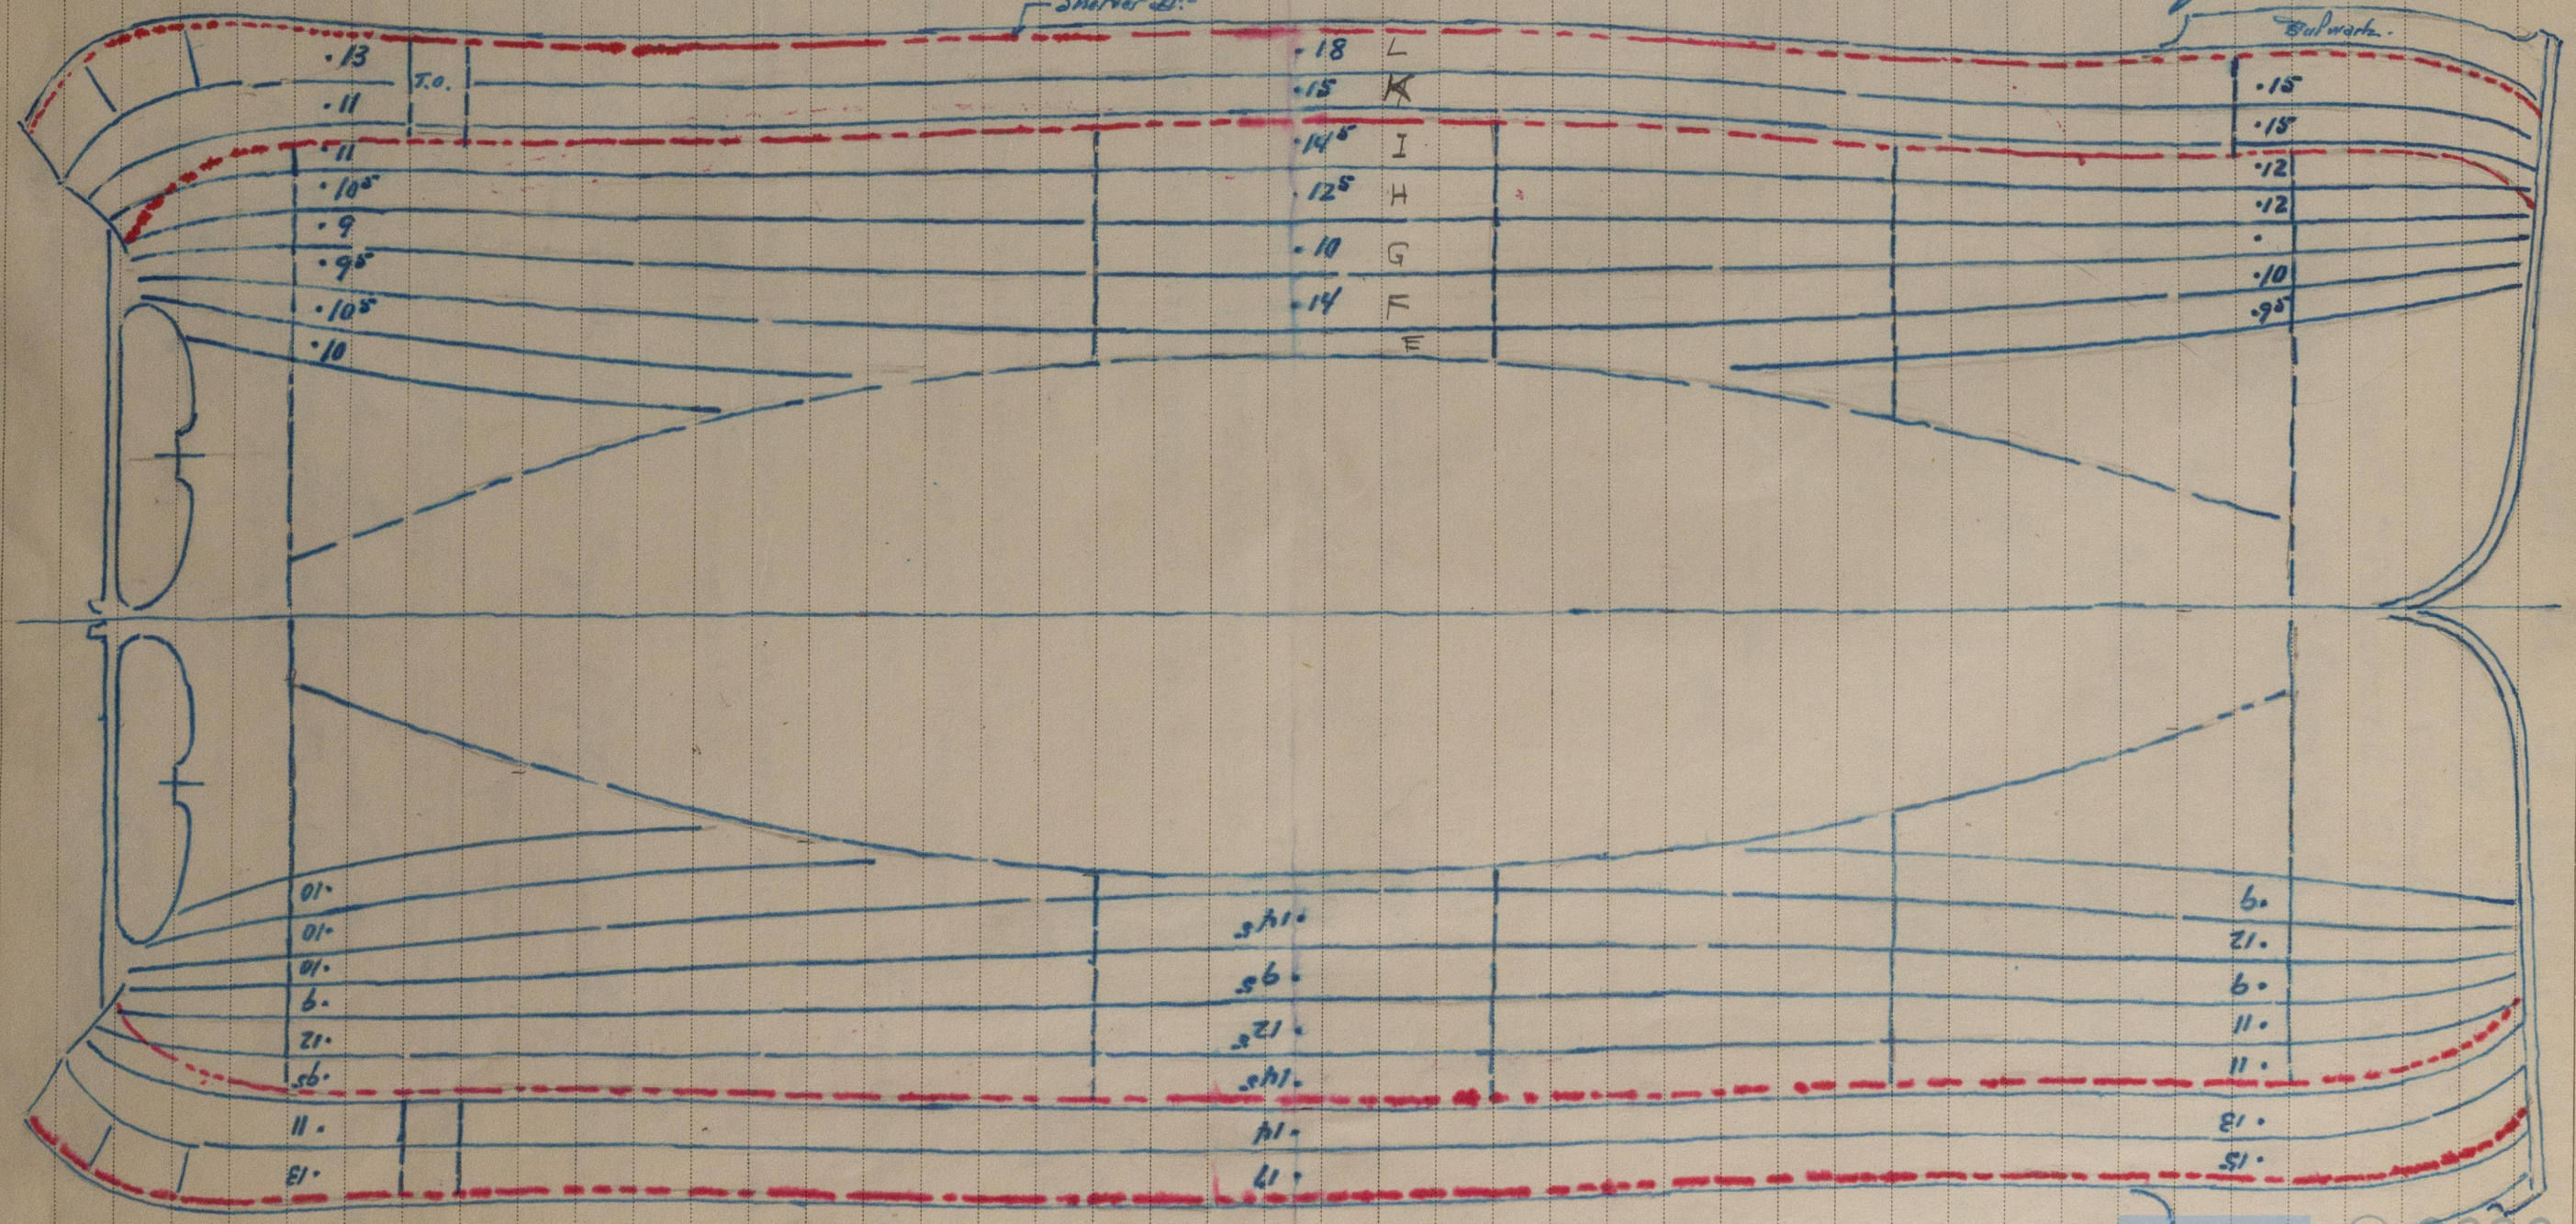
Starboard Side

Thickness given in Millimetres 3.46
