Lloyd's Register of British and Foreign Shipping

PORT OF BARCELONA 17 Dec 1908

Re steamer *Delfin* ex *Ophie* Report

Nº 645

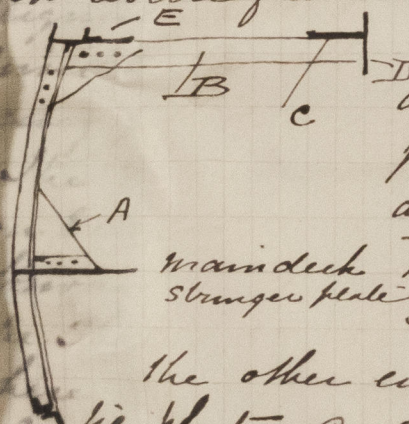
The doors were entirely removed and the frames and reverse frames prolonged from below being connected as in a repair job.

A bracket plate A being further provided secured to the frame and the main deck stringer plate.

To each alternate frame a half beam ^B was fixed, secured at

the other end first to a longitudinal plate C, which plate was prolonged at each end to come over two complete beams already existing, and secondly to the hatchway carlings. The frames and reverse frames were made of $3\frac{1}{2} \times 3\frac{1}{2}$ angles. The half beams B were made of the same scantlings as the whole beams already existing for this deck. The stringer plate E with its angles was of the same width and thickness as the stringer plate already existing on this ^{partial} deck. It was carried about 6 feet beyond the opening on

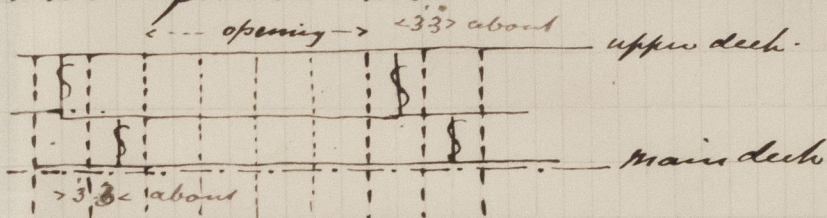
The plating, in two shakes of equal to those on each side and of the same was fitted thus. The butts being

as the others already existing in same shakes —
