1105 on the ~~Wood, Iron or~~ Steel Ciudad de Reus. Master E. C. Pracartequi
TONNAGE:- Built at Grangemouth By whom Grangemouth Ship Co. When 1893. 2.
GROSS 1608 Owners La Mutua Sociedad Anonima Port belonging to Barcelona.
UNDER DK. ✓

REPAIRS, OR EXAMINATION AS PER RULE, FOR *Survey of repairs*

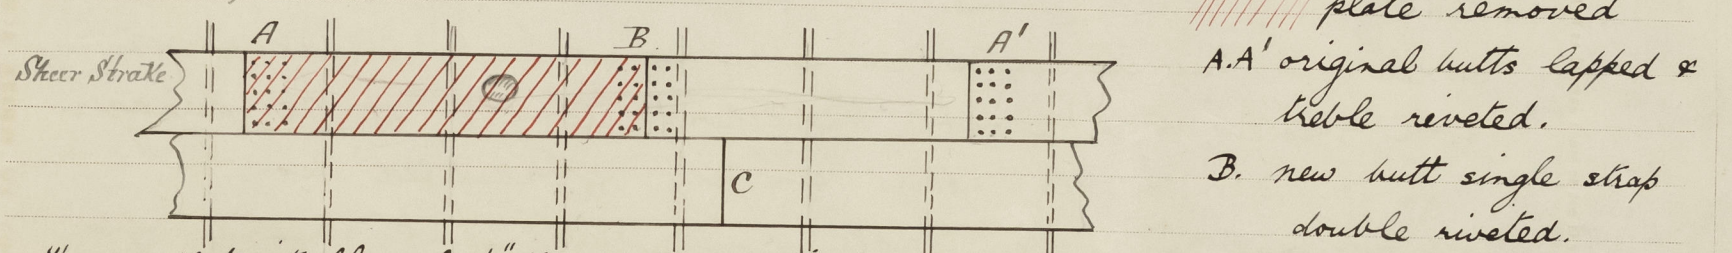
On the starboard side aft abreast of the engines and in way of one of the cabins the sheer strake was found corroded and cut out without advising me it was cut thus: |||||

The new plate itself nearly $\frac{1}{8}$ " thinner than the original one. c. Butt in adjoining strake
I at once pointed out to the master that this repair could not be passed for the
following reasons.

- 1st. Plates must be equal to 6 frame spaces.
 - 2nd. No butts in adjoining strakes can be nearer than 2 frame spaces.
 - 3rd. That the new plate cannot be of less thickness than the original one.
 - 4th. That the butts must at least be equal to the original ones
- The Repairs as being carried out did not fulfil any of these requirements.

The plate had been cut on the 19th or 20th. I saw it on the 21st and at once advised the Master as above - On the 22nd finding that the repair was being proceeded with. I again called the Masters attention to the impossibility of admitting it and wrote to the Company as per copy enclosed - I could get no reply from either Master or Manager except that, if the Committee insisted on it the plate would be entirely renewed when the vessel was again in Barcelona.

As there would have been ample time to renew the whole plate and I pointed out the dead loss it would be to the owners' if they persisted in carrying out the repairs in the form objected to I cannot understand the action of the manager. In my opinion the repairs can only be considered as provisional and the whole plate ought to be renewed before December next. This especially as the engines are far aft and

I understand cause a great deal of vibration.

As the repairs to sheer strake are not in accordance with the Regulations and were carried out in spite of both verbal and written protest made when there was ample time to carry out the said repairs in a proper manner I beg leave to recommend that the said repairs be considered as only provisional and to be made permanent before next December.
