## REPORT of SURVEY for REPAIRS, &amp;c.

REPAIRS, OR EXAMINATION AS PER RULE, FOR Special Survey N° 3 for Classification.

"CROWN ARUN" ex "HANNAH BÖGE"

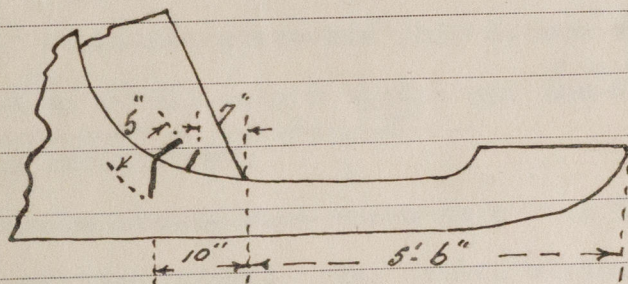
LOOKING ON PORTSIDE.

Found fracture in solepiece of stern frame, this was weed out and electric welded (P.S.), recommend to be specially examined next docking.

This vessel is in an efficient condition & eligible in my opinion to be classed 100 A—, with record of survey 12,39 & the notation of S.S. Lth N° 3-12,39, subject to Solepiece of stern frame (C.W. 12,39) to be specially examined next docking.
