Survey held at HAMBURG Date, First Survey 7 Last Survey 4th Dec. 1931.
 (No. of Visits 1)

on the Machinery of the Wood, Iron or Steel S.S. "ELSA MENZEL"

Gross 6559 Vessel built at Kiel By whom Lüthgen S.B. Co. When 1921-5
 Net 3996 Engines made at Glasgow By whom J. Henderson & Co When 1921
 Main Boilers 3 M.T. Boilers, when made Main (Donkey)

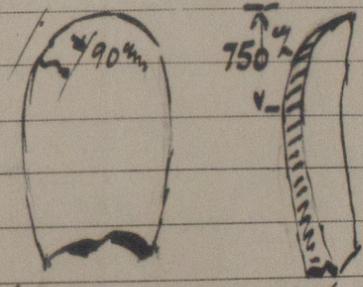
At request of the Owners representatives examined the propeller (brass) - damage alleged sustained in consequence of vessel's collision with quay wall at Lüttenau on the 25th Sept. 1931. - vessel on a voyage from Lundersvall to the U.S.A. and found one lip of the propeller bent forward and a crack of 90th in length near tip. (Please see sketch). Due to shortness of time vessel has been only dipped, and crack drilled off.

as seen, appear to be in satisfactory condition and eligible in my opinion to remain as classed in the Reg Bk without fresh revision to re-examination of the propeller in Dry Dock after vessel's return on present voyage to America and back to Hamburg.
