S.S. "MINDEROO" *Free Refit* No 804

Rough Sketch showing upset in bottom of Hull & Tank tops and Engine bed plate fractures. When vessel rested aground at Port Hedland on 14-9-35

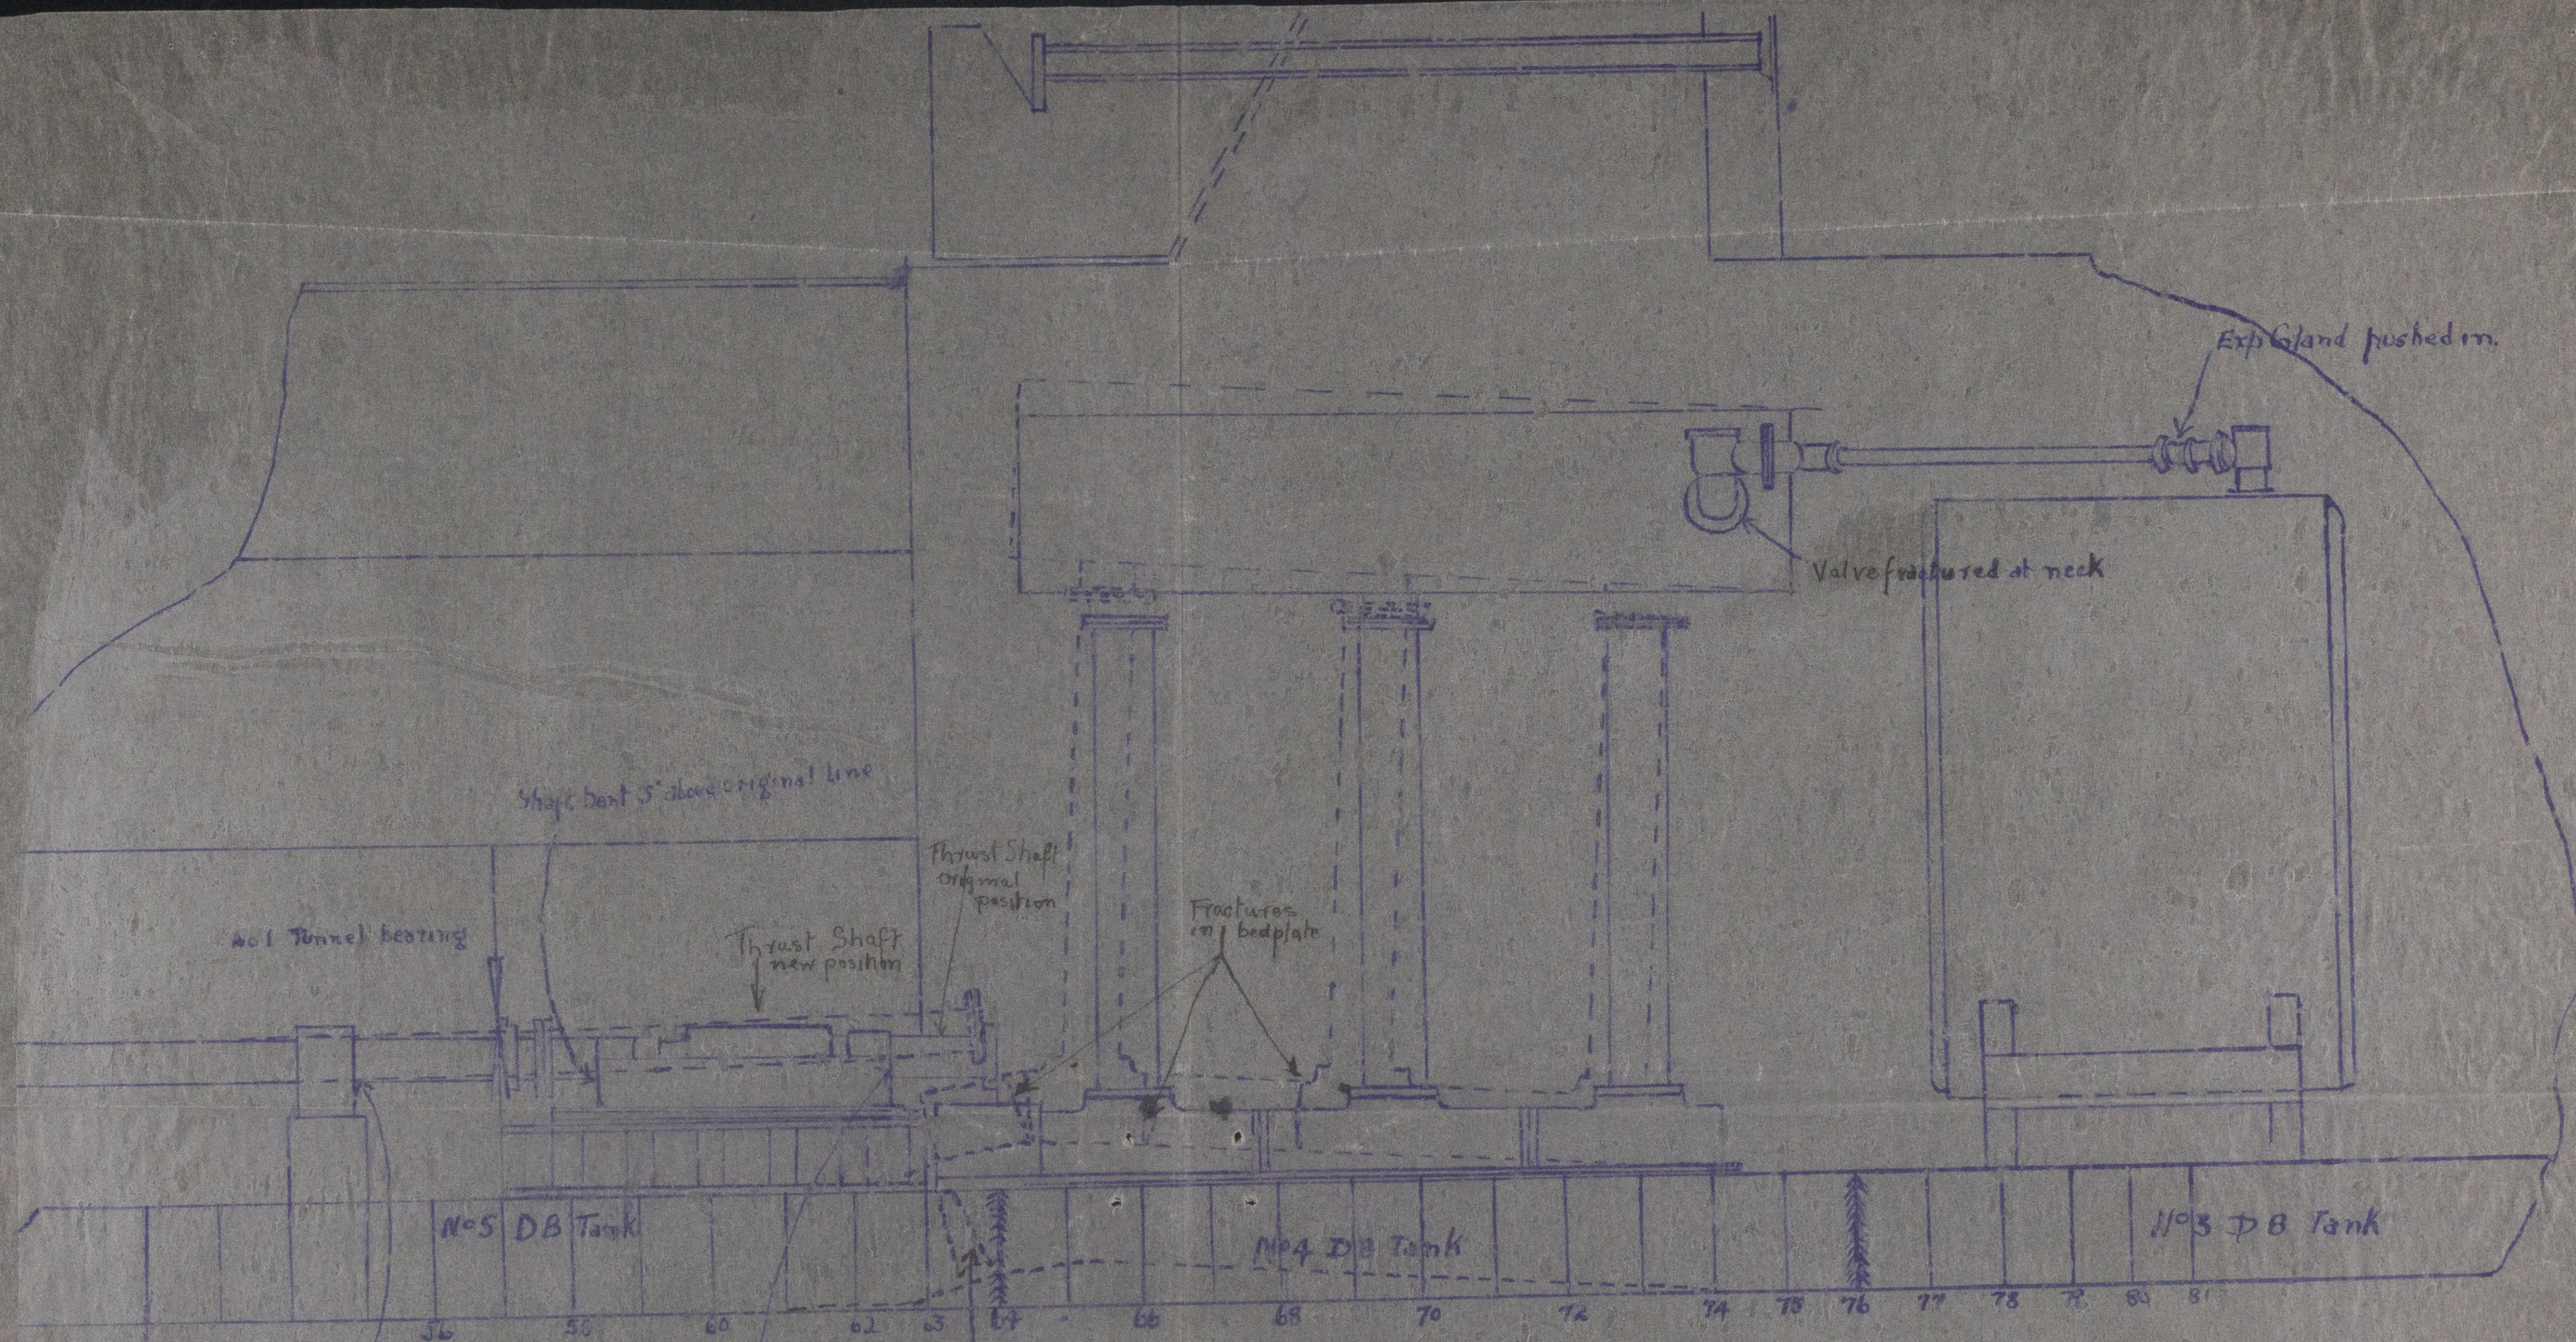
Shaft bent 5" above original line

Fractures on bedplate

Valve fractured at neck

Exp Gland pushed in.

Shaft bent 1" above original line.

Shaft now bent 6" above original line.

Keelson buckled seriously in first bay aft of No 4 No 5 Tank Division resulting in upset of Tank Tops & Engine structure
