S. S. Marengo

S. S. Marengo
at Hull
24/1/13.

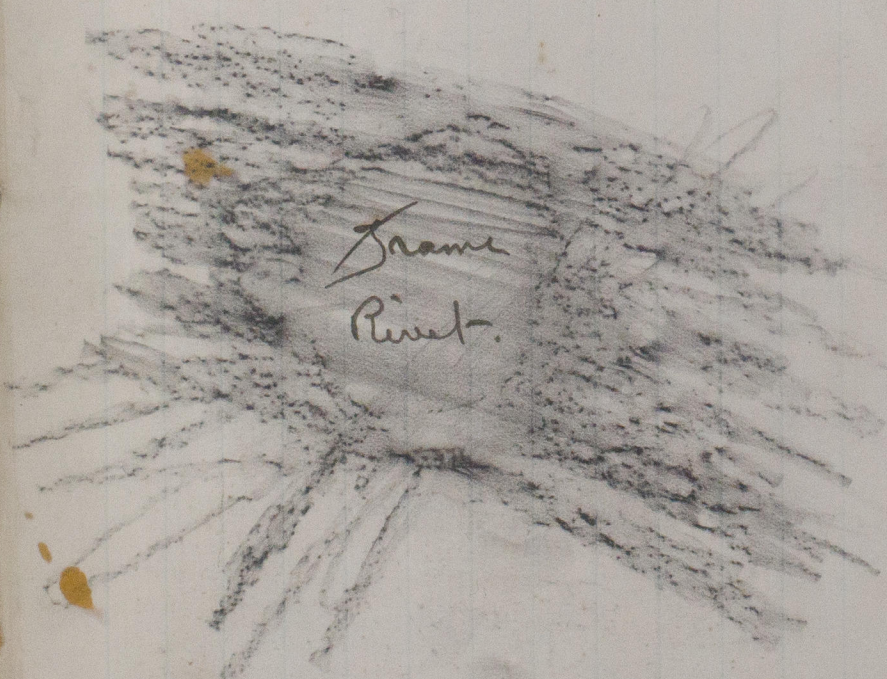
Rubbing from Portside
in 6th Space

Fracture in 6th Space abaft Collision Bulk
in E. strake No. 2 (Portside)

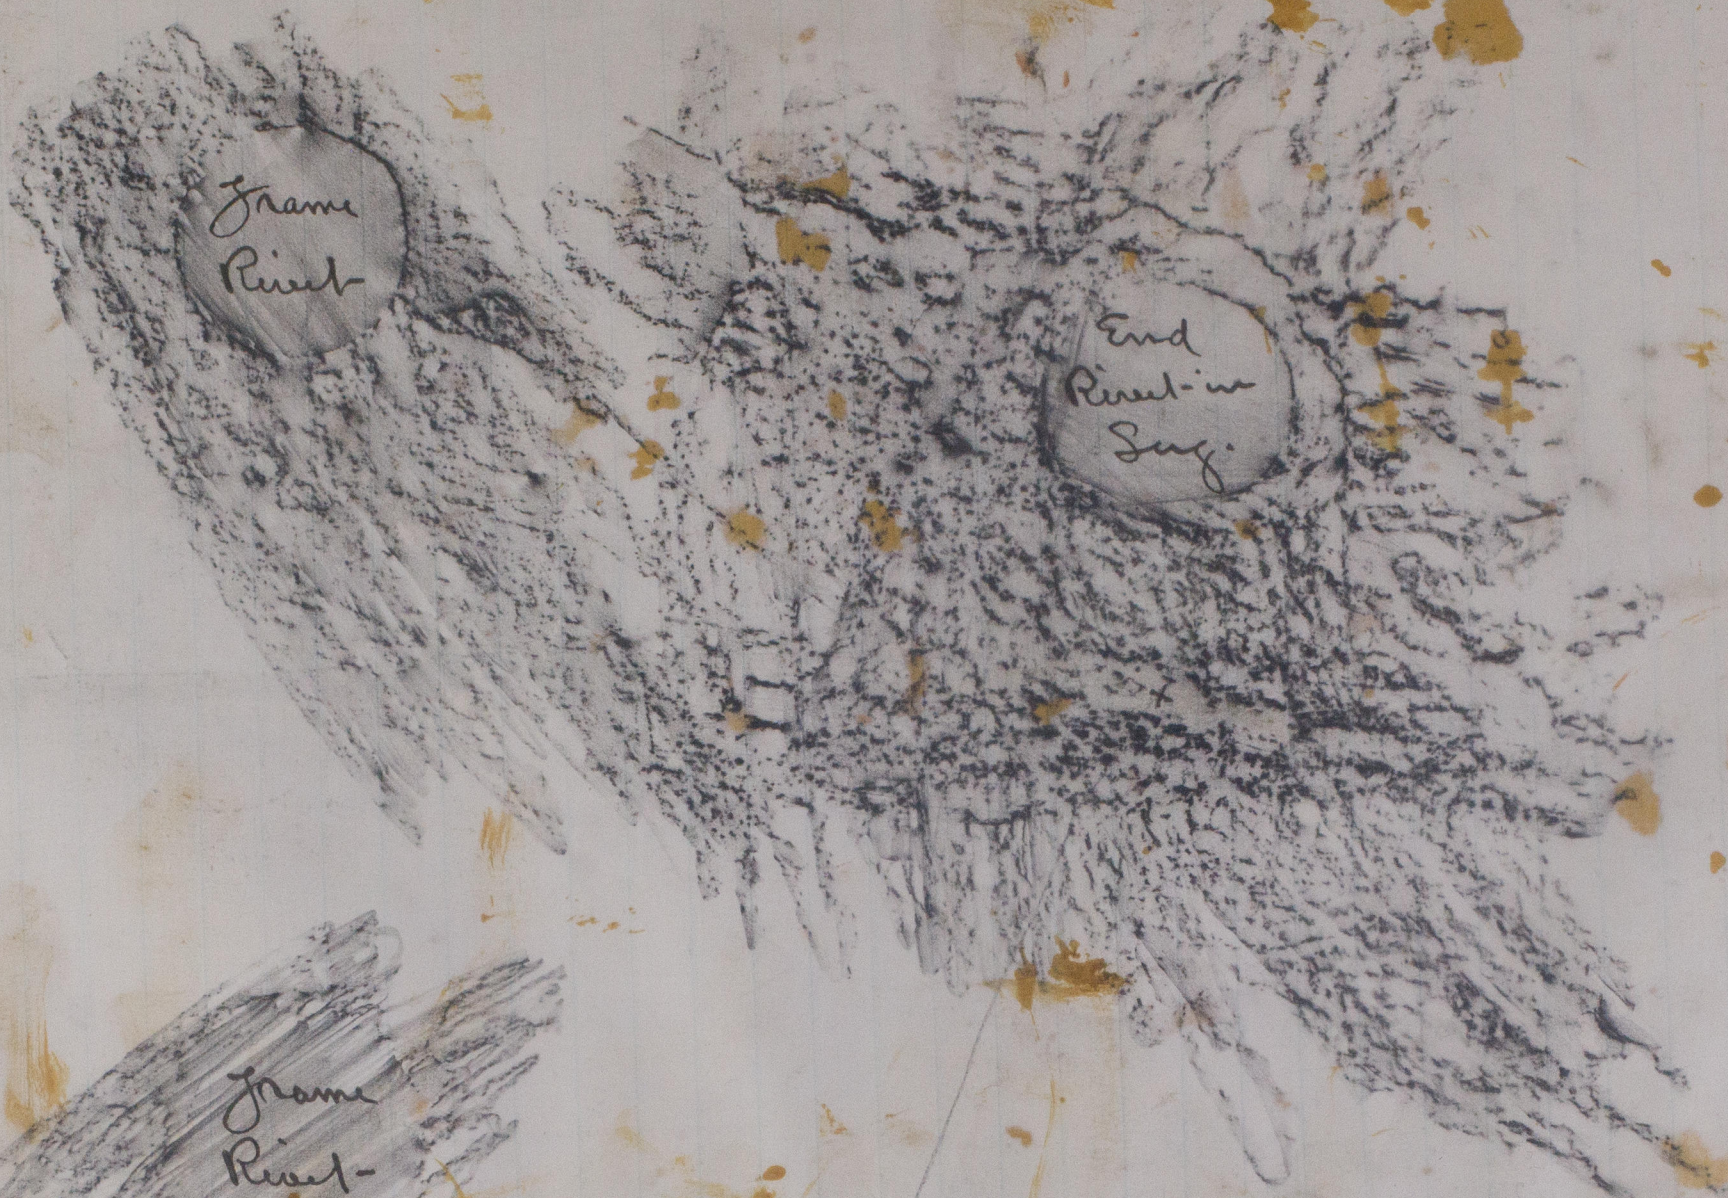
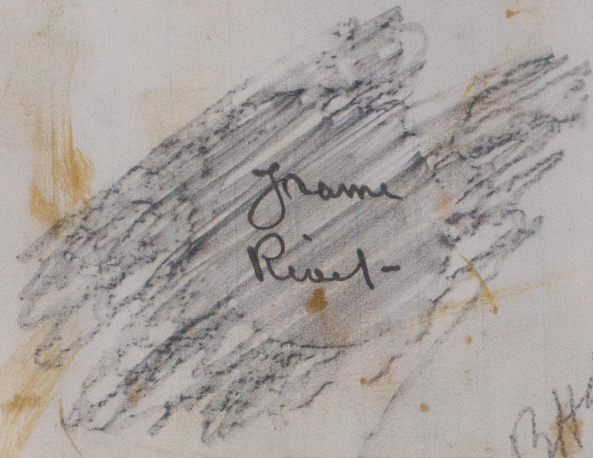
2nd space
in 6th str. Portside

*Slight fracture
in 2nd space abaft Peak Wh. on Portside
in E. strake No. 2 from Stem.

Shell plates about 28 ft. in length.
