New York, Feb. 24th, 1911.

SS "CACIQUE".

W. R. GRACE & CO.
NEW YORK.

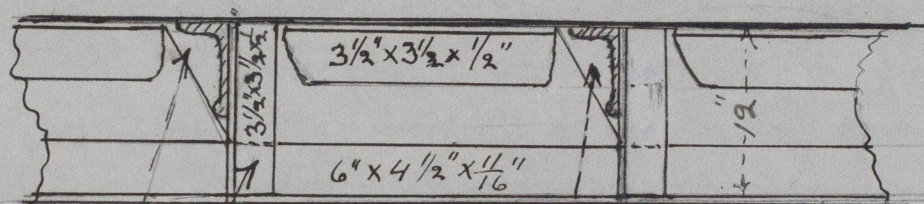
Rough sketch of Girder under decks

My own opinion is that it is more the fault of construction than of design, and I enclose you a rough sketch illustrating this view. On the sketch you will note that the vertical plate forming the backbone of the girder is cut away to allow the bulb beams to pass through and that

compensating strength by means of an angle lug has only been given to the vertical plate on the flat side of the bulb beam.

I think that you will agree with me that the only strength left in the girder is the depth of the bottom angles, viz: 4 inches. To put it in a more concrete form, if you were to take a saw and cut from the bottom of the triangular piece cut out to the bottom of the girder, you would have absolutely no girder left and, therefore, you have two-thirds practically of the strength of the vertical member of your girder cut away.

Vertical plate cut away to allow
bulk beams to pass through.

Compensating angle lug on one side of beam.
