## REPORT of SURVEY for REPAIRS, &amp;c.

No. in Survey held at Barry Date, First Survey 1-9-30 Last Survey 23-9-1930  
Reg. Book. 76212. on the Wood, Iron or Steel S LA CRESCENTA Master

REPAIRS, OR EXAMINATION AS PER RULE, FOR DOCKING, DAMAGE AND PART SPECIAL SURVEY N°2.

S/S LA CRESCENTA.

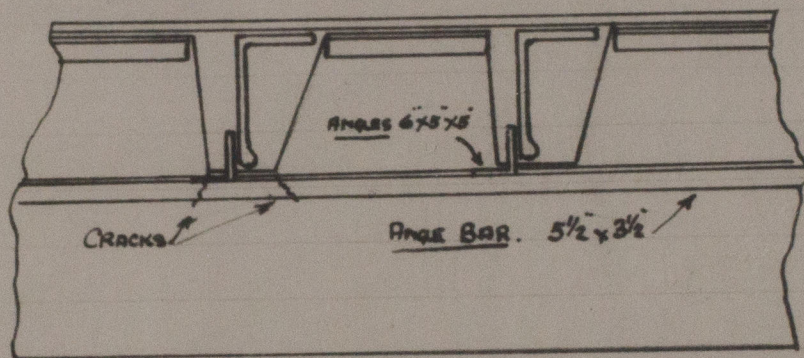
In No 8 tank on port and starboard sides, the lower side stringer plates were found to be slightly fractured where plotted out for the frames; as compensation inner stringer angles  $5\frac{1}{2} \times 3\frac{1}{2}$  have been fitted on the face of the frames, connected to same by lugs and riveted to the stringer plates.

A SIDE STRINGER SHELL LUGS RENEWED, OR REMOVED & RE-RIVETED AS FOLLOWS.
