Report of Survey for Repairs, &c., of Engines and Boilers.

Survey held at Barry

on the Machinery of the Wood, Iron or Steel S.S. LACRESCENTA

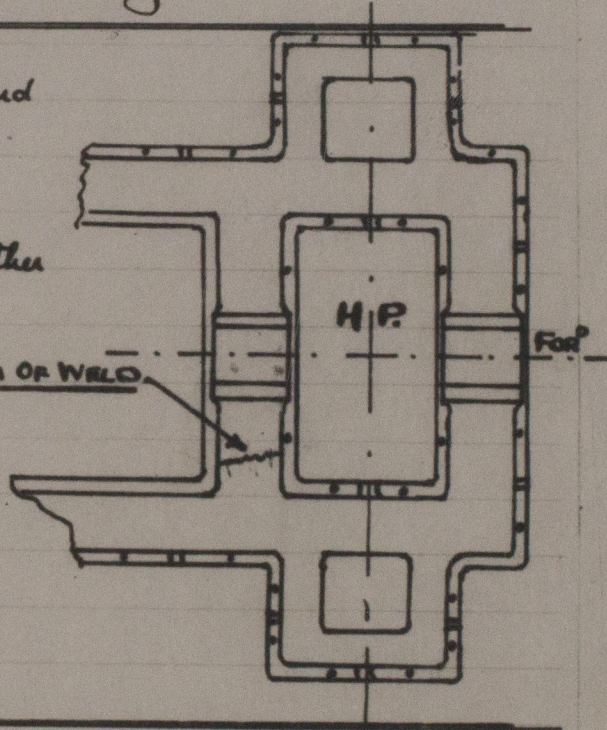
POSITION OF WELD

DAMAGE REPAIRS: Top halves of all main bearings dressed up and oil ways deepened.
 Crack in bedplate after HP bearing on starboard side, weed out and built up solid with electric welding. (SEE SKETCH BELOW).
 Thrust shoes dressed up and oil ways deepened.
 MP and LP guide shoes remetalled. and refitted in place.
 All holding down bolts of main engine tested and hardened up as found necessary. 7 bolts renewed.

LIMIT:- Crack in bedplate, after HP bearing on starboard side, weed out and built up solid with electric welding.
 It is recommended that this repair be further examined before the end of March 1931.

seen is eligible in my opinion to remain as classed with fresh record of survey LMC MS with date when the survey is completed as stated above, and records of BS 9.30, and screw shaft (CL) seen 9.30 now; subject to electric repair of main engine bedplate being specially examined before the end of March 1931.
