REPORT of SURVEY for REPAIRS, &c.

76212 on the Wood, Iron or Steel S LA CRESCENTA Master

REPAIRS, OR EXAMINATION AS PER RULE, FOR DOCKING. DAMAGE AND PART SPECIAL SURVEY N°2.

S/S "LA CRESCENTA"

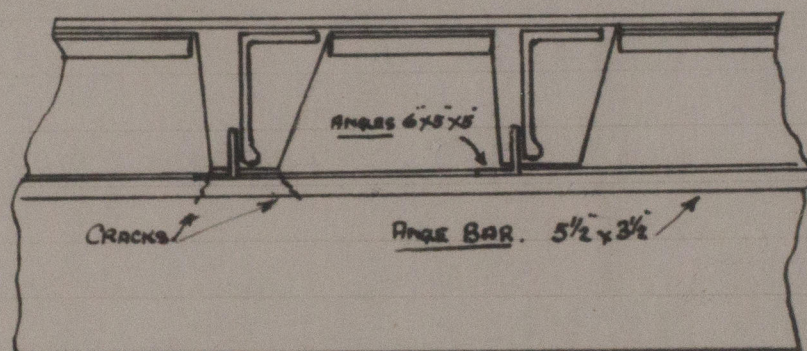
A SIDE STRINGER SHELL LUGS RENEWED, OR REMOVED & RIVETED AS FOLLOWS.

DAMAGE REPAIRS NO 1: All cargo tanks (except summer tanks) examined and tested by water pressure as per rule requirements, a number of shell rivets in side stringer lugs, particularly in the lower stringer were found loose and leaking.

In No 8 tank on port and starboard sides, the lower side stringer plates, were found to be slightly fractured where platted out for the frames; as compensation inner stringer angles $5\frac{1}{2} \times 3\frac{1}{2}$ have been fitted on the face of the frames, connected to same by lugs and riveted to the stringer plates.

On testing, a number of rivets in the vertical stiffeners of the centre line, and transverse bulk heads, also in the lugs connecting the horizontal stiffeners were found leaking, and have now been renewed. Lugs removed for access and refitted as found necessary.
