Report of Survey for Repairs, &c., of Engines and Boilers.

76212 on the Machinery of the Wood, Iron or Steel S.S. LACRESCENTA

Particulars of Examination and Repairs (if any) Docking. Damage. TS.

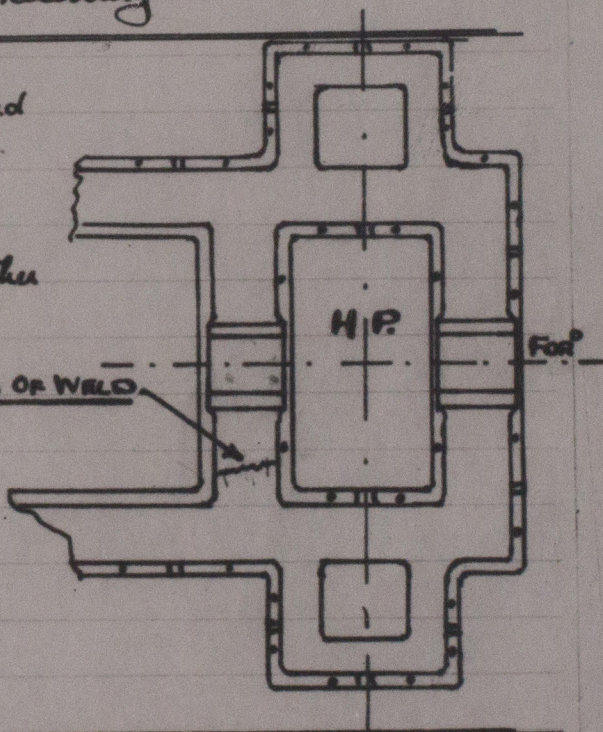
POSITION OF WELD

DAMAGE REPAIRS: Top halves of all main bearings dressed up and oil ways deepened.
 Crack in bedplate after HP bearing on starboard side, weed out and built up solid with electric welding. (See sketch below).
 Thrust shoes dressed up and oil ways deepened.
 MP and LP guide shoes remelted and refitted in place.
 All holding down bolts of main engine tested and hardened up as found necessary, 2 bolts renewed.

Crack in bedplate, after HP bearing on starboard side, weed out and built up solid with electric welding.

LMC MS with date when the survey is completed as stated above, and records of BS 9, 30, and screw shaft (CL) seen 9, 30 now; subject to electric repair of main engine bedplate being specially examined before the end of March 1931.

It is recommended that this repair be further examined before the end of March 1931.
