REPORT of SURVEY for REPAIRS, &c.

Date of writing Report.....19.....When handed in at Local Office 16/4 1923 Port of Hull
No. in Survey held at Hull Date, First Survey 4 Last Survey 9-4 1923
Reg. Book. 68839 on the Wood, Iron or Steel Lion Se NOWSHERA Master Workman Clark & Co. L^d
(No. of Visits)

Built at Belfast By whom Workman Clark & Co. L^d When 1919
Owners British India Steam Nav. Co. L^d Port belonging to Glasgow
Owners' Address

RS, OR EXAMINATION AS PER RULE, FOR Classification See Secretary's letter M. 4th April 1923.

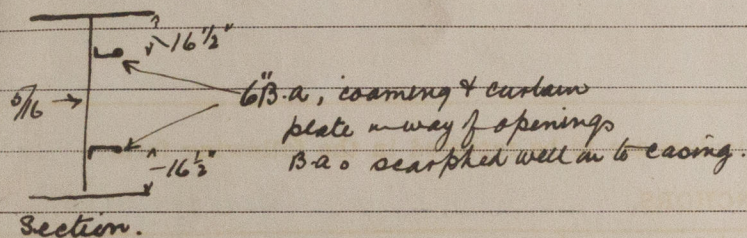
Section.

Frames spacing 36"

In cross bunker in hold * 9" B. a with $6 \times 3\frac{1}{2} \times \frac{1}{2}$ reverse bar.

Above lowest deck * $9 \times 3\frac{1}{2}$ B. a and $7 \times 3\frac{1}{2} \times \frac{7}{16}$ O. a on all frames

Half Beam at forward cross bunker under lowest deck $10 \times 3\frac{1}{2} \times \frac{1}{2}$ B. a

Beams under upper deck (first deck below weather deck) * $9 \times 3\frac{1}{2}$ B. a
