S. S. "Hartley"

Jan. 17th 1925.

CAUSE OF DISASTER

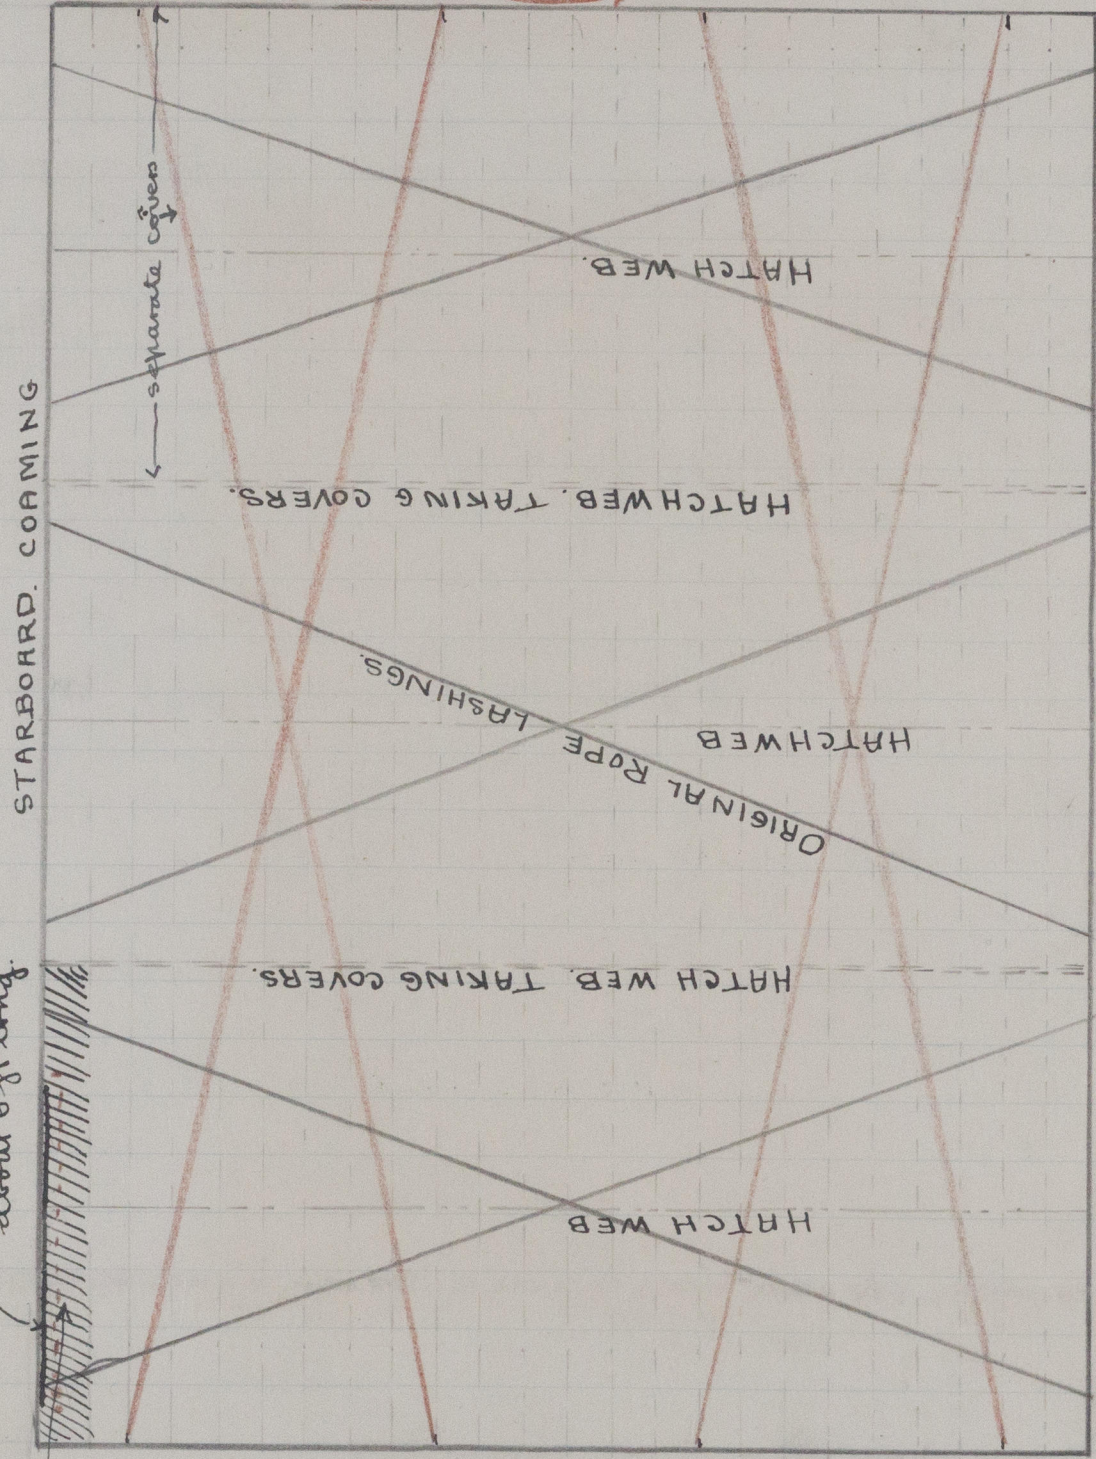
Nº 3 Hatch.

The lashings of No 3 Hatch stretched and were slack and practically useless.

Both tarpaulins were ripped in the same place right at the edge of the hatch coaming.

First hatch to be washed overboard.

Rips in both tarpaulins about 6 ft long.

Size of hatch covers about 11'0" x 11'3". approx: 96 covers per hatch.

Lashings fitted at 6.30 a.m. --- wedges tightened up or removed. Tarpaulins nailed to hatch AFTER cover COAMING.

Stems in red done after rip in tarpaulins first found.
