Report, No. 10749 Port Don

RIVER TREES Proposed Modification to Rudder. Scale 1" = 1 foot.

S. S. River Tees.

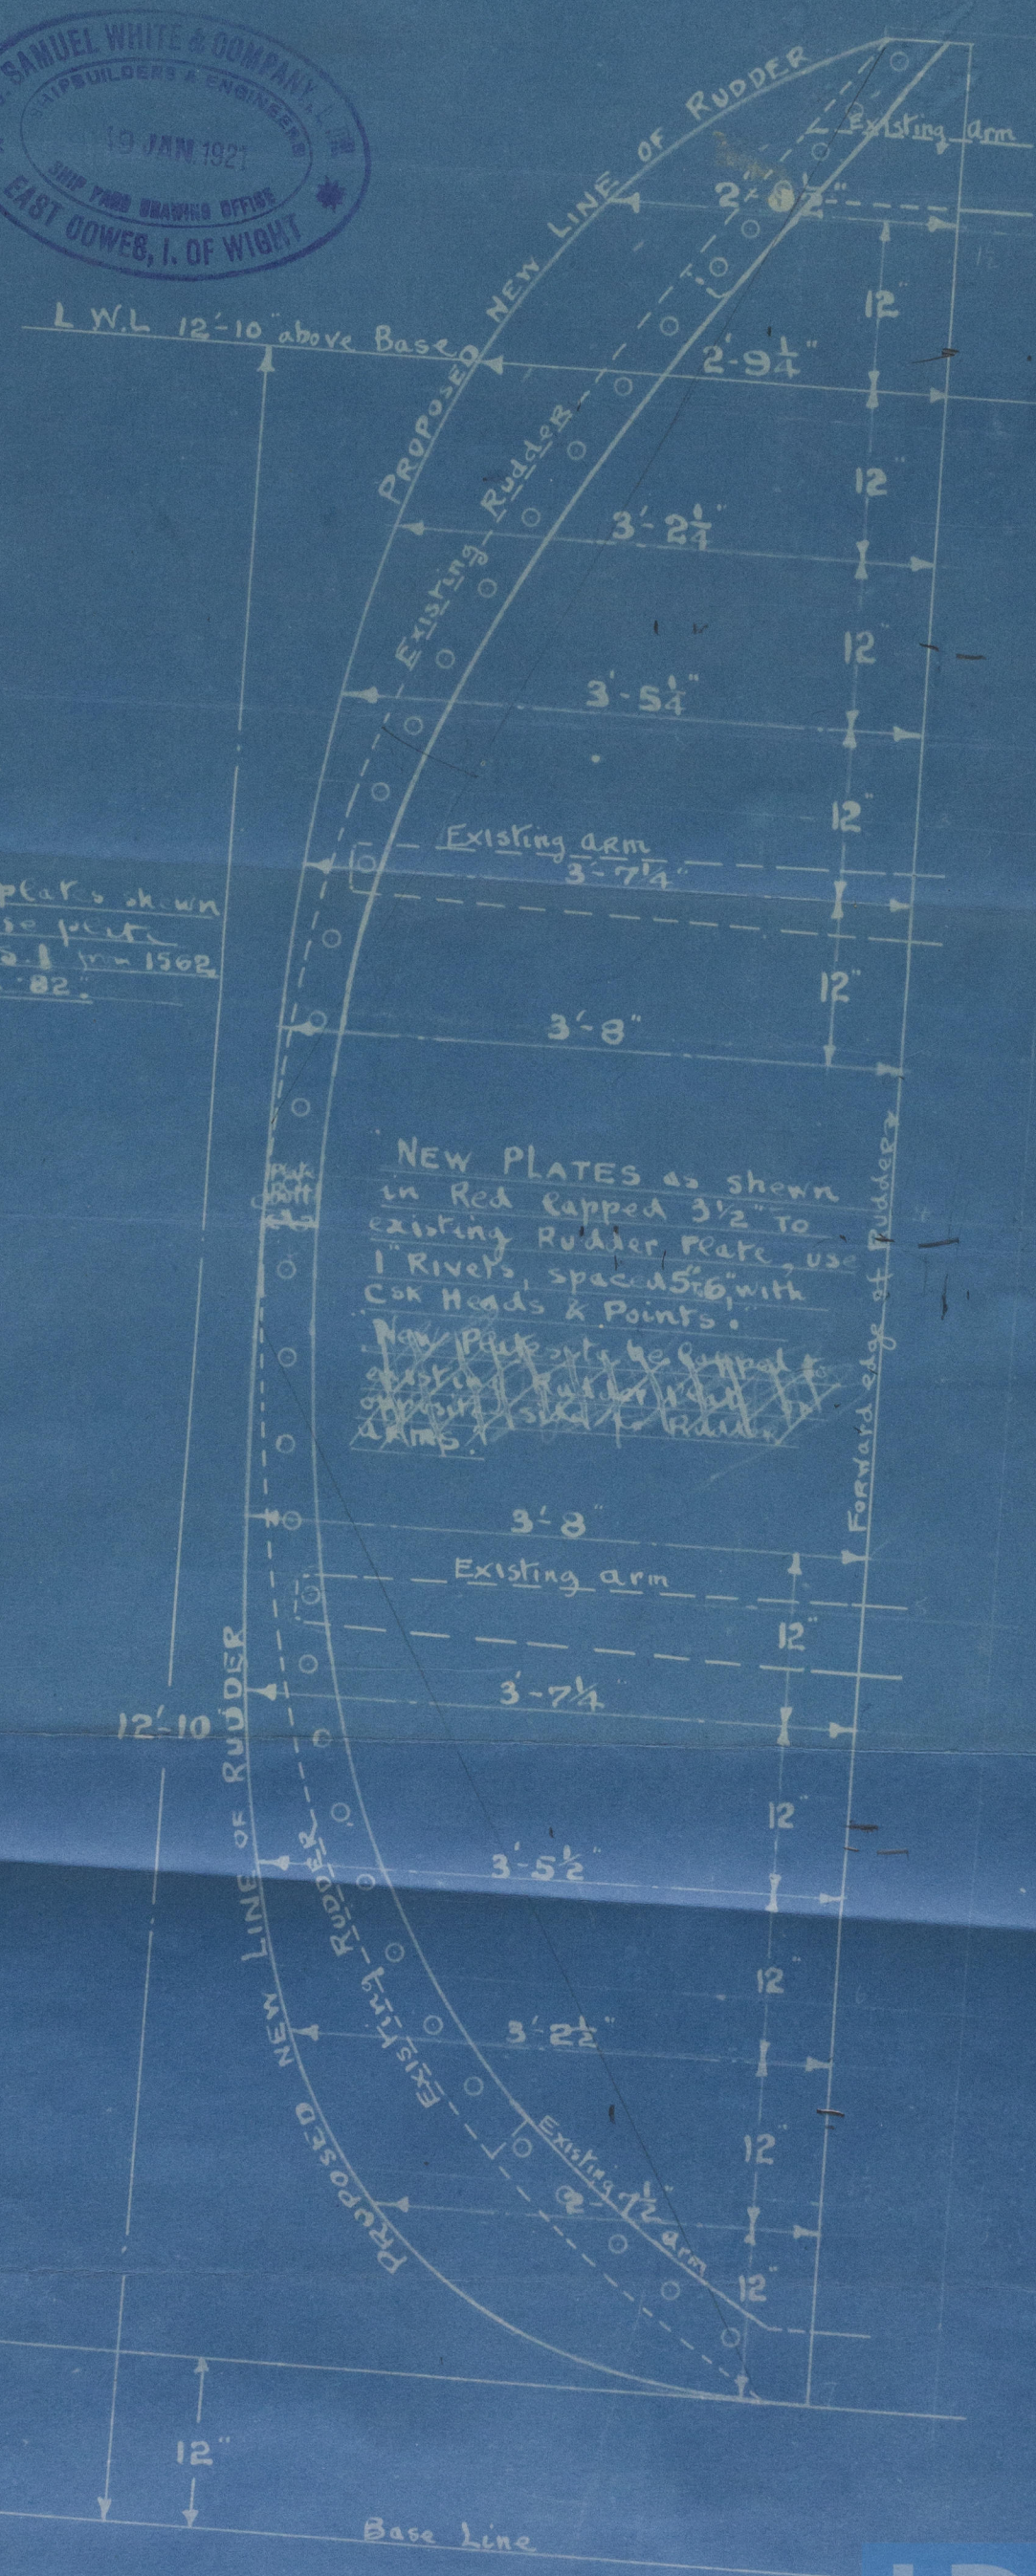
alteration to
existing Rudder
Plate.

For new plates shown in Red, use plate marked K.S. 1 mm 1562 10'-2 x 17' x 82.

NEW PLATES as shown in Red capped 3 1/2" to existing Rudder plate, use 1" Rivets, spaced 5 1/2" with Cork Heads & Points.
