REPORT of SURVEY for REPAIRS, &c.

Date of writing Report 19... When handed in at Local Office 31/3/1931 Port of NEWCASTLE-ON-TYNE
No. in Survey held at Helburn on Tyne Date, First Survey 5 Aug/30 Last Survey 23 March 1931
Reg. Book. "SARANAC" (No. of Visits 95)

83720 on the Wood, Iron or Steel SS. "SARANAC"
TONNAGE: GROSS 12070 Built at Newcastle By whom Palmers Co. Ltd. When 1918 57
UNDER DK. 9024 Owners Anglo-American Oil Co. Ltd. Owners' Address
NET 7551 Managers J. Hamilton Port belonging to Newcastle

SS. "SARANAC"

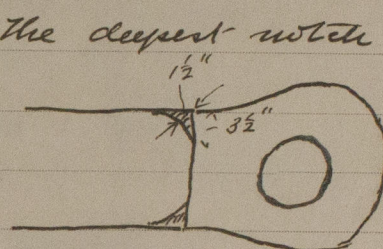
on stern frame in way of judgson at about 13' mark eroded
notches were observed - 4 in no at top bottom of judgson and
on both sides. These were thoroughly cleaned

and bottomed
1½" deep and there
was no indication
of fracture.

These were thoroughly cleaned

These notches have now been filled by electric welding which in my opinion may be taken as a satisfactory permanent repair.
