## REPORT of SURVEY for REPAIRS, &amp;c.

Date of writing Report 2nd June 1939 When handed in at Local Office 1939 Port of Amsterdam  
 No. in Survey held at Amsterdam Date, First Survey 3rd Jan 1938 Last Survey 22nd May 1939  
 Reg. Book. 33331 on the Wood, Iron or Steel M/V. SCOTTISH MAIDEN (No. of Visits 51)

REPAIRS, OR, EXAMINATION AS PER RULE, FOR Special Survey No 3 and Alterations.

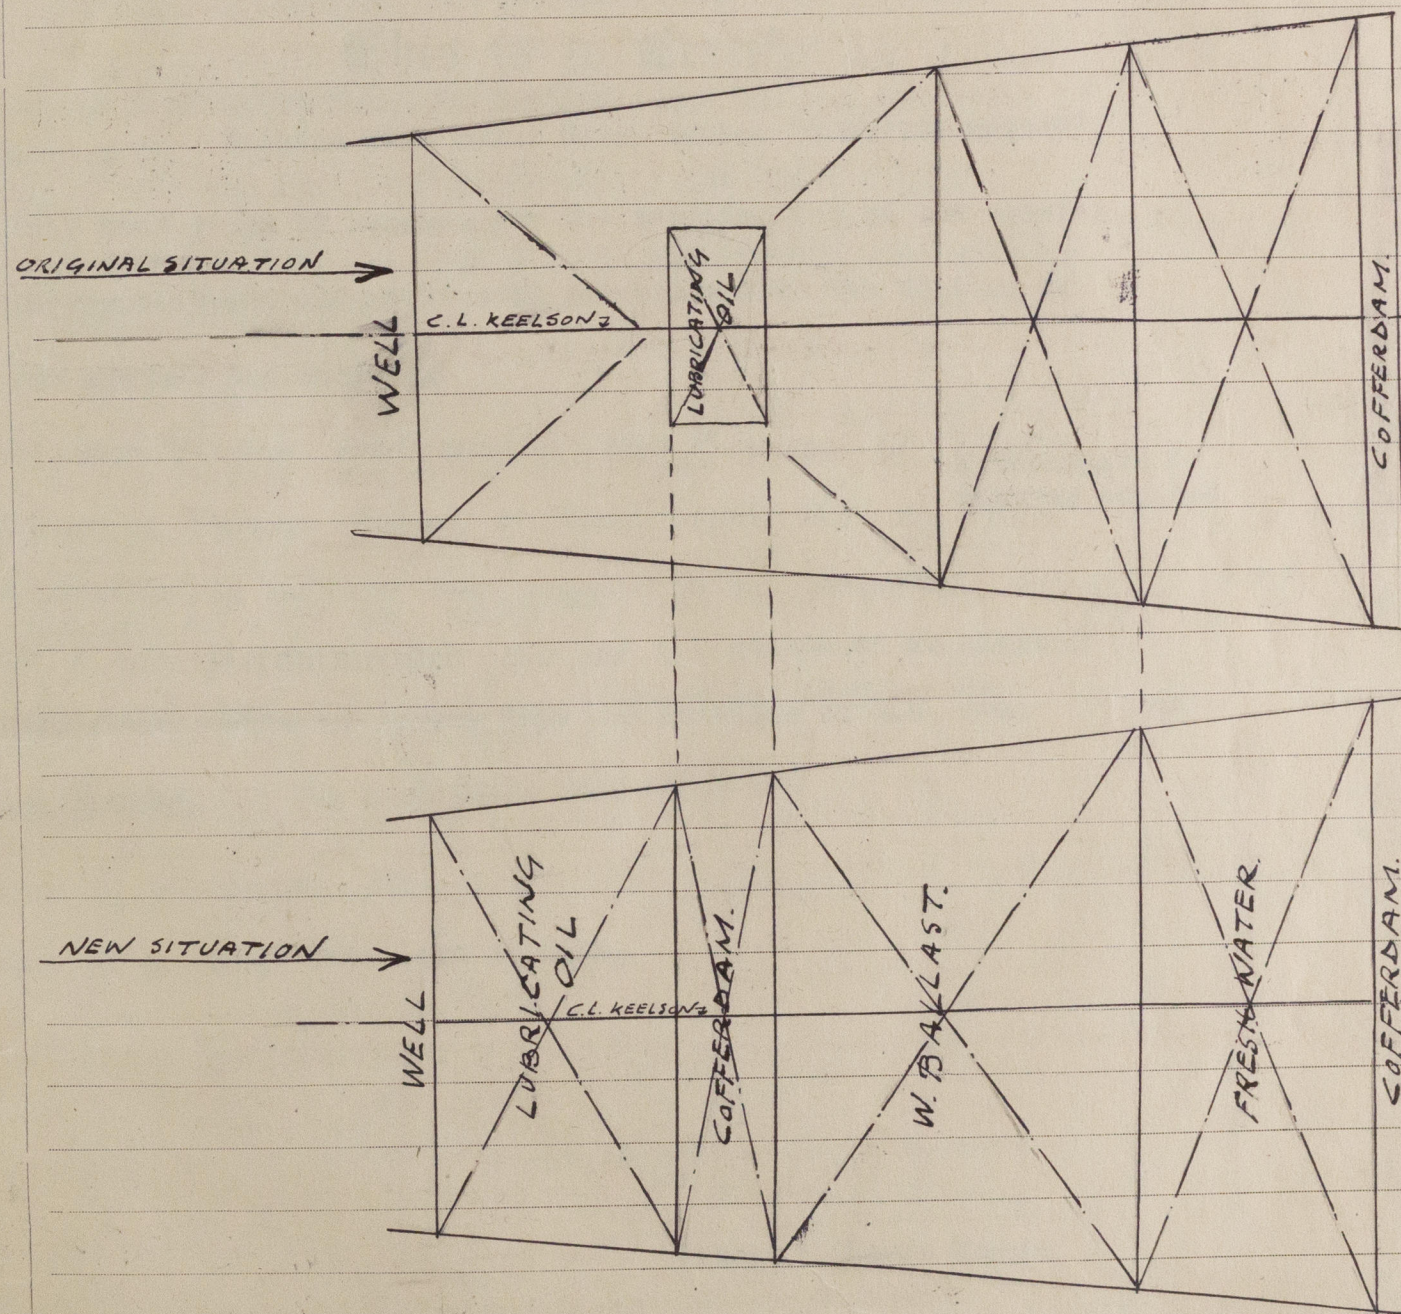
In connection with the fitting of new main engines and new Donkey-boiler have new seatings in the Eng. Room been fitted and has the platform in the Eng. Room intended for the Donkey Boiler been altered, all in accordance with the approved plans, please see your letters M 14-10-'38 and M 20-12-'38 copies of which are retained in the London Office. The workmanship was found good and the material used in the construction made by the Open Hearth Process and tested by the Society's Surveyors as required.

The subdivision of the respective E.R. D.B Tanks has been changed as showed in the sketches here below.

Upon completion of the work have the Eng. Room D.B. tanks been tested and found tight.
