S.S. "FOLIA"

HULL DAMAGE.

S/S Folia
Repairs made in
Montreal

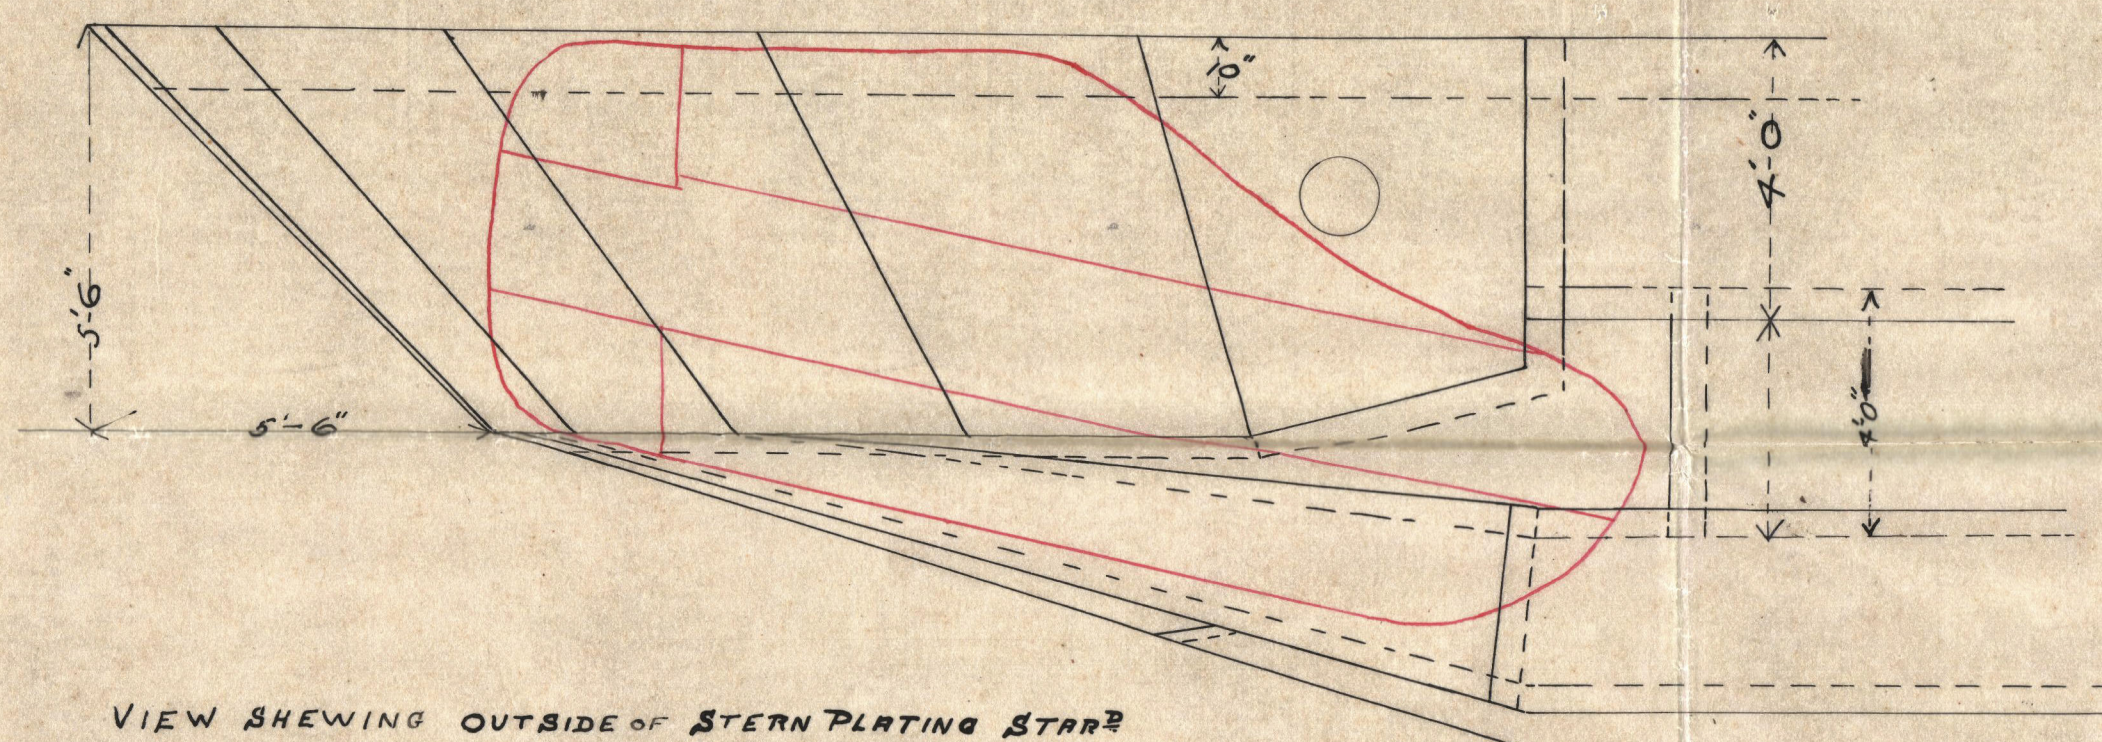
VIEW SHEWING OUTSIDE OF STERN PLATING STARBOARD
 WITH PATCH IN POSITION
 3 SHELL AND 5 TRANSVERSE PLATES DAMAGED

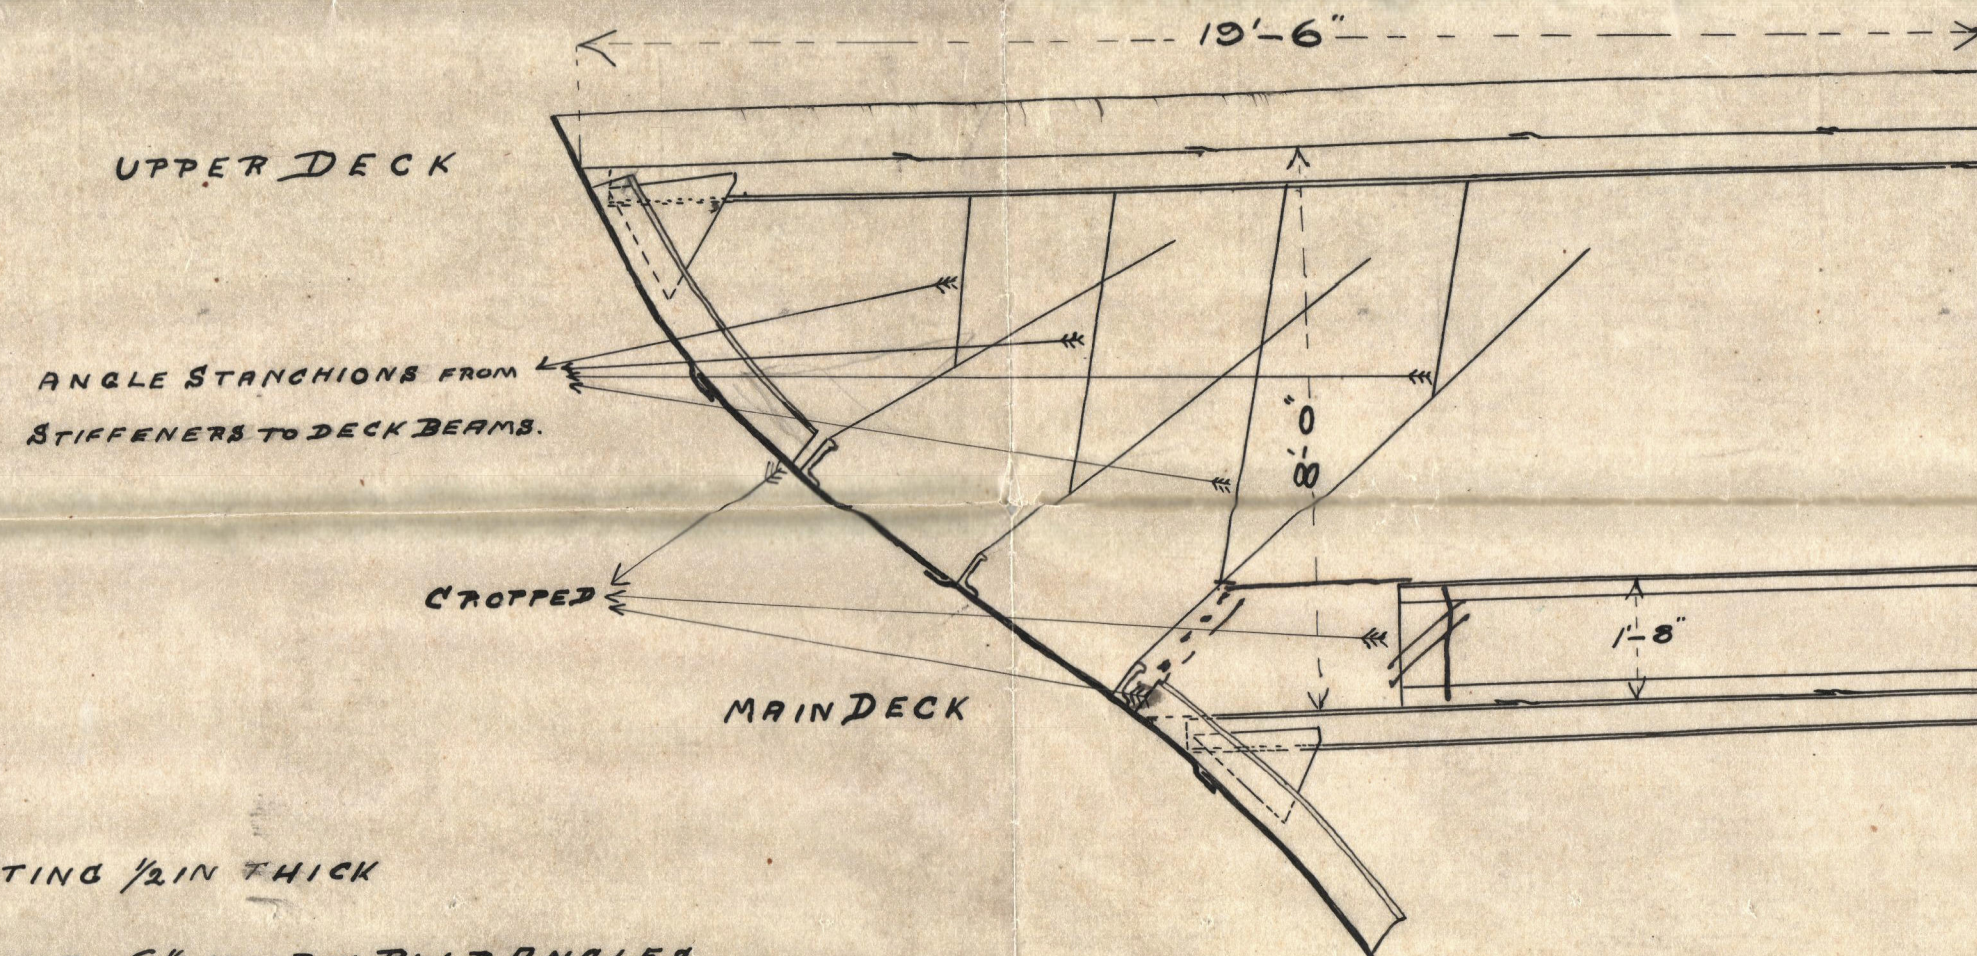
CROSS SECTION LOOKING AFT
 SHEWING LAST TRANSVERSE FRAME
 AND WASH PLATE CROPPED.
 ALSO POSITION OF Y-Y3 BULB STIFFENER
 Wash plate extended & brackelled
 all cropped frames brackelled to bulk

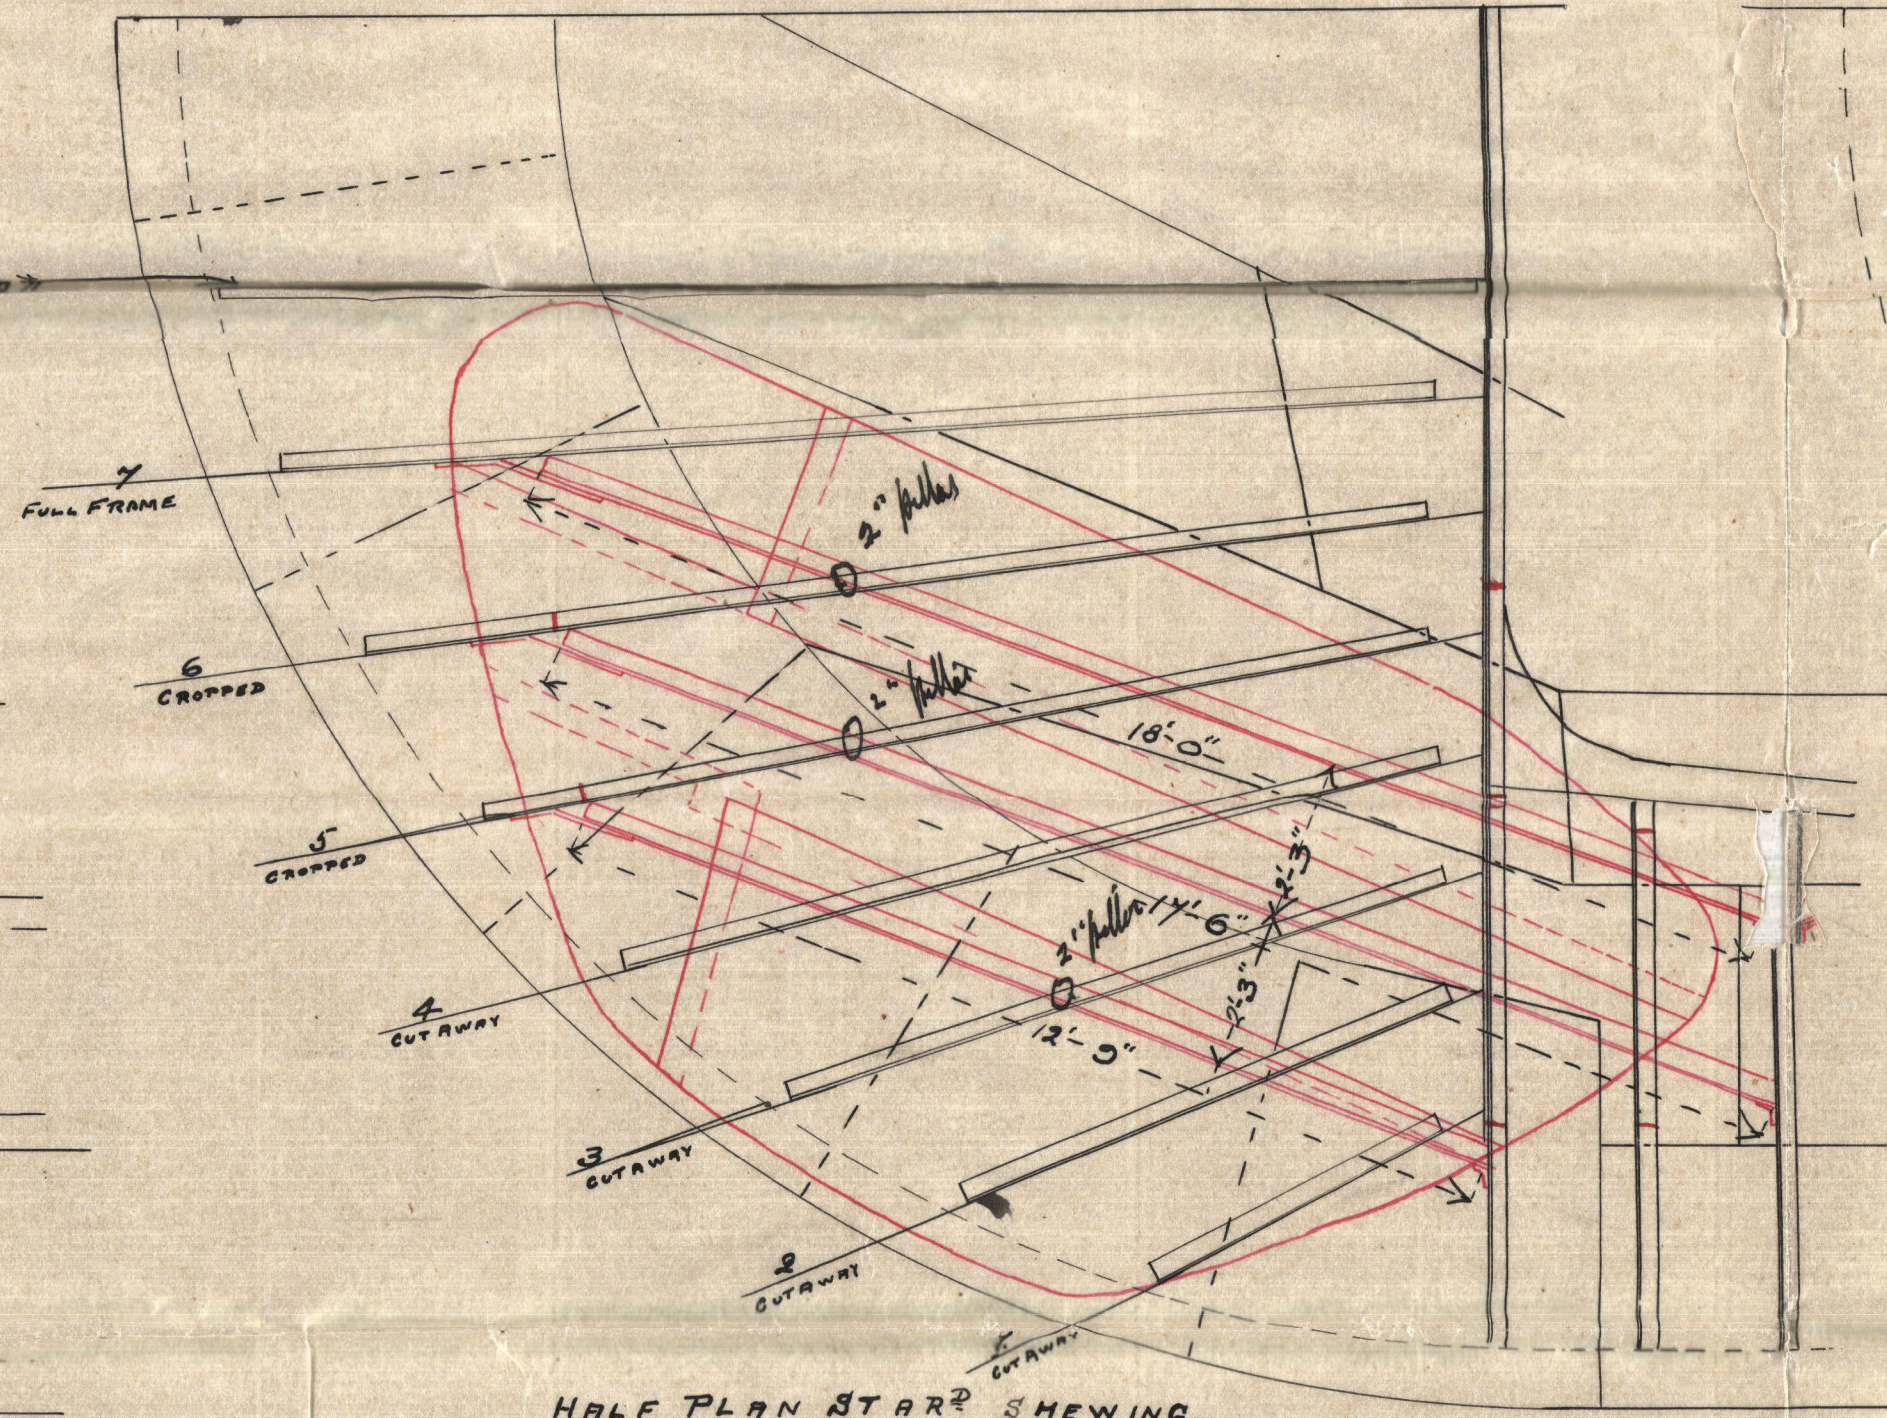
HALF PLAN STARBOARD SHEWING
 POSITION OF PATCH AND STIFFENERS,
 AND TRANSVERSE AND TRANSVERSE FRAMES CROPPED.
 NOS. 1-2-3-4-5 AND 6 " " " AS SHEWED
 LAST AND NEXT TRANSVERSE " " " "
