## Report of Survey for Repairs, &amp;c., of Engines and Boilers.

REC'D NEW YORK Jan. 12/1918  
 Date of writing Report Jan 10, 1918 When handed in at Local Office Jan 10, 1918 Port of Boston, Mass.  
 No. in Reg. Book. Survey held at Boston, Mass. Date, First Survey 24th Dec. Last Survey Dec. 31, 1917.  
 1407 on the Machinery of the Wood, Iron or Steel S.S. "HARRINO."  
 Tonnage Gross 4484 Net 2843 Vessel built at Glasgow By whom J. & W. Henderson & Co. Ld. When 1906 8.  
 Registered Horse Power 485 Engines made at Glasgow By whom J. & W. Henderson & Co. Ld. When 1906.  
 No. of Main Boilers 3 Boilers, when made (Main) 1906 (Donkey)  
 No. of Donkey Boilers 1 Owners Thinder, Anderson & Co. (Mgr. Port) London Voyage France.  
 Steam Pressure in Main Boilers 200 If Surveyed Afloat or in Dry Dock Simpson's Dry Dock.  
 in Donkey Boilers (State name of Dock.) and Leyland Line Pier.

S/S ARRINO of London

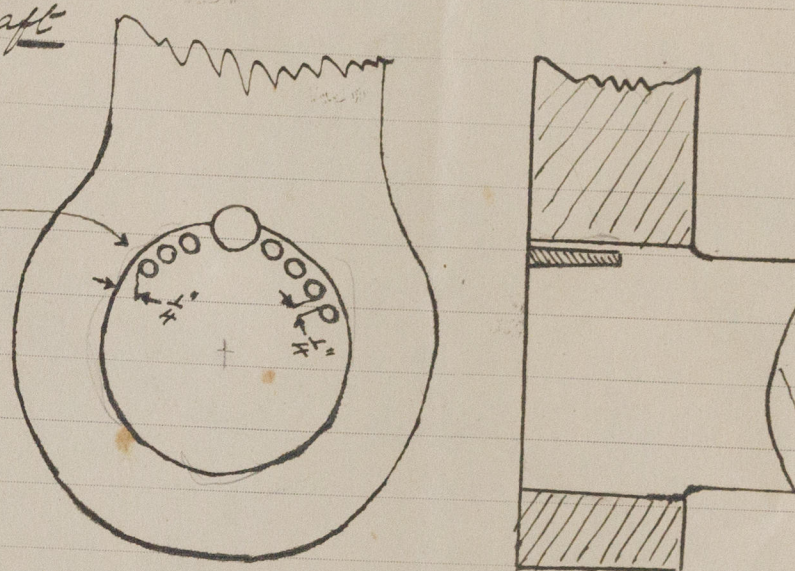
Crank Shaft

7-1/4" slightly tapered hard steel pins driven into journal to make same tight in crank web

The after journal of the H.P. crank shaft had been found slack in the crank web on the previous voyage as per Boston report No. 945. A temporary repair had been made by drilling 7-1/4" holes in the journal & driving hard steel pins into the same to make the shaft tight in the web, as shown on sketch above.

The H.P. section of crank shaft was examined. The temporary repair described above was found still strong & efficient & in my opinion, it is in safe working condition for the present voyage from Boston to France & return. It is respectfully submitted however, that this temporary repair weakens the shaft somewhat, & that it should be again examined on the vessel's return to Boston. It was understood from the chief engineer that this section might be renewed at or before that time.

H.P. section of crank shaft to be again examined (or renewed) after the present voyage Boston to France & return.

The machinery of this vessel is now in good & safe working condition & eligible in my opinion to remain as classed & to have record of TAIL SHAFT SEEN 12.17, subject to the H.P. section of crank shaft being again examined (or renewed) after the present voyage from Boston to France & return.
