May 23, 1933

Mr. H. F. Norton, Naval Architect.

SUBJECT: Physical Characteristics of Plates Removed
from S.S. Charles Pratt, J.O. 1808-S.
Lab. Test #376.

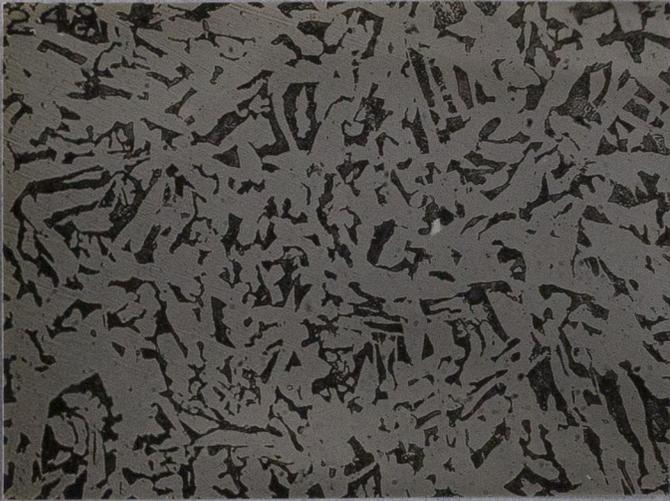
A-4-S

Microstructure of Plates Taken
at right angles to rolling
Magnification 100 Diameters

The microstructure of the plate also indicate an unstrained condition due to the absence of strain lines and the undistorted ferrite and pearlite pattern.

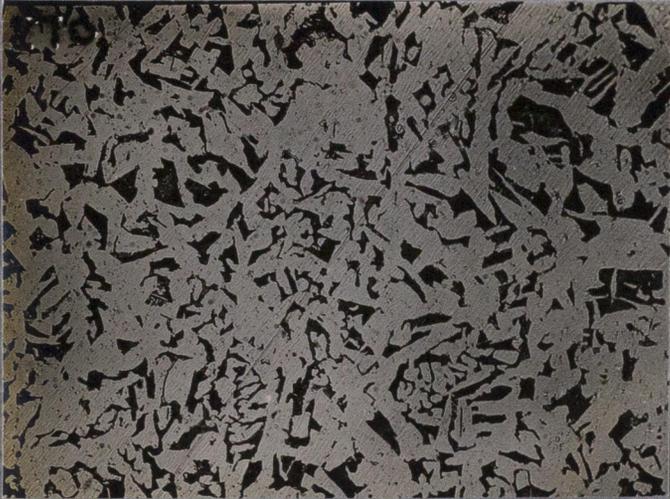
Microstructure of Plates Taken
at right angles to rolling
Magnification 100 Diameters

It should also be noted that the physicals of cracked plates B-6-P and D-5-S taken by the American Bureau of Shipping at locations adjoining the cracks of the respective plates also show good results.

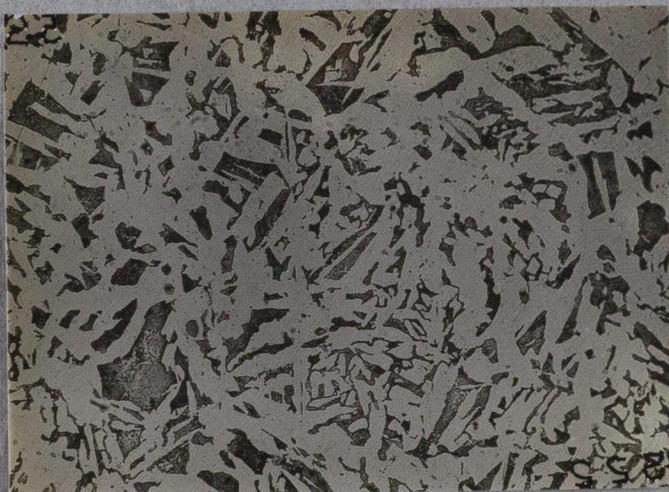
E-13-S

Microstructure of Plates Taken
at right angles to rolling
Magnification 100 Diameters

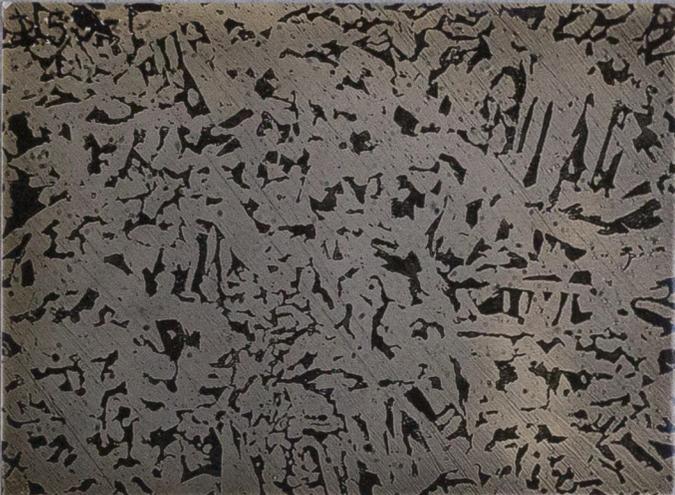
G-4-S

Microstructure of Plates Taken
at right angles to rolling
Magnification 100 Diameters

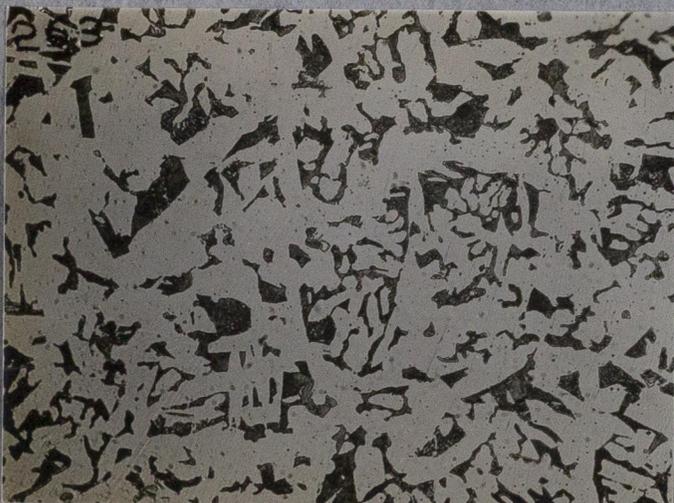
N-4-S

Microstructure of Plates Taken
at right angles to rolling
Magnification 100 Diameters

Five plates N-4-S, N-6-S, N-8-S, N-21-S and O-6-S show a yield point less than 50.0% of the tensile strength as required by the American Bureau of Shipping. The tensile strength with the exception of N-8-S is also less than 62,000 p.s.i. as required by the A. B. S. The elongation, however, is well above the minimum limit.

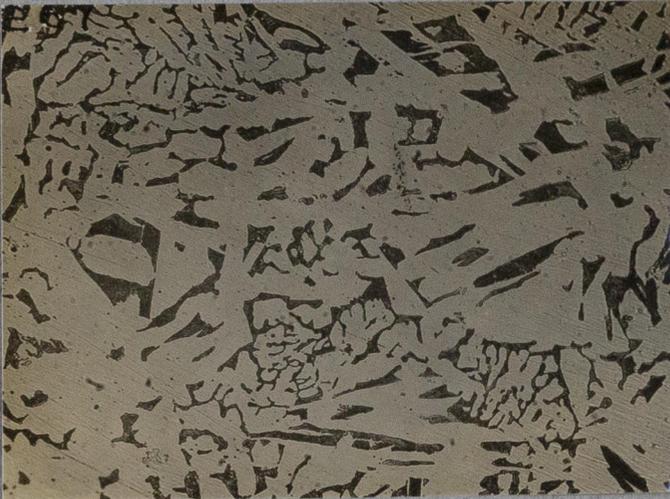
0-6-8

Microstructure of Plates Taken
at right angles to rolling
Magnification 100 Diameters
