M. V. "KELLETTIA"

SKETCH SHOWING CRACK

AT BOTTOM OF STERN FRAME

AFTER REPAIR (P.&S.)

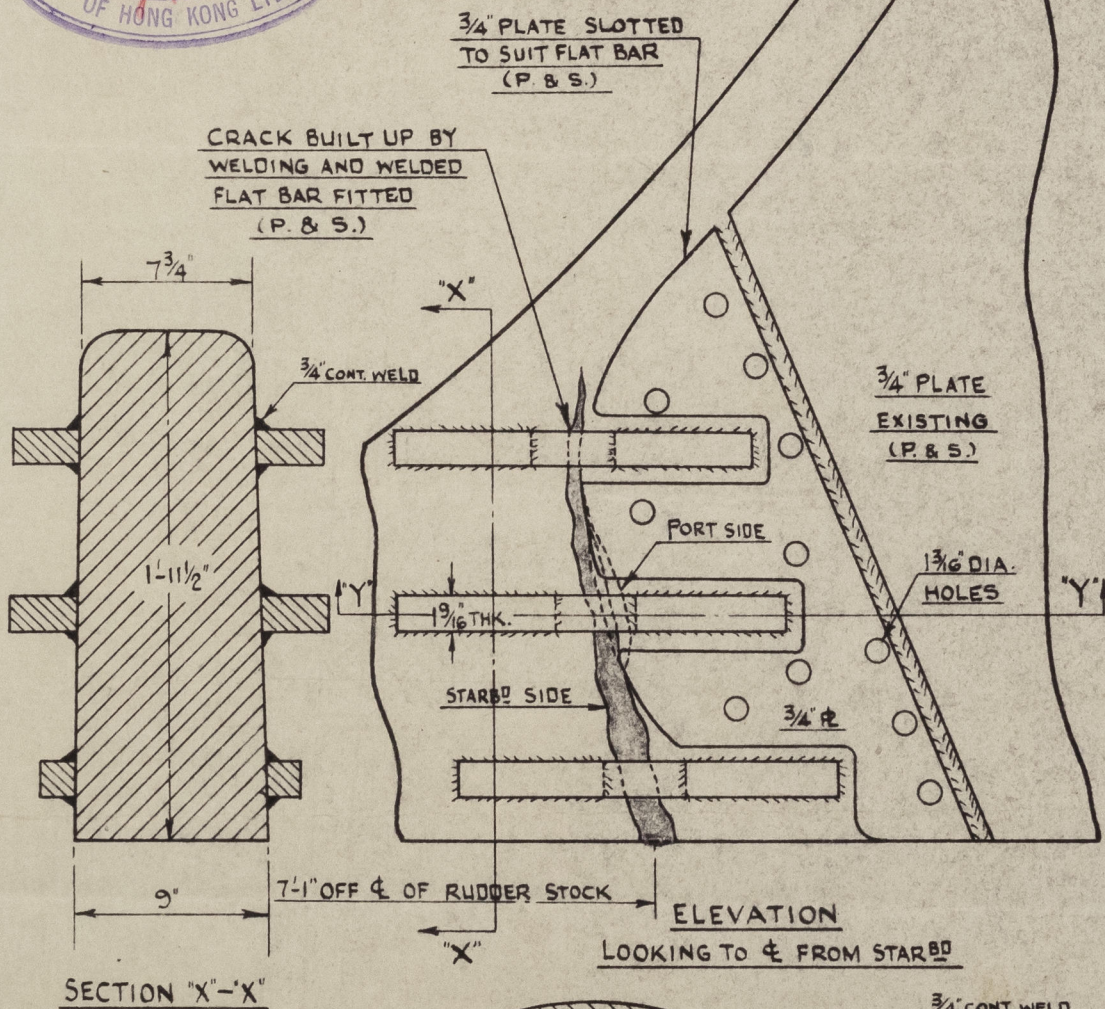
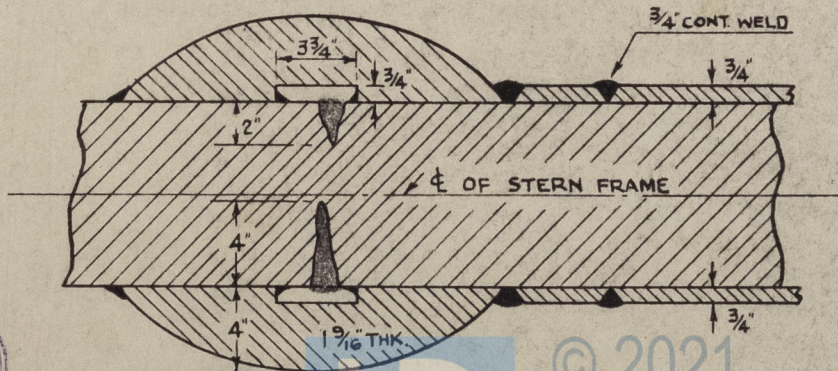
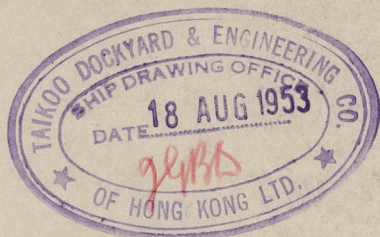
T. D. & E. COMPANY
DRAWING NO 3457

SECTIONAL PLAN VIEW THRO' "Y"- "Y"

Crack in bottom of stern
frame
