BELONGS TO
ROTTERDAM REPORT No. 43253A

GET. R.	JAN -56	SCHAAL	BOUW № 317
GEZ. <i>me</i>	10-5-56	1:10 1:15	KUSTMOTORVRACHTBOOT
<u>ROER</u>			
N.V. SCHEEPSBOUW WERF IN DE GROOT IN VAN VLIET SLIKKEVEER (BIJ ROTTERDAM)			317008

"BERN" ★

Rudder -

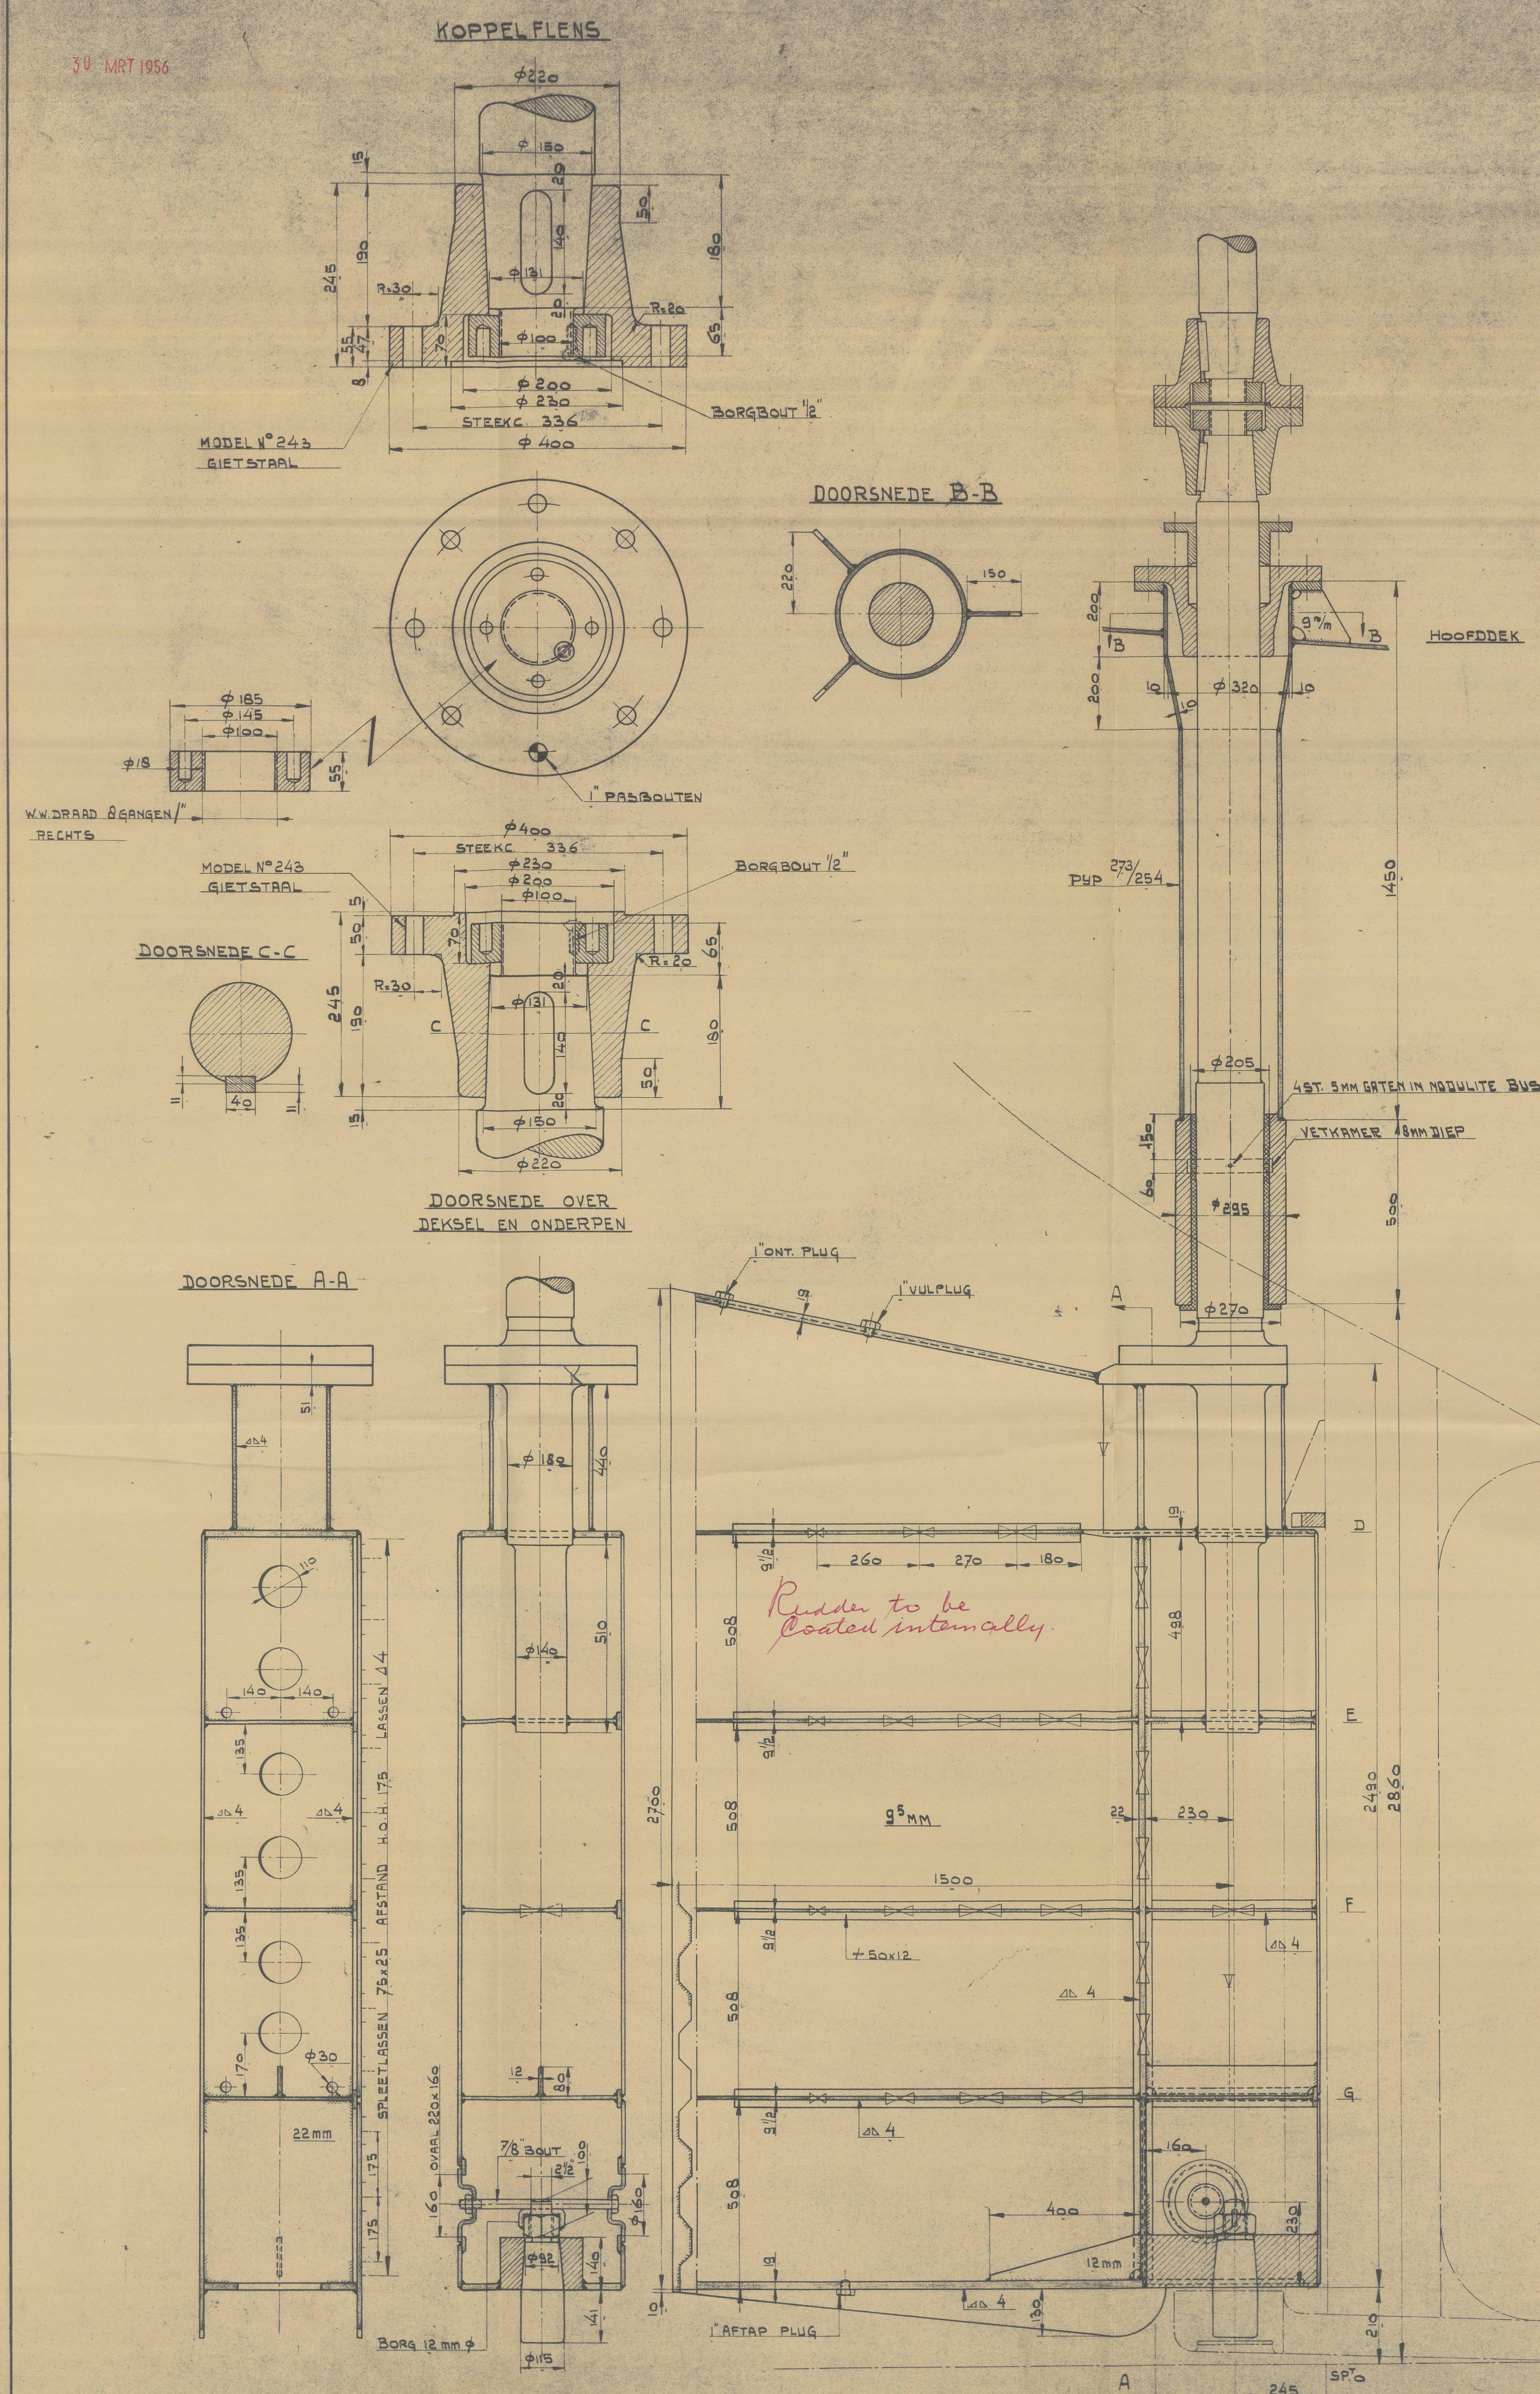
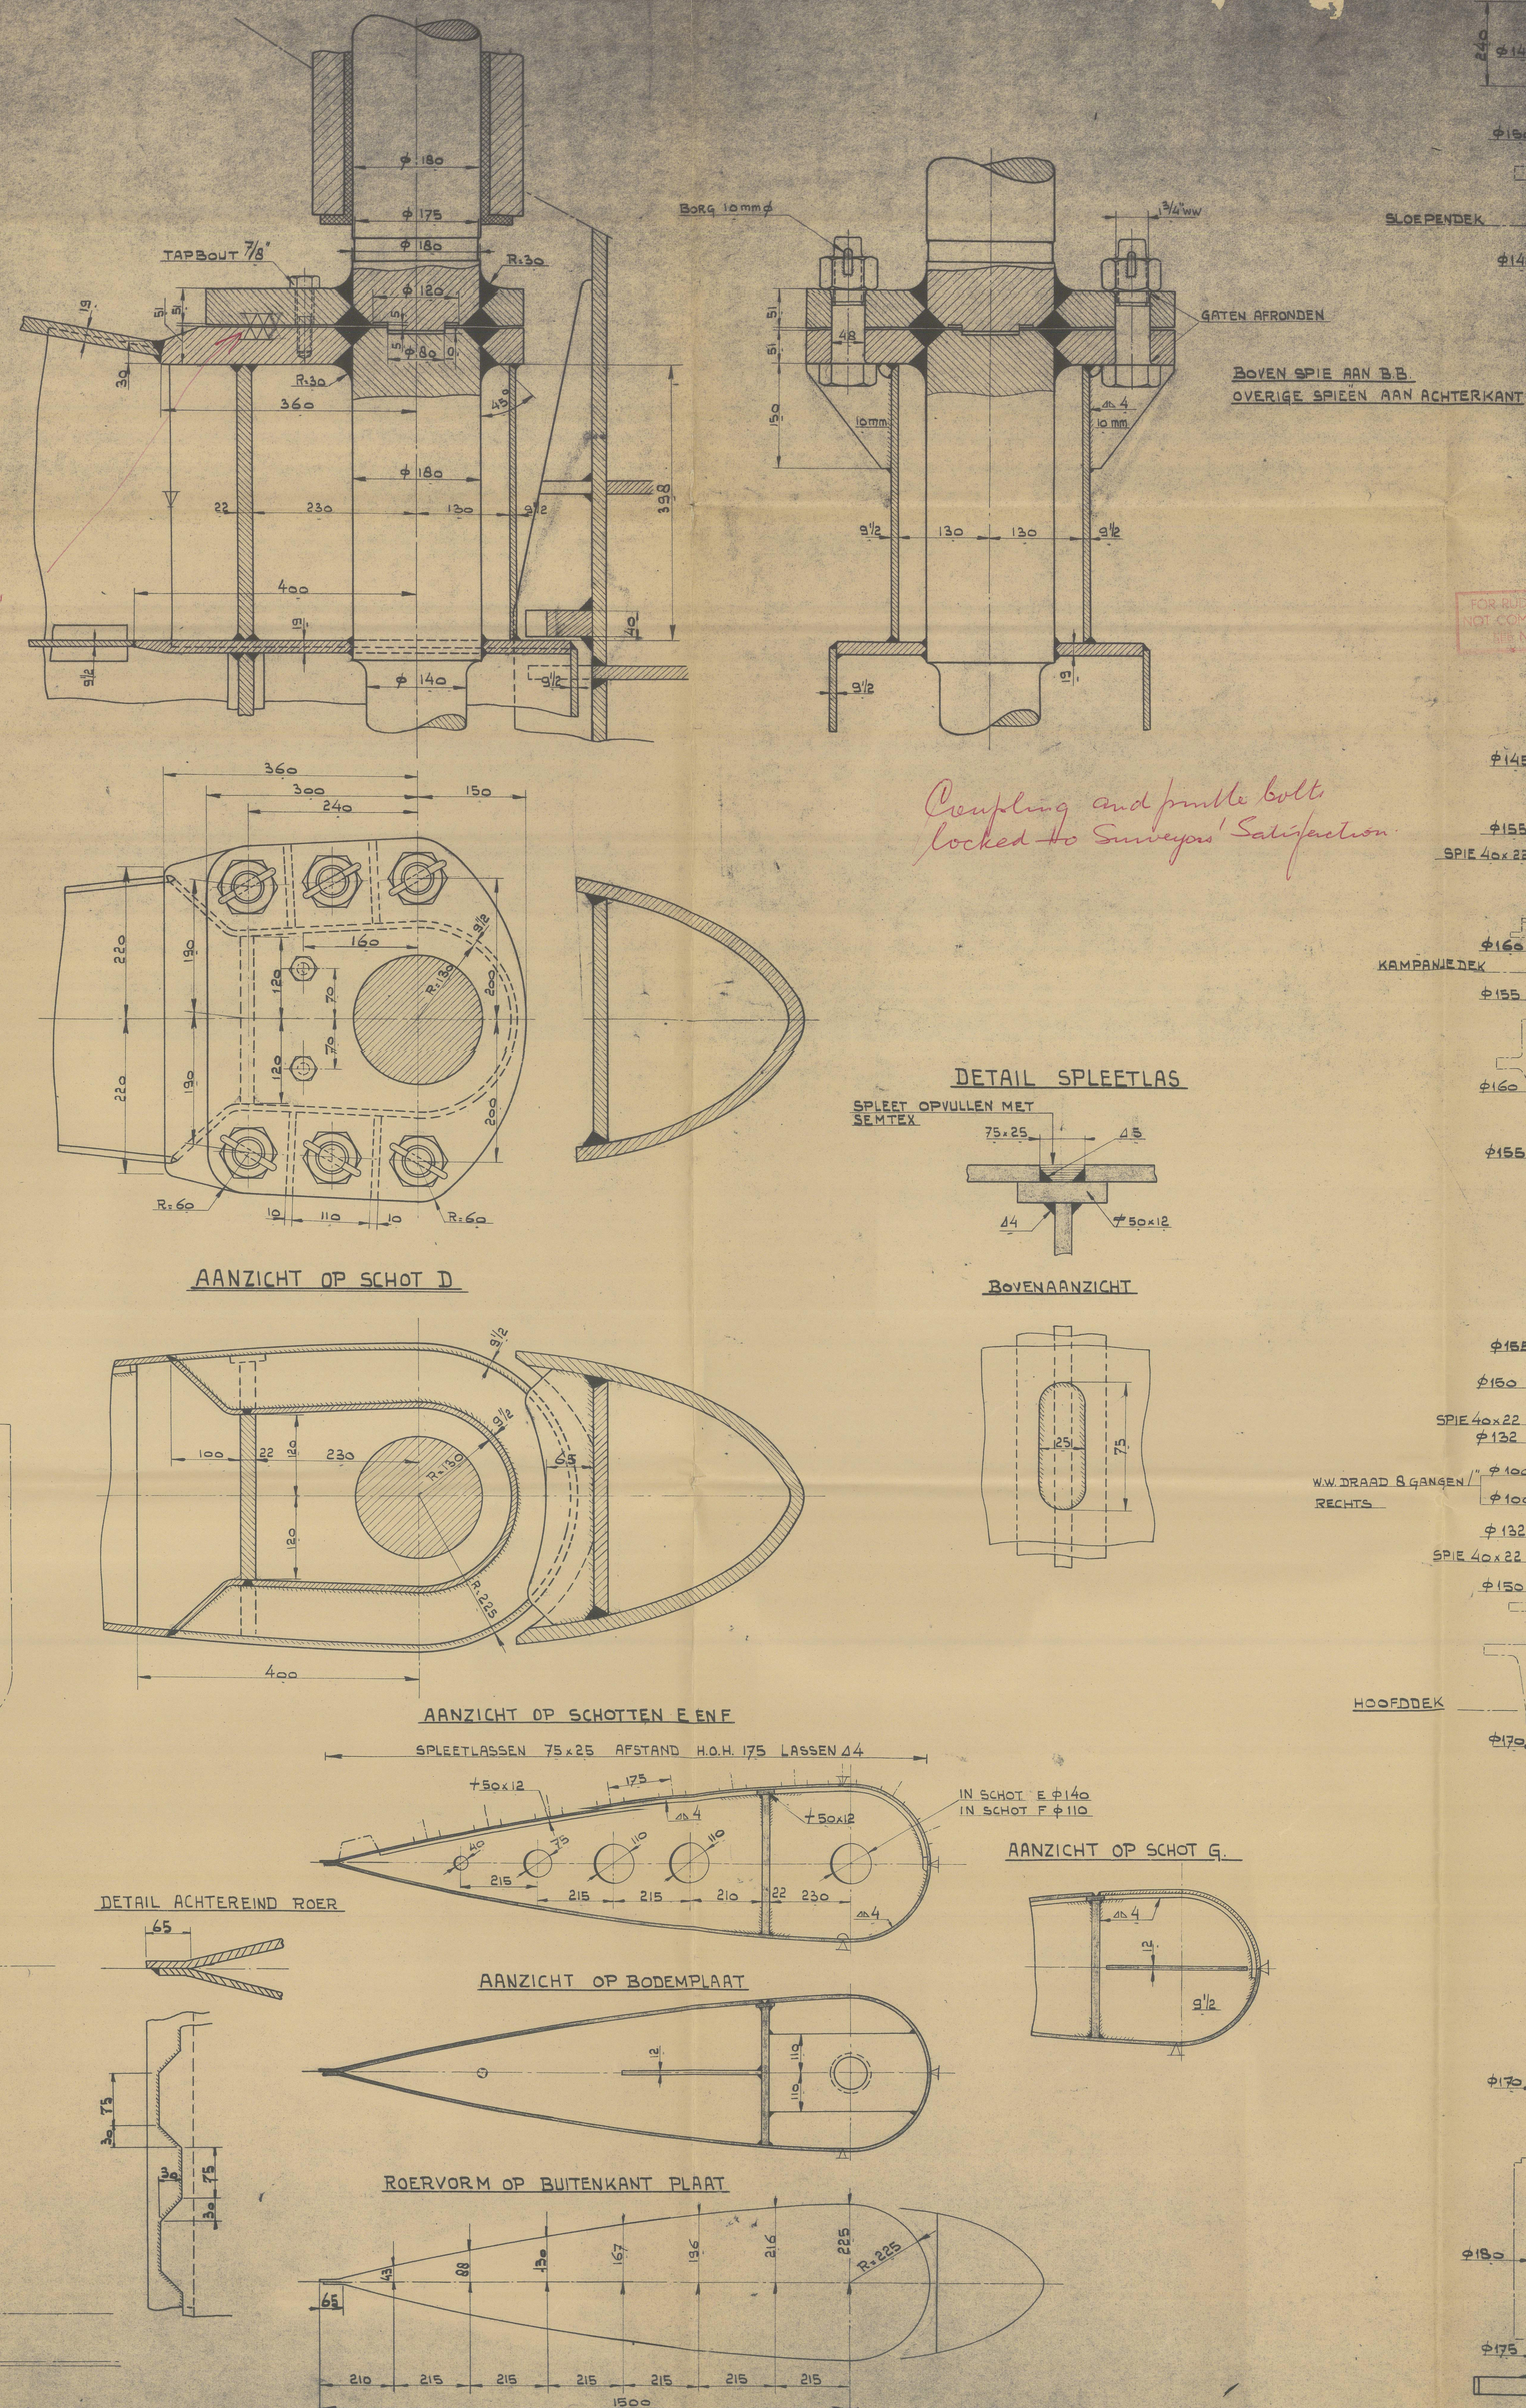
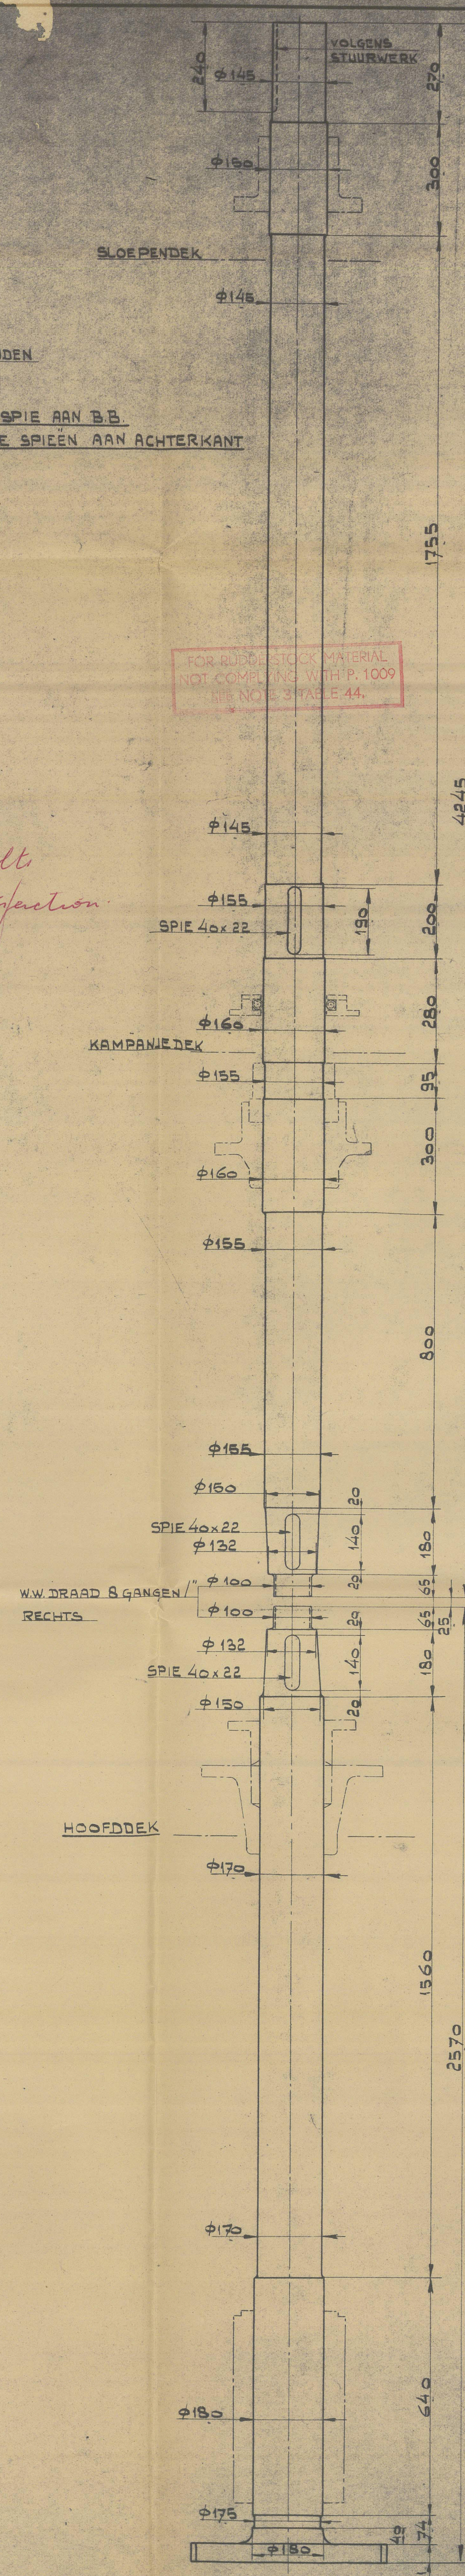
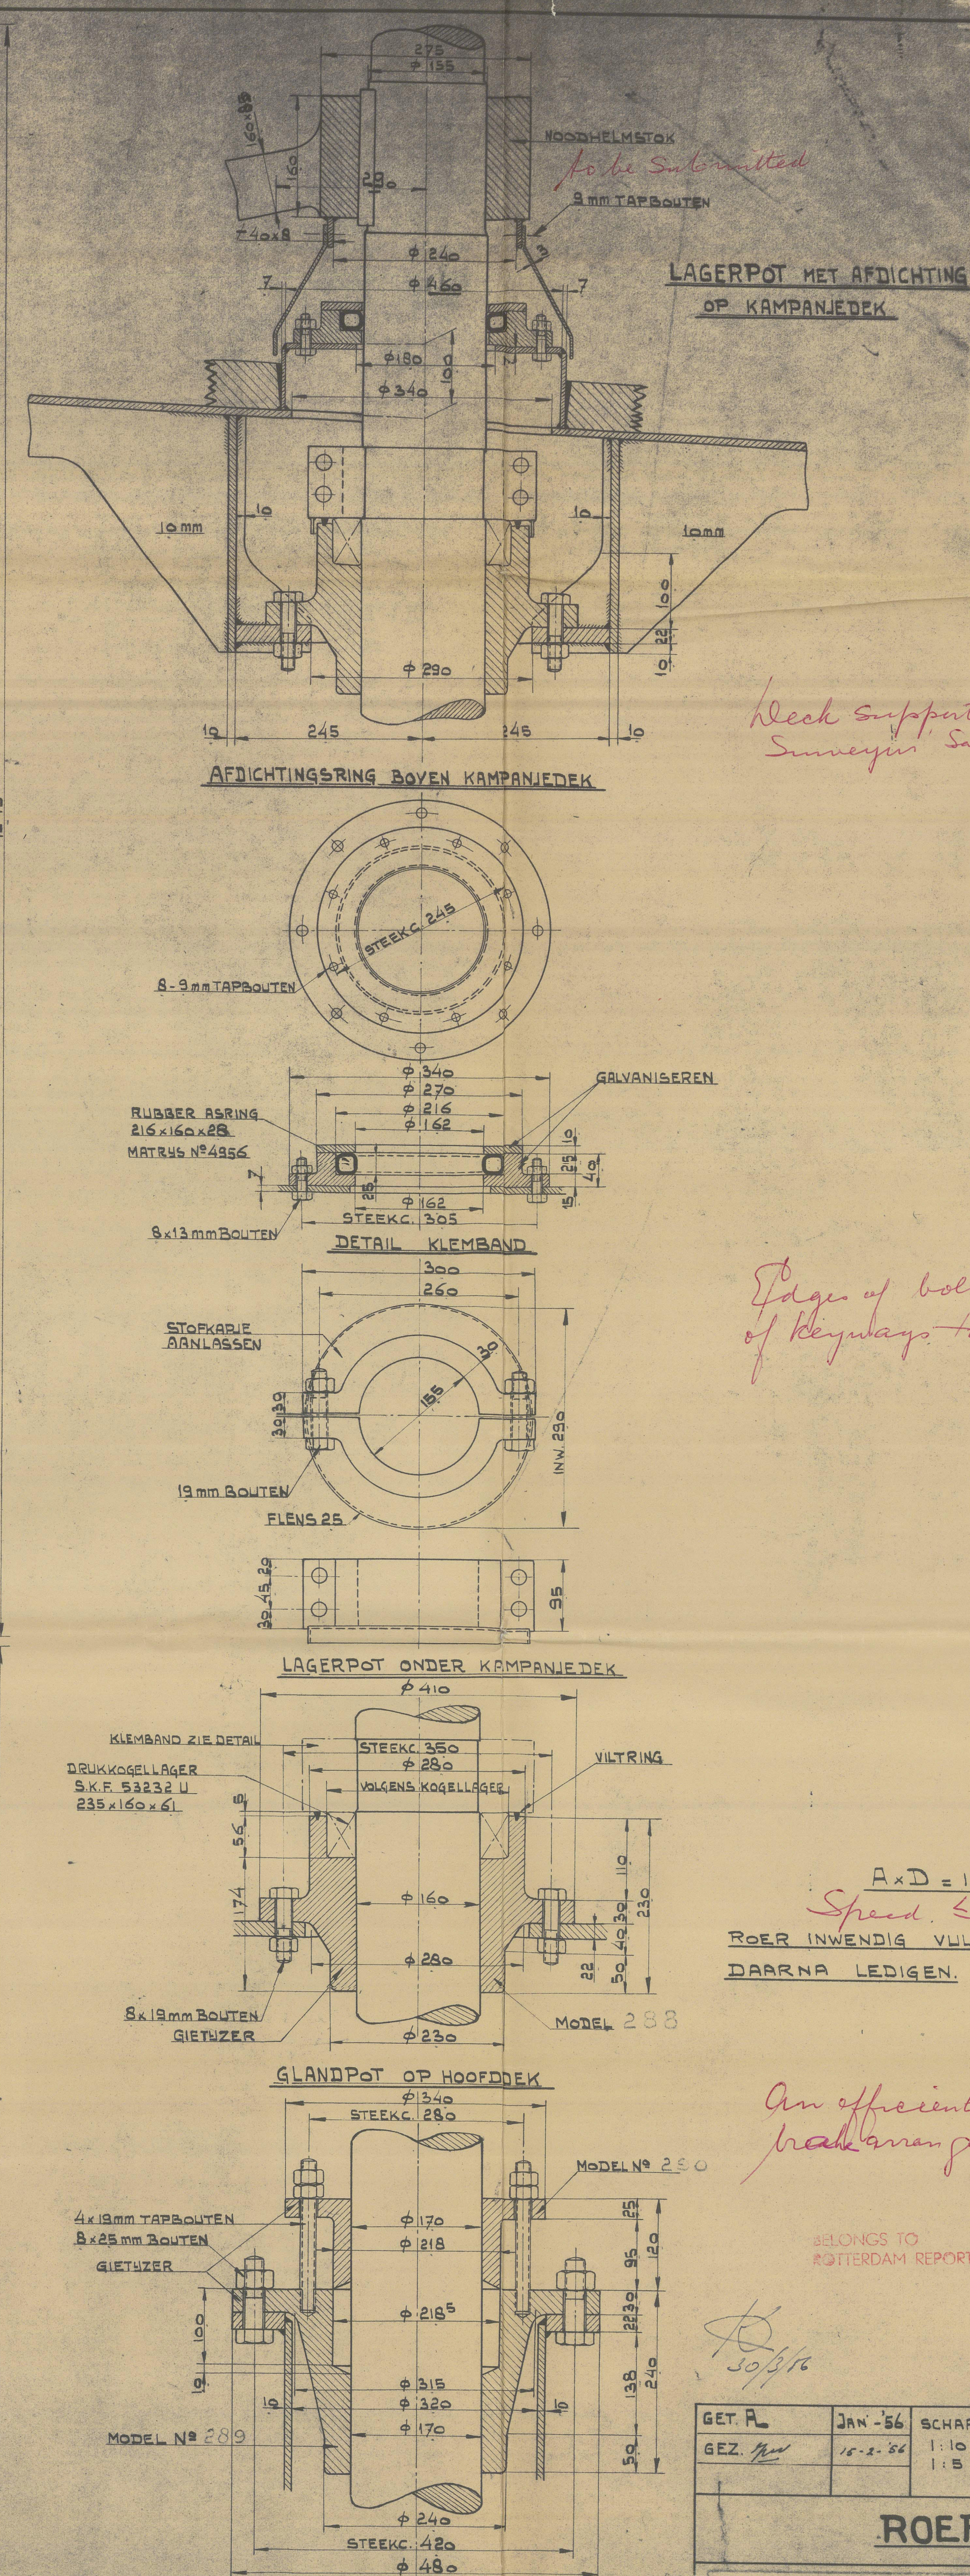
FOR RUDDERSTOCK MATERIAL
NOT COMPLYING WITH P. 1009
SEE NOTE 3 TABLE 44.

$A \times D = 107$
Speed. ≤ 10 knots
ROER INWENDIG VULLEN MET OLIE EN
DAARNA LEDIGEN.

An efficient locking or
brake arrangement to be fitted
