No 657-8 ~~7~~

Amended Plan

"Francesco Crispi"

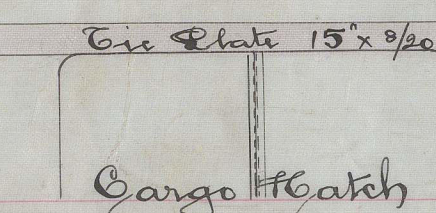
Spacing of stringers at ends not to exceed spacing amidships.

Strips of each plate 6/16 thick.

Stroke of local platy near opening  $\frac{1}{16}$  thick

Cargo Hatch

## Engine Crasing

### Foot Tunnel Casing

Donkey	Stroke
Boiler	hole
