S. S. "Nellie" Hull report No. 51747.

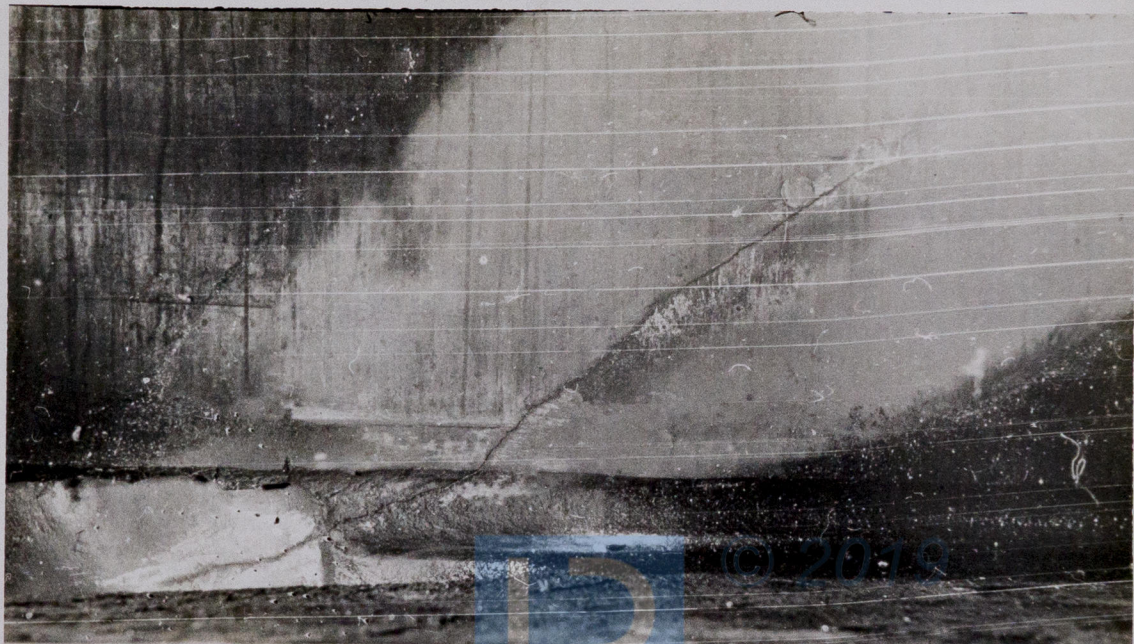
W200-0132

View of crack in h.p. byl. from inside, showing
studs tapped into cyl. wall at ends of original
fracture.
