W226-0179 Outer strap

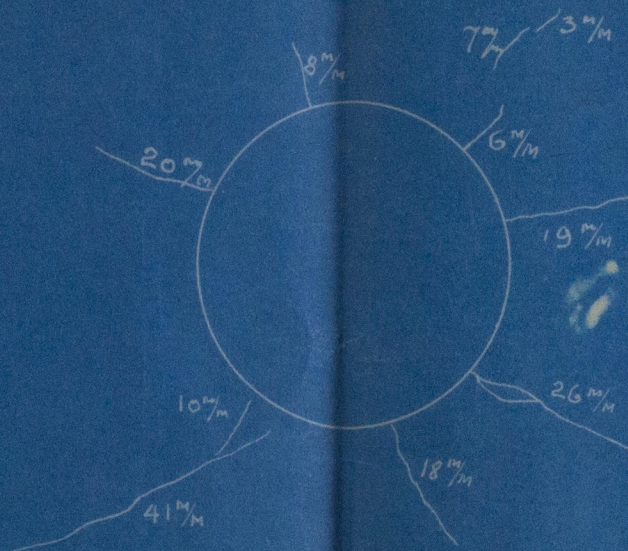
undersurface of piece
of outer built strap
sketch A.

Centre Mark

almost disappeared, a black mark about the size of a pin head
out half the depth of the hole being all that could be seen.
