ADDITIONAL GUSSET PLATES & ANGLES IN WAY OF N:2 TANK. P&S.

NON W.T. SH^d
98.

NEWCASTLE ON TYNE.
S.S. ANGLO PERUVIAN.

Report No. 86670.

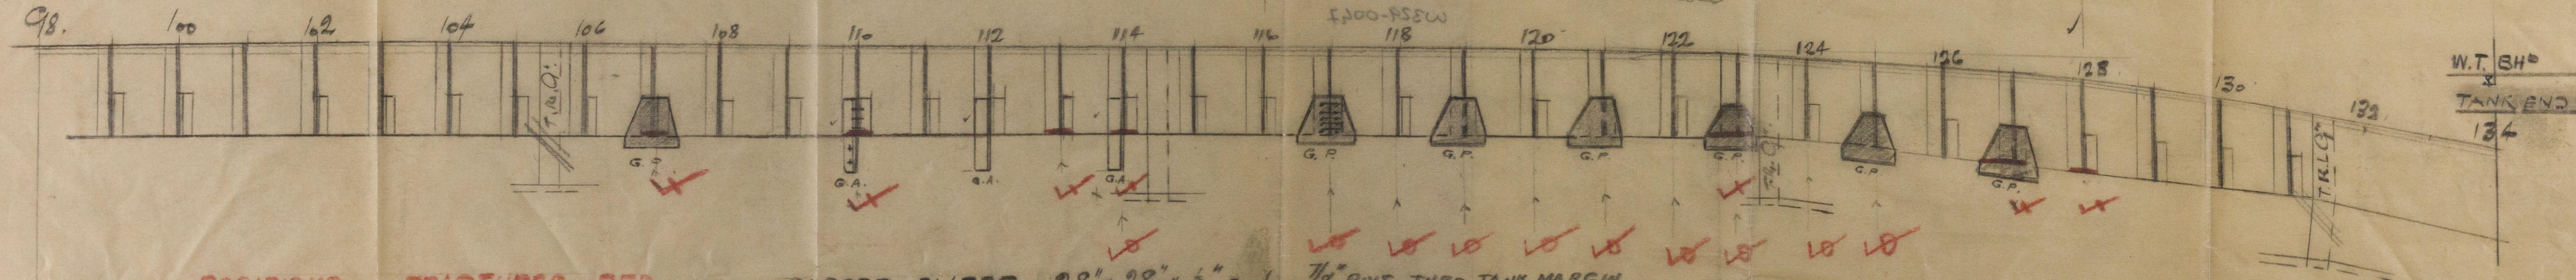
POSITIONS OF FRACTURES IN RED

STAR^d SIDE MARKED LO
PORT SIDE X

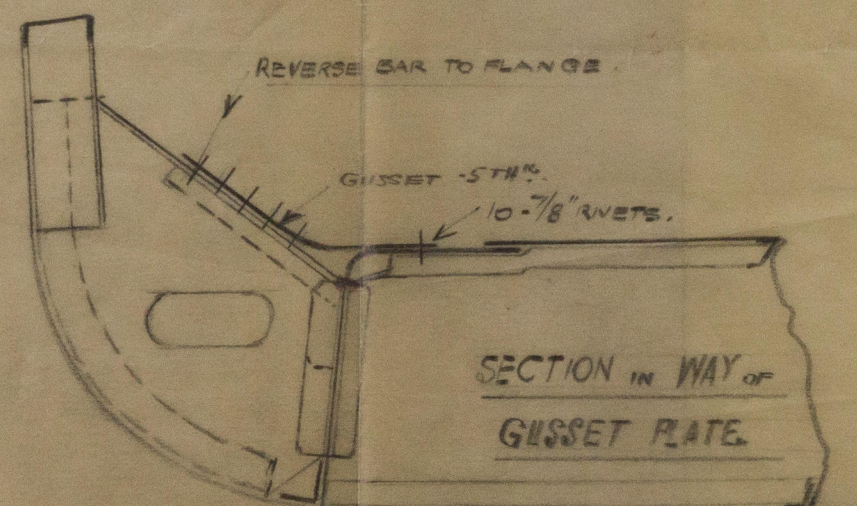
PLAN VIEW - PORT SIDE.

POSITIONS OF GUSSET PLATES & ANGLES SIMILAR ON STAR^d SIDE.

GUSSET PLATES 38" x 28" x 1/2" - 10-7/8" RIVS. THRO TANK MARGIN.

REVERSE BARS TO MARGIN BKT^s 3 1/2 x 3 1/2 x 40 - 5-7/8" RIVS.

GUSSET ANGLES 3 1/2" x 3" x 40 - 2 RIVS. THRO BKT - 2 RIVS THRO TANK TO P₂ REVERSE FRAME.
