S.S. "IRENE MARIA"

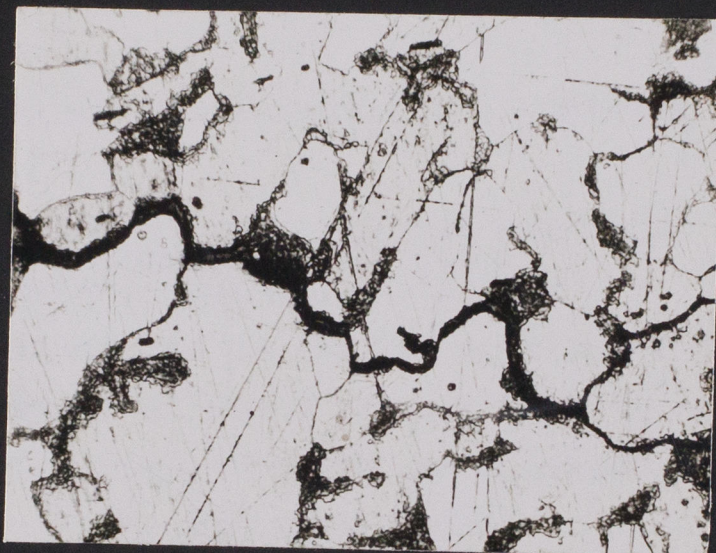
500x.

Inter-crystalline crack in
Port Boiler.
