"  
m.v. Lagarto"

Broken Crankshaft

Micrographs

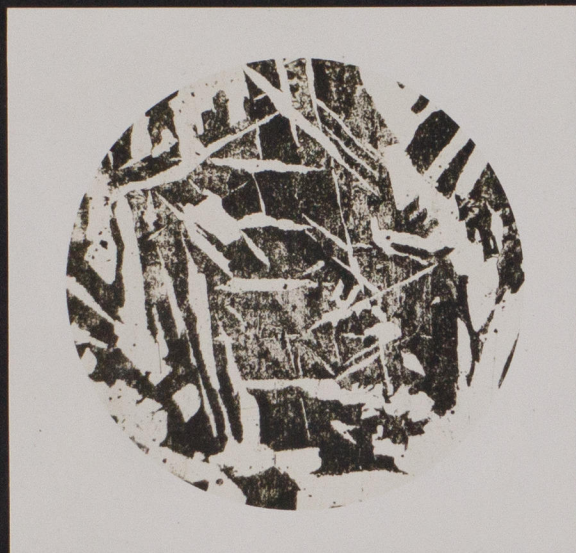
No 112 - From web near fracture.

x 80

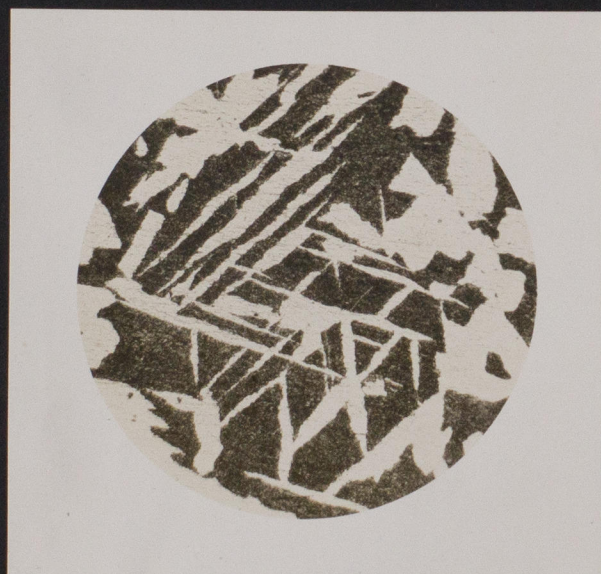
No 111 From pin away from fracture.

x 80

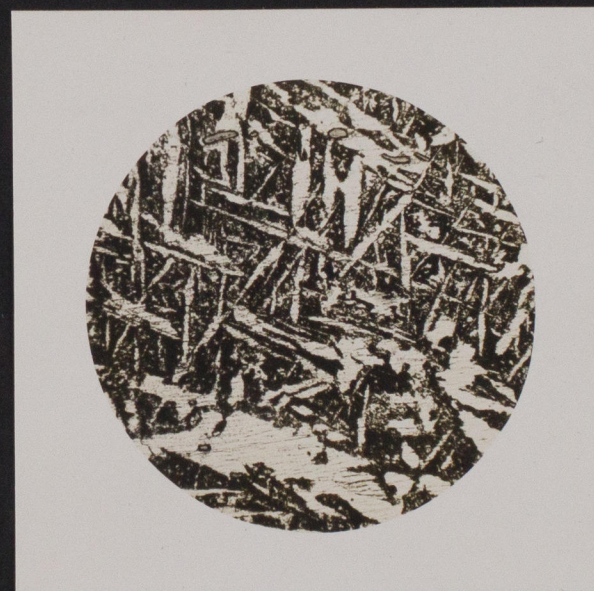
No 115 From flange - after end.

←  
Direction of  
forging.
