# — M.V. CHALLAMBA. —

S.S. Challamba.

Vcr report no 1889

Sketch shewing  
extent of damage.

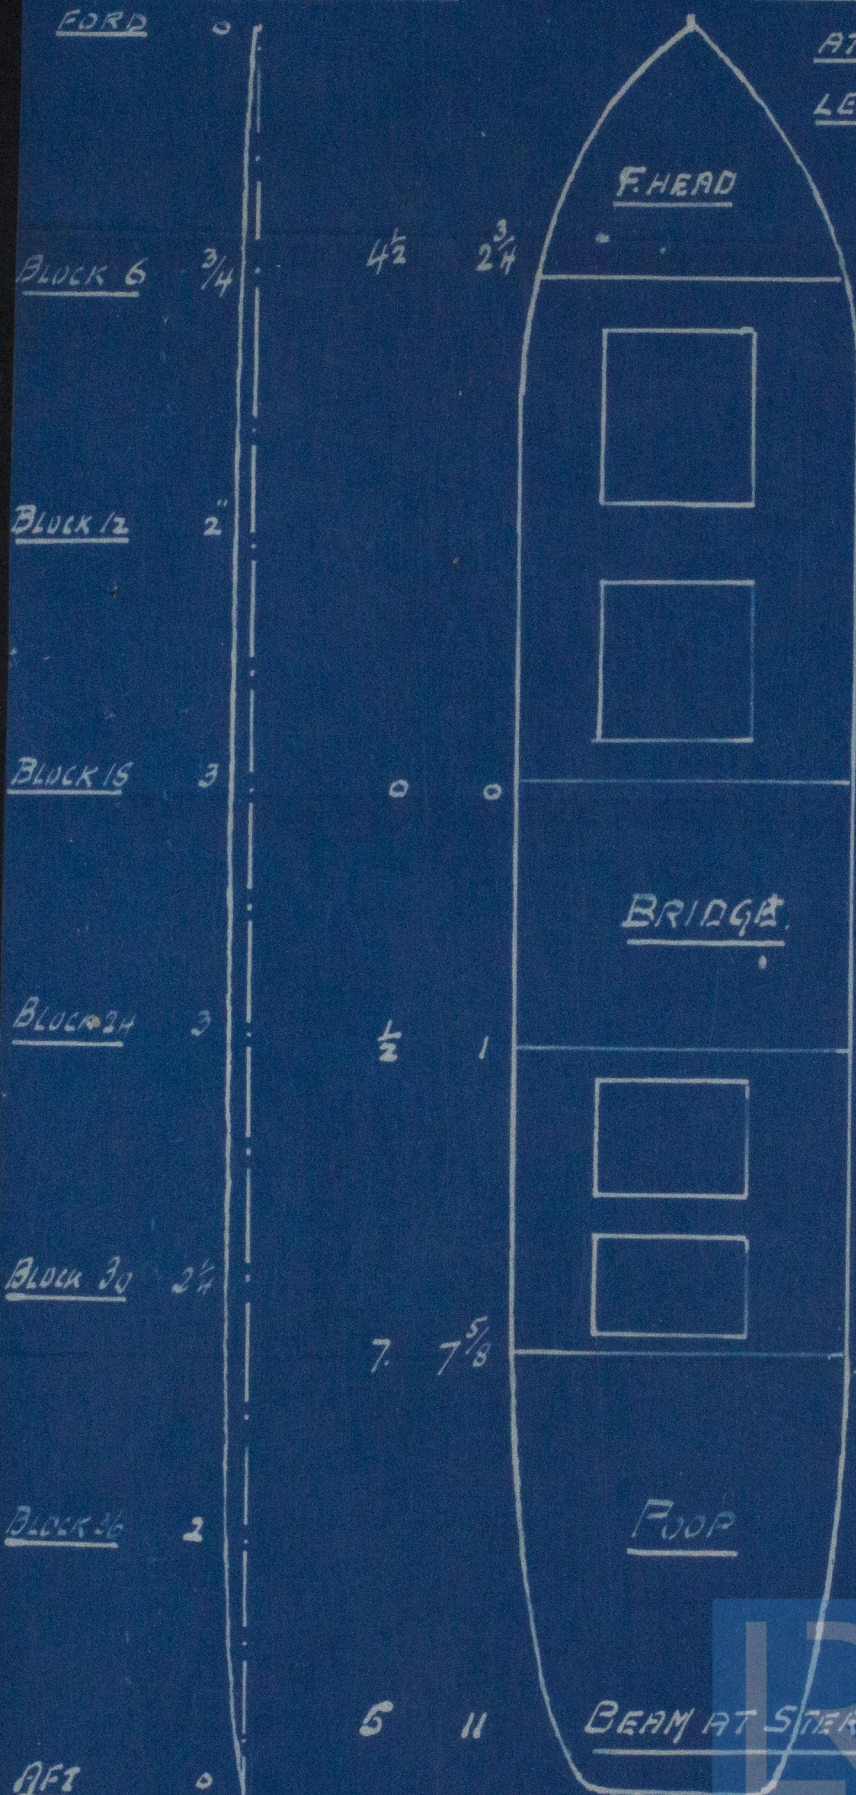
SHOWING VARIATION  
IN LINE OF KEEL

SHOWING TWIST TO PORT  
ON DRYDOCK. JULY 1<sup>st</sup> 1927

LEFT HAND FIGURES SHOW  
TWIST AFTER UNDOCKING.  
JULY 5, 1927

GARBOARDS SHOWN  
HOG OF  $3\frac{3}{4}"$  AT  
MIDDLE OF LENGTH

TOP OF STEM OVER  
TO PORT  $5"$  IN FULL  
DEPTH OF STEM.
