EXTENT OF DAMAGE M.V. VIOLETTE.

NOTE:- THIS PLAN SUBSTANTIALLY REPRESENTS DAMAGE TO CONCRETE STRUCTURE.

PLAN N° 10625
JAMES POLLOCK, SONS & CO. LTD.
SHIPBUILDERS & ENGINEERS
3 LLOYDS AVENUE,
LONDON, E.C.3.

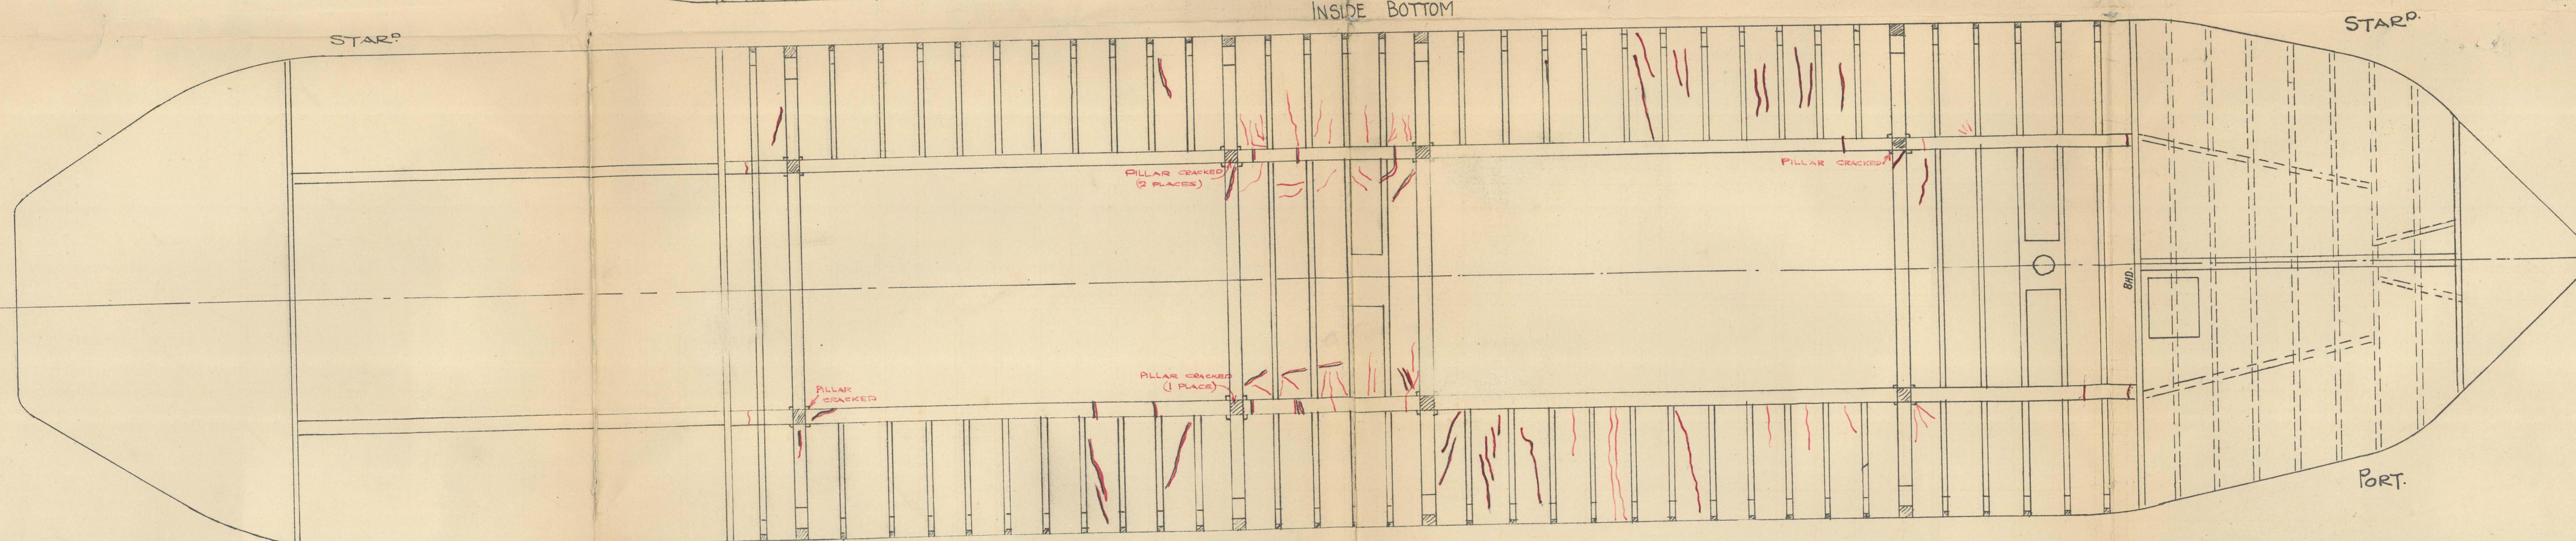
UNDERSIDE OF DECK

AT THESE POSITIONS THE DECK STRINGER (UPPER CHINE) APPARENTLY CRACKED THROUGH.
