SHEET Nº 1.

GIRTH READINGS Nº 5 TANK.
S.S. "CALTEX LIVERPOOL"

SURVEYOR TO LLOYD'S REGISTER
SYDNEY, N.S.W.

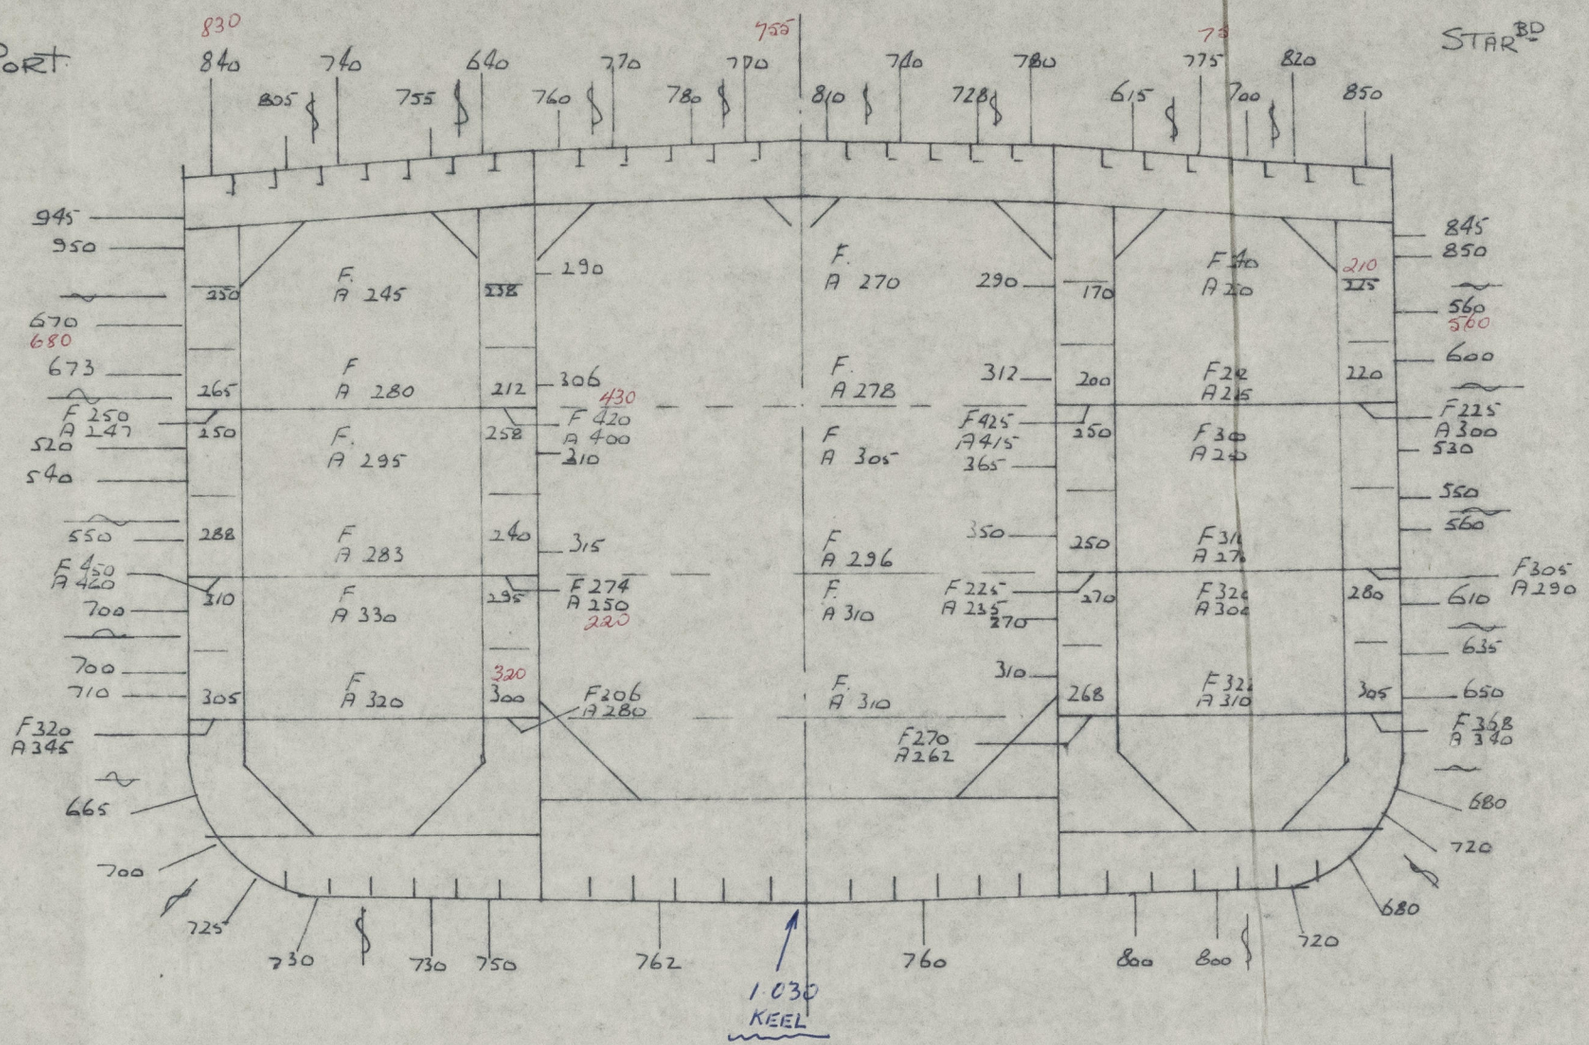
Note. No access to For^wd Bulk^hd
Nº 5 Centre Tank.
No 4 Flooded Preventing
access to Hº 5 Port Wing Tank
For^wd Bulk^hd

Figures in red indicate check drillings.
