Ship's Name SS/MS "WINCHESTER QUEEN" Gross tons 7.176
 LR 516.284
 Is there a rpt. 8? No Port DAKAR Rpt. No. DK 253
 No. of visits First date Last date
 Interim Cert. issued & copy herewith? Yes Damage rpt. issued & copy herewith? No Last rpt. (H.Q. only)
 Date of completing rpt. Surveyed at, if different from Port above
 Is a rpt. 9A attached? Yes MN Nature of survey Damage and Wear and Tear Repairs
 Survey fees Damage fee Expenses
 (see Rpt. 9A) S.A. fee

Ship's Name SS/MS "WINCHESTER QUEEN"
LR 516.284

Rpt. No. DK 253

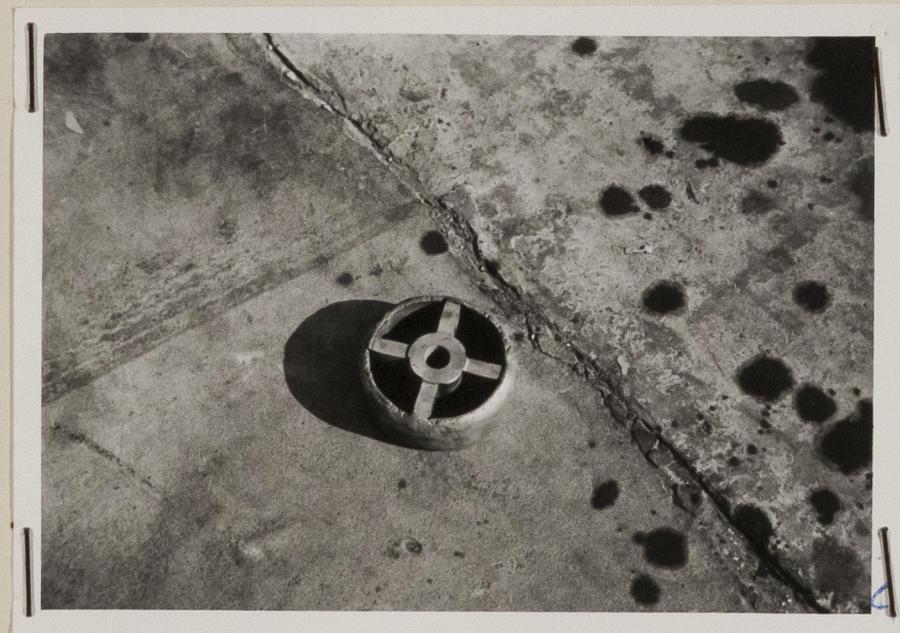
Photo N° 3

Found holed at several places. Now partly renewed.
Boilers water recirculating valves from blowdown lines to general service pump suction chest, were found heavily leaking (see photograph N° 3) and the blowdown valves on boilers being also leaking, it is supposed that a quantity of boiler-water has been discharged overboard by the G.S. Pump during the voyage completed.
