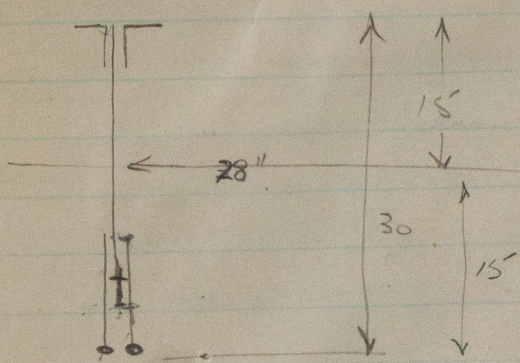
This submitted the surveyor he requested  
to inform the owners that the rule  
requirements for the hatchway web  
is a plate  $23\frac{1}{2}'' \times .40$  with double  
angles top and bottom  $5 \times 3\frac{1}{2} \times .50$   
and the web the fitted must be  
equivalent thereto.

If it be desired to dispense with  
bottom angles the web would  
require the of the scantlings  
intimated in the Secretary's  
letter of 10<sup>th</sup> inst.

With reference to the owner proposal gradually  
to replace the existing beams for  
wear and tear the surveyor should  
be reminded of the correspondence  
which has taken place regarding the  
condition of these beams, and he should  
inform the owners that in order to  
retain the present assignment it  
will be necessary <sup>at this time</sup> for the beams  
to be made in accordance with the  
regulations. ~~without delay~~.
