S.S. "FOLIA"

HULL DAMAGE.

S/S Folia
Repairs made in
Montreal

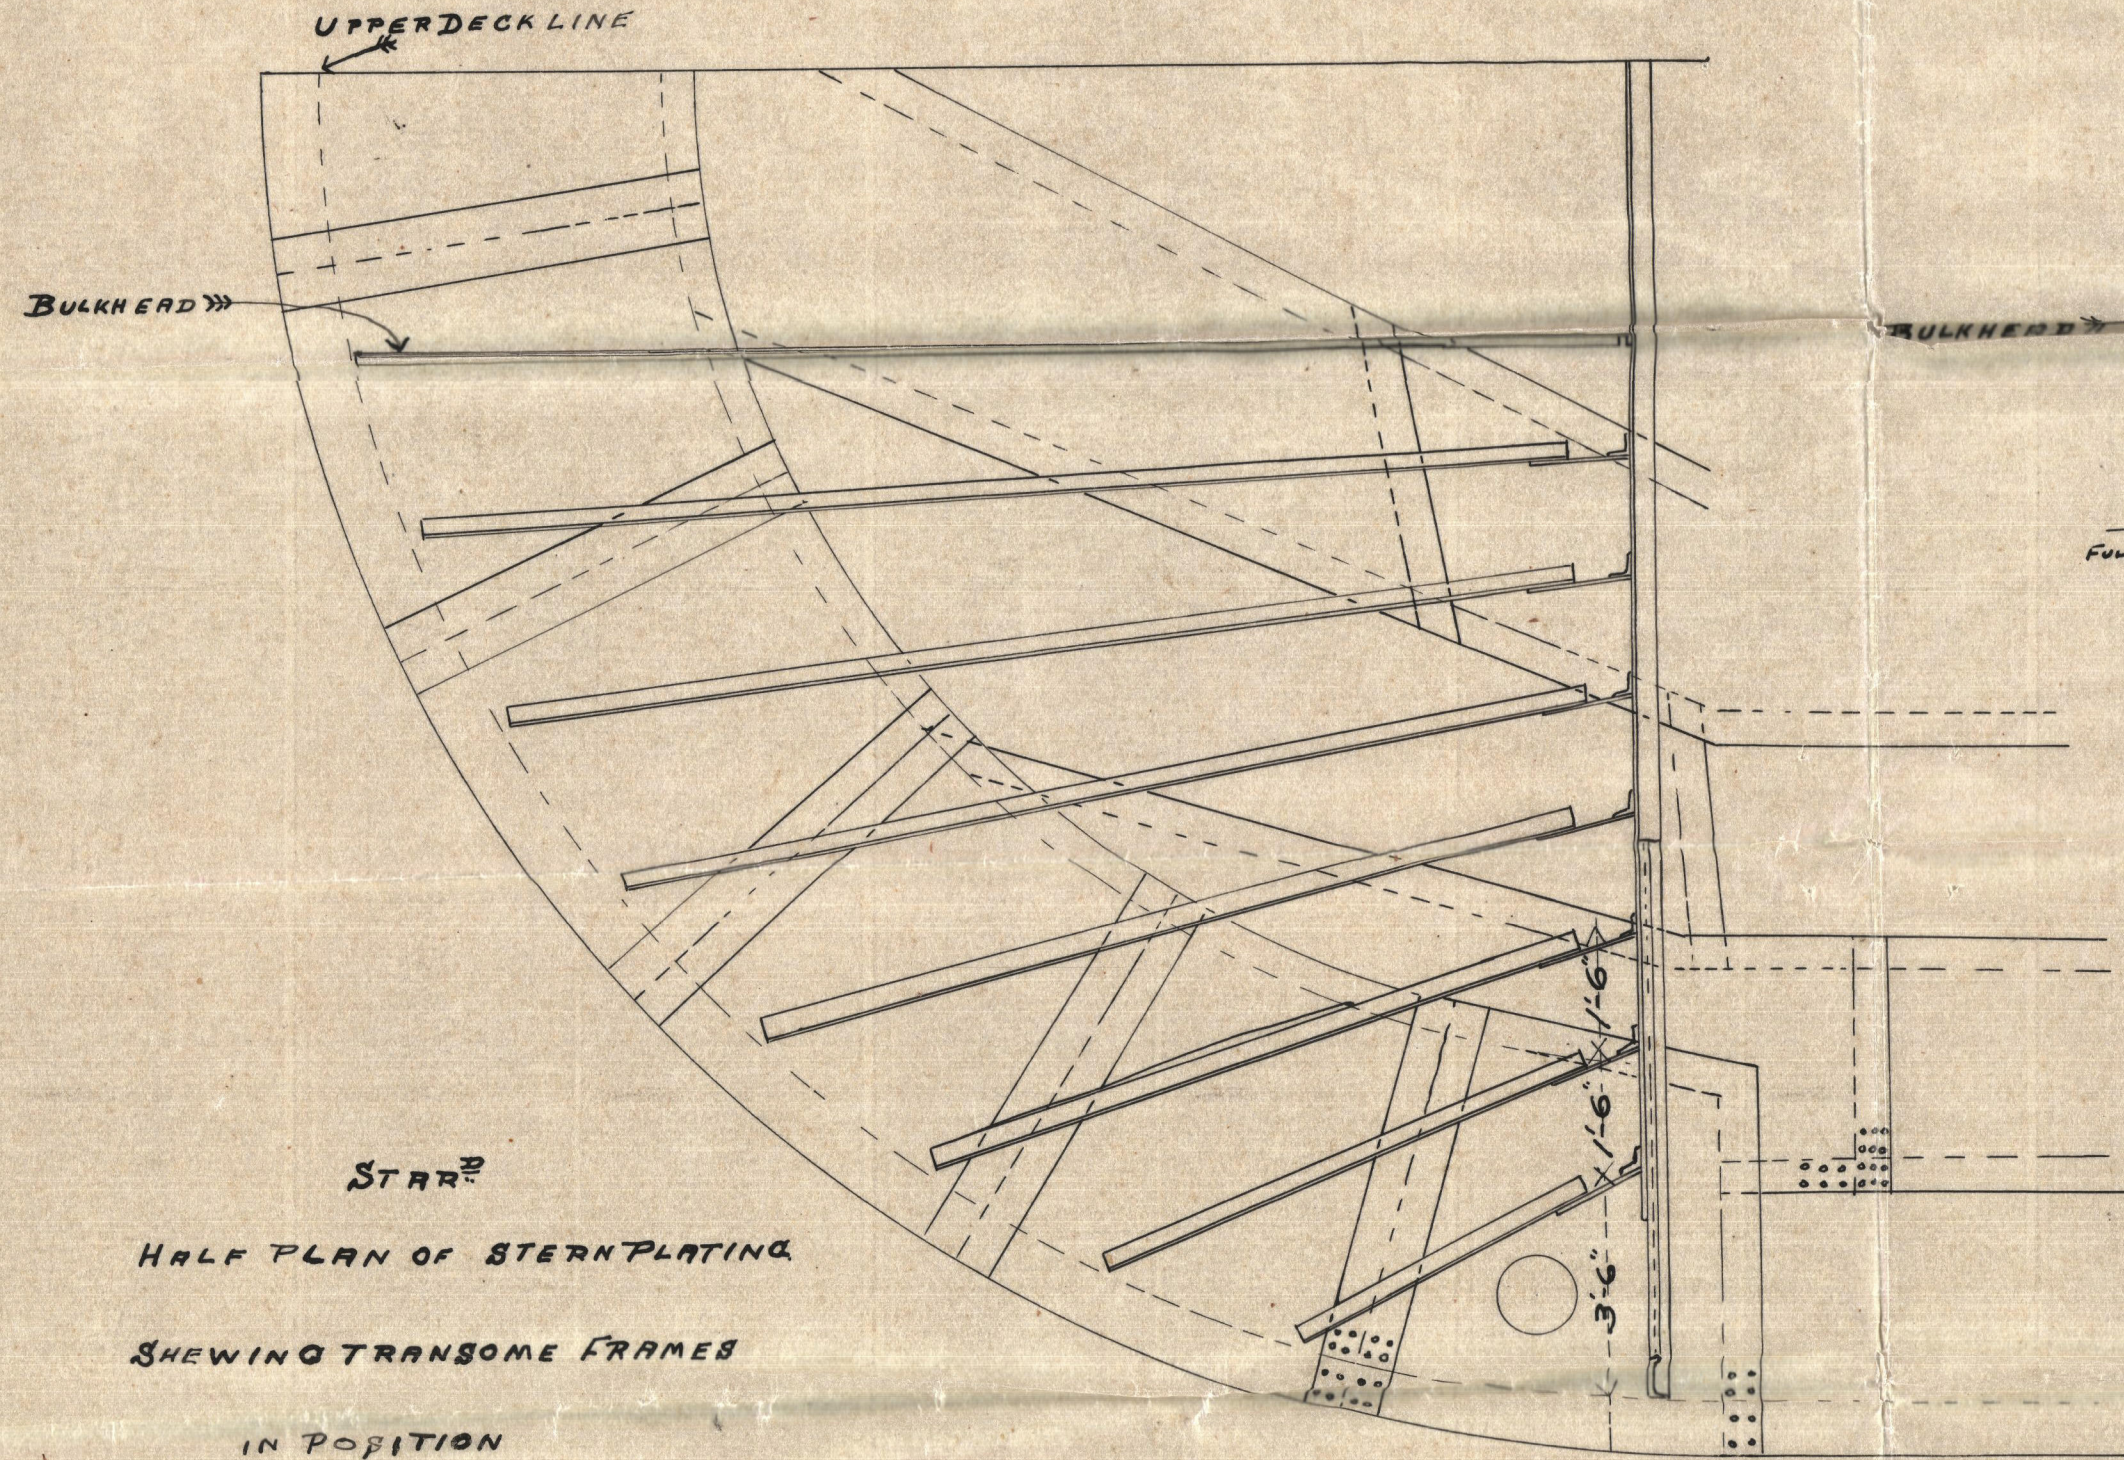
CROSS SECTION LOOKING AFT
 SHEWING LAST TRANSVERSE FRAME
 AND WASH PLATE CROPPED.
 ALSO POSITION OF Y-Y3 BULB STIFFENER
 Wash plate extended & brackelled
 all cropped frames brackelled to bulk

STARBOARD
 HALF PLAN OF STERN PLATING
 SHEWING TRANSVERSE FRAMES
 IN POSITION

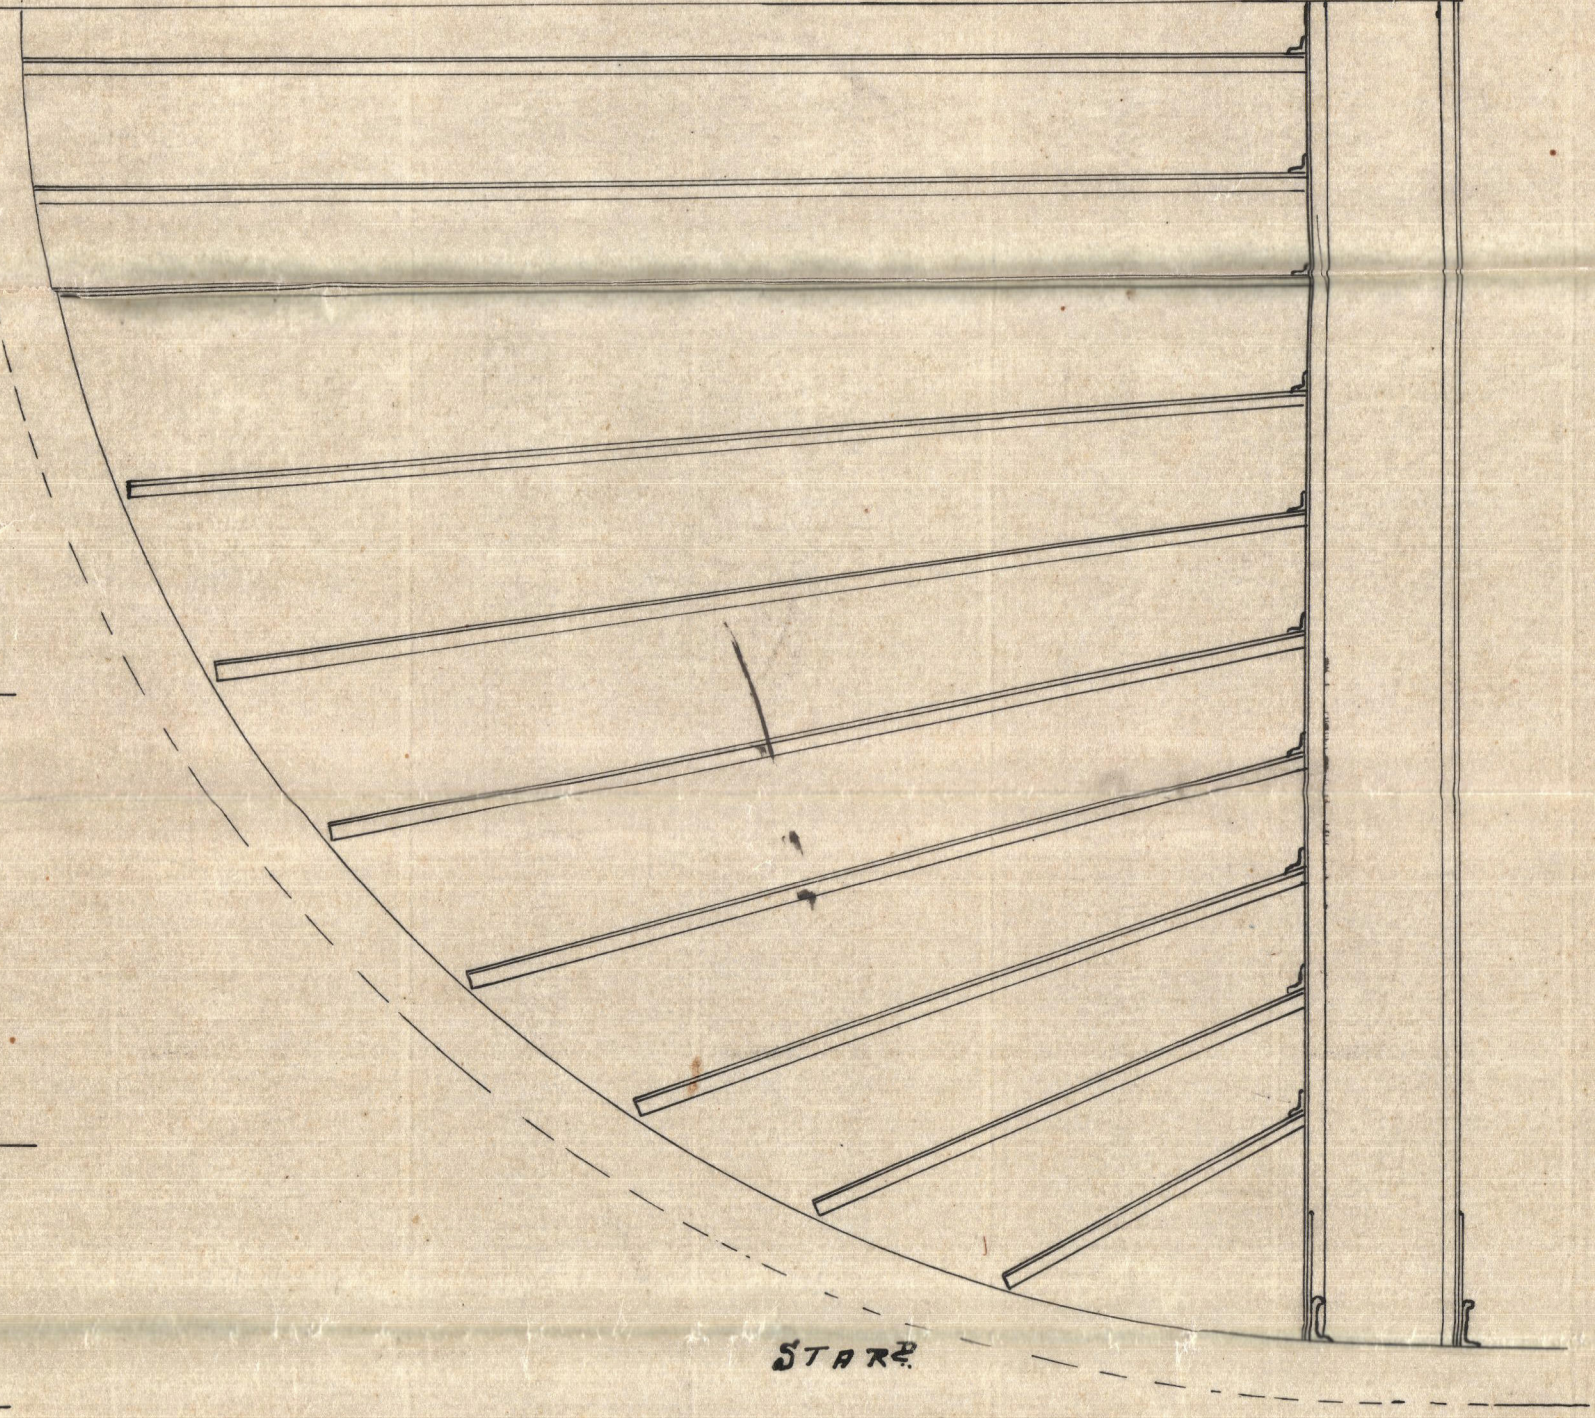
HALF PLAN STARBOARD SHEWING
 POSITION OF PATCH AND STIFFENERS,
 AND TRANSVERSE AND TRANSVERSE FRAMES CROPPED.
 NOS. 1-2-3-4-5 AND 6 " " " AS SHEWED
 LAST AND NEXT TRANSVERSE " " " "
