Date of writing Report 17-9-48 when handed in at Local Office 18-9-48. Port of SWANSEA.  
 D.O. Survey held at SWANSEA. Date, First Survey 2-7-48. Last Survey 31-8-48.  
 Reg. Book. 77251 on the Wood, Iron or Steel s.s. "THALAMUS".  
 TONNAGE: Built at Portland Or: By whom Kaiser Co. Inc. When 1945  
 GROSS 10673 Owners Anglo Saxon Petroleum Co. Ltd., Owners' Address  
 UNDER DK. 9489 Managers Port belonging to LONDON.  
 NET 6318

s.s. "THALAMUS".

Alterations.

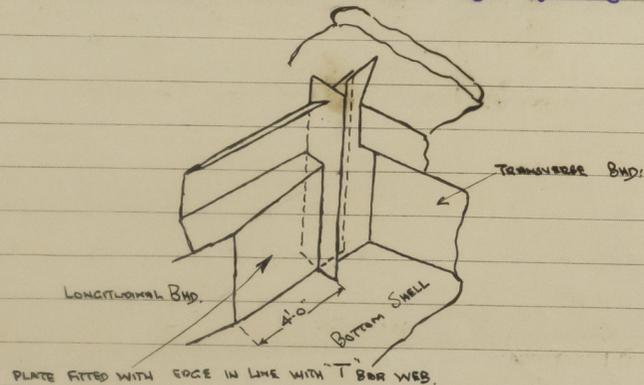
(1) At the junction of the Longitudinal Bulkheads to the "T" Section on the Transverse Bulkheads between Nos. 4 & 5 Tanks and between Nos. 6 & 7 Tanks, the lower vertical Plate of the Longitudinal Bulkhead which is connected to the edge of the Transverse Flange of the "T" Bar has been cropped and part removed from a position 4' 0" from the Flange and new Plate fitted with edge adjoining "T" Bar in line with "T" Bar Web.

(2) The Web tripping brackets of the transverse bulkheads between Nos. 4 & 5 Tanks and between Nos. 6 & 7 Tanks, centre and wings have been dealt with by fitting "T" Bar connections to Bulkhead as per approved specification.
