REPORT OF SURVEY FOR REPAIRS, &c.

Date of writing Report 3-2-1956 When handed in at Local Office 3-2-1956 Port of NEWCASTLE-ON-TYNE
 No. in Survey held at Wallsend Date, First Survey 12-8-55 Last Survey 27-1-56
 04280 on the ~~Woods~~ Steel M.V. "BRITAMER" (No. of Tons 47)

TONNAGE Built at Glasgow By whom Barclay, Curle & Co. When 1939 MONTH 3
 GROSS 9976 Owners D/S A/S Baltimore Owners' Address
 UNDER DEK Managers Halle & Petersen Port belonging to Oslo
 NET 5932

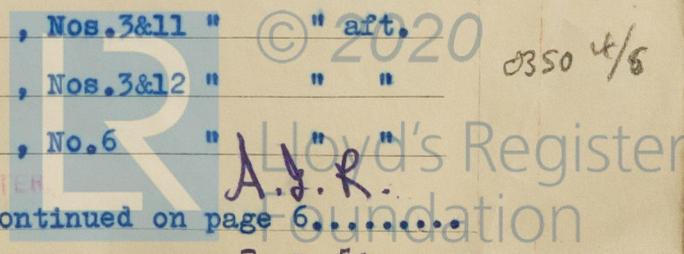
Fractures in stringers veed out, welded and doublings fitted over fractures and extended around notches in stringer:-

No.1 Starboard,	upper stringer on longitudinal bulkhead,	No.2 stiffn. from aft.
No.1 Port	, middle " " shell	, No.2 frame " "
	, upper " " longitudinal bulkhead,	No.2 stiffn. " for'd.
No.3 Starboard,	" " " " " "	, No.2 " " "
No.3 Port	, middle " " shell	, No.2 frame " aft.
	, " " " longitudinal bulkhead,	Nos.2&3 stiff." "
	, " " " " " "	, No.3 stiffn. from For'd
	, upper " " " " " "	, No.3 " " aft.
No.4 Starboard,	" " " " " "	, Nos.2&3 " " for'd.
	, " " " " " "	, Nos.2&3 " " aft.
	, middle " " " " " "	, Nos.2&3 " " for'd.
No.5 Starboard,	" " " " " "	, Nos.3&11 " " aft.
No.5 Port	, " " " " " "	, Nos.3&12 " " "
	, lower " " " " " "	, No.6 " " "
