STERNFRAME

ODENSE STAALSKIBSVÆRFT  
VED A. P. MØLLER  
11/1-35. *Admiral*  
57 & 58

Sternframe

Yard No. 57/58

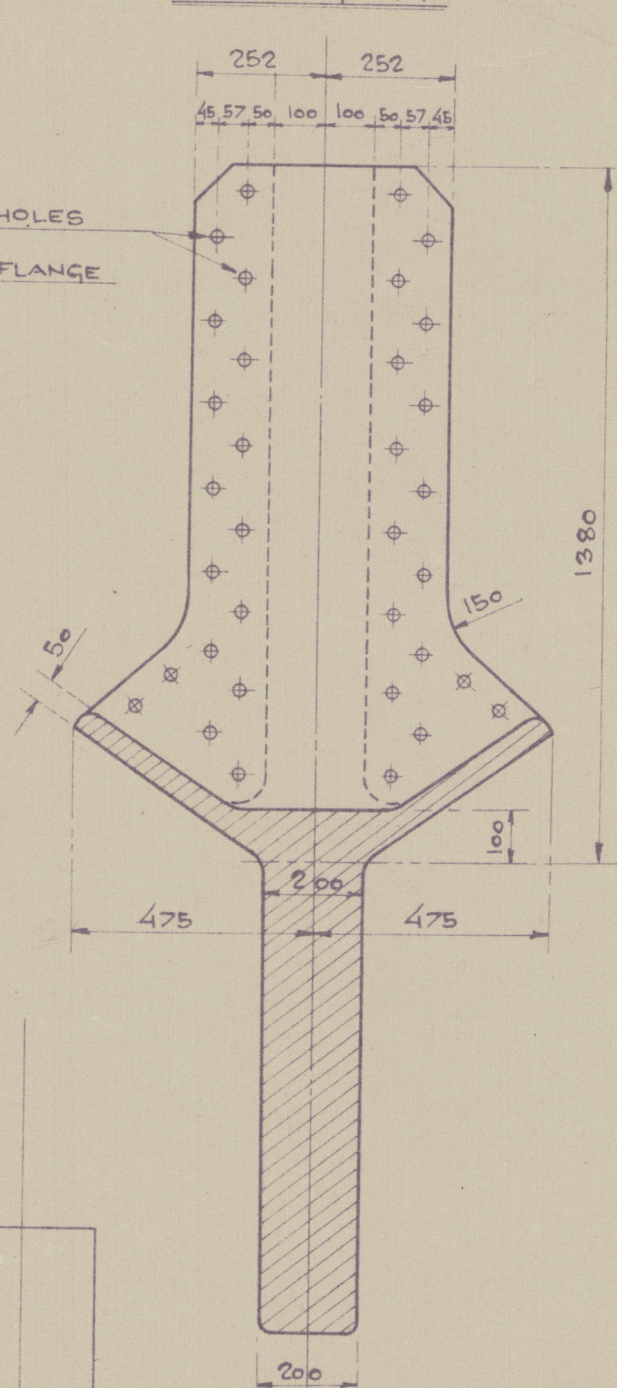
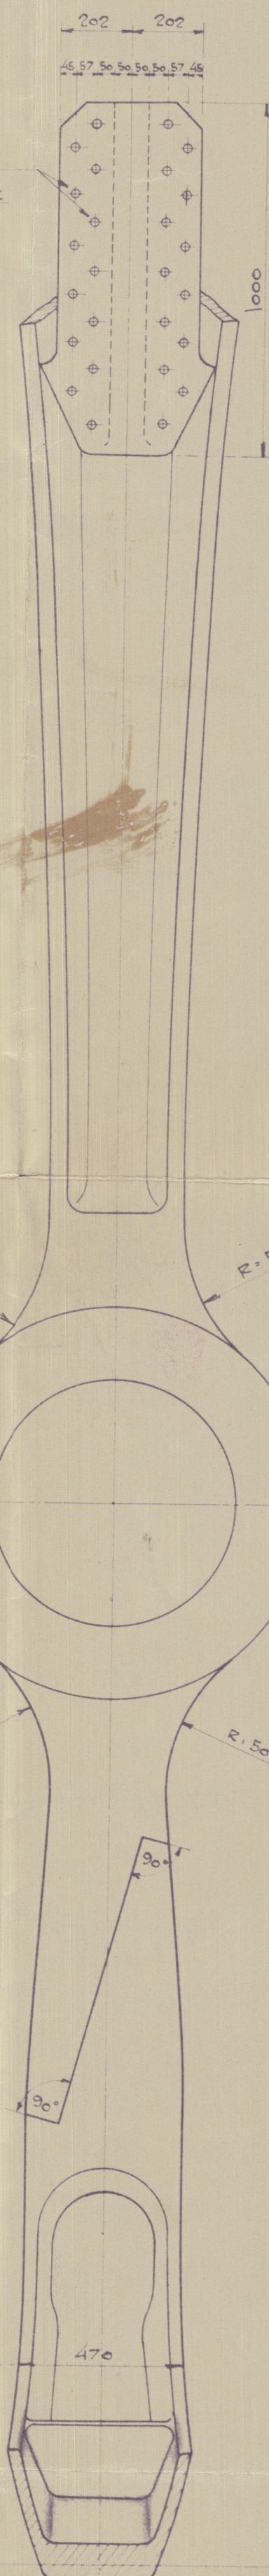
LOOKING AFT.

25% RIVETS 27% HOLES  
17 RIVETS IN EACH FLANGE

- SCALE 1:15

STERNFRAME OF CAST STEEL

RUDDER POST TO BE INCREASED 6% AND HEELPIECE 10%  
IN AREA BEYOND CLASS REQUIREMENTS FOR TANKERS  
THIS TO BE INCLUDED IN APPROVED DIMENSIONS.

LOOKING AFT

25% RIVETS 27% HOLES  
13 RIVETS IN EACH FLANGE
