Lloyd's Register of Shipping.

Ship's Name **S.S. " U E I C E "**

Memorandum of alterations reported since ship was surveyed for assignment of Load Lines
in _____

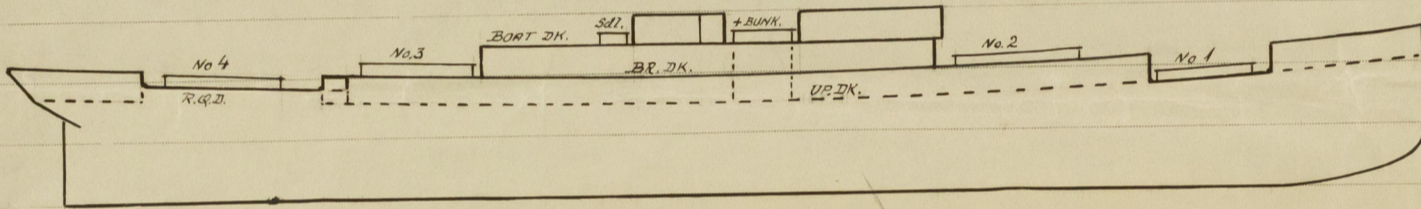
HATCHWAYS ON FREEBOARD AND SUPERSTRUCTURE DECKS.

No. 1	No. 2	+ BUNKER	COALING H.	No. 3	No. 4				
Description of Hatchway		UPPER DK.	BRIDGE DK.	BOAT DK.	BOAT DK.	BRIDGE DK.	R.Q. DK.				
Dimensions of Hatchway		7295x6100	8550x6100	3480x4013	1524x2794	8550x6100	8550x6100				
COAMINGS	Height above Deck	1000	890	762	912	870	860				
	Thickness	13	13	13	10	11	11				
	Sides	11	11	9	10	11	11				
	Stiffeners	ONE	ONE	—	—	ONE	ONE				
	Brackets, Stays	TWO	TWO	—	—	TWO	TWO				
HATCH BEAMS	Number	4	5	1	—	5	5				
	Spacing	1459	1425	1740	—	1425	1425				
	Scantling and Sketch	455x9	100x75x11	343x12	90x75x10	SAME AS Nos. 1+2					
	Bearing Surface	90	90	90	90	90	90				
FORE AND AFTERS	Number	/		2	1	/					
	Spacing			1338	1397						
	Unsupported Lengths			1740	1524						
	Scantling* and Sketch			75x75x9	75x75x9						
HATCH COVERS	Material	Wood	Wood	Wood	Wood	Wood	Wood				
	Thickness	75	75	75	75	75	75				
	How fitted	f+a	f+a	Thush.	Thush.	f+a	f+a				
	Bearing Surface	70	70	70	65	70	70

Spacing of Cleats		560	560	580	600	560	560				
Number of Tarpaulins		2	2	2	2	2	2

New arrangement of hatch shifting beams on exposed Upper, R.Q. and Boat Deck was
now carried out as per plan approved London 18/3/48. For particulars see below.
