# STEEL BOILER NO 397 & S

WORKING PRESSURE = 160 LBS.

EARLES SHIPBUILDING  
ENGINEERING COMPANY  
LIMITED  
H U L L  
2.5.94.

s/s Robin  
Hull Report No. 9704

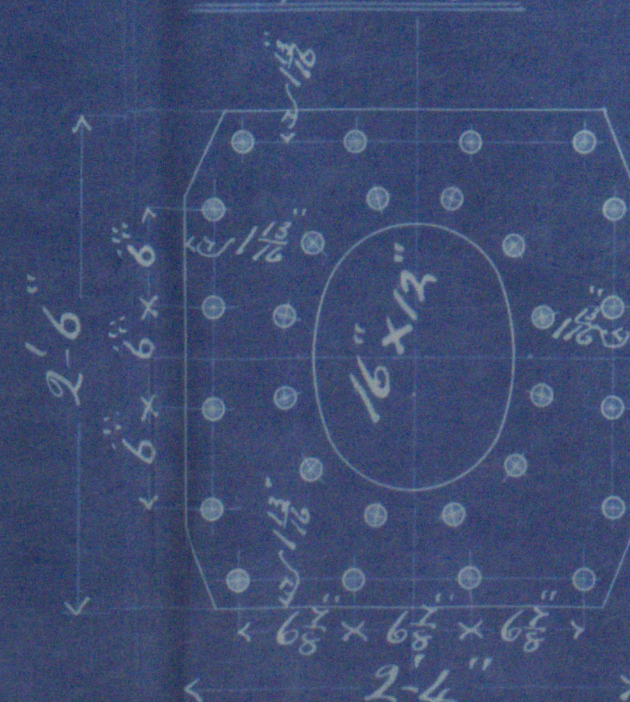
DOUBLING PLATE AROUND MANHOLE.

2 1/32" THICK.

1 1/8" RIVET HOLES  
INNER ROW COUNTERSUNK  
AND FLUSH RIVETED.

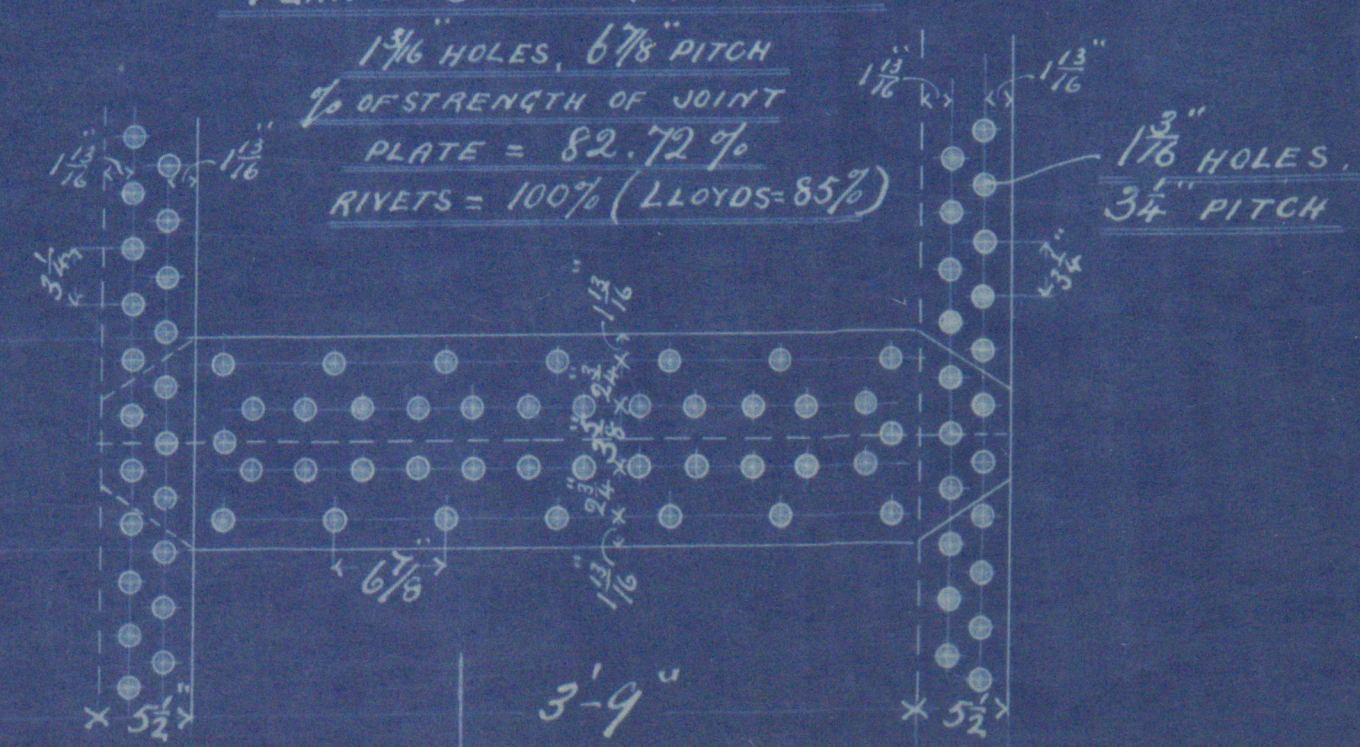
PLAN OF SHELL RIVETING.

1 1/8" HOLES, 6 1/2" PITCH  
1/2" STRENGTH OF JOINT  
PLATE = 82.72%  
RIVETS = 100% (LLOYDS-85%)

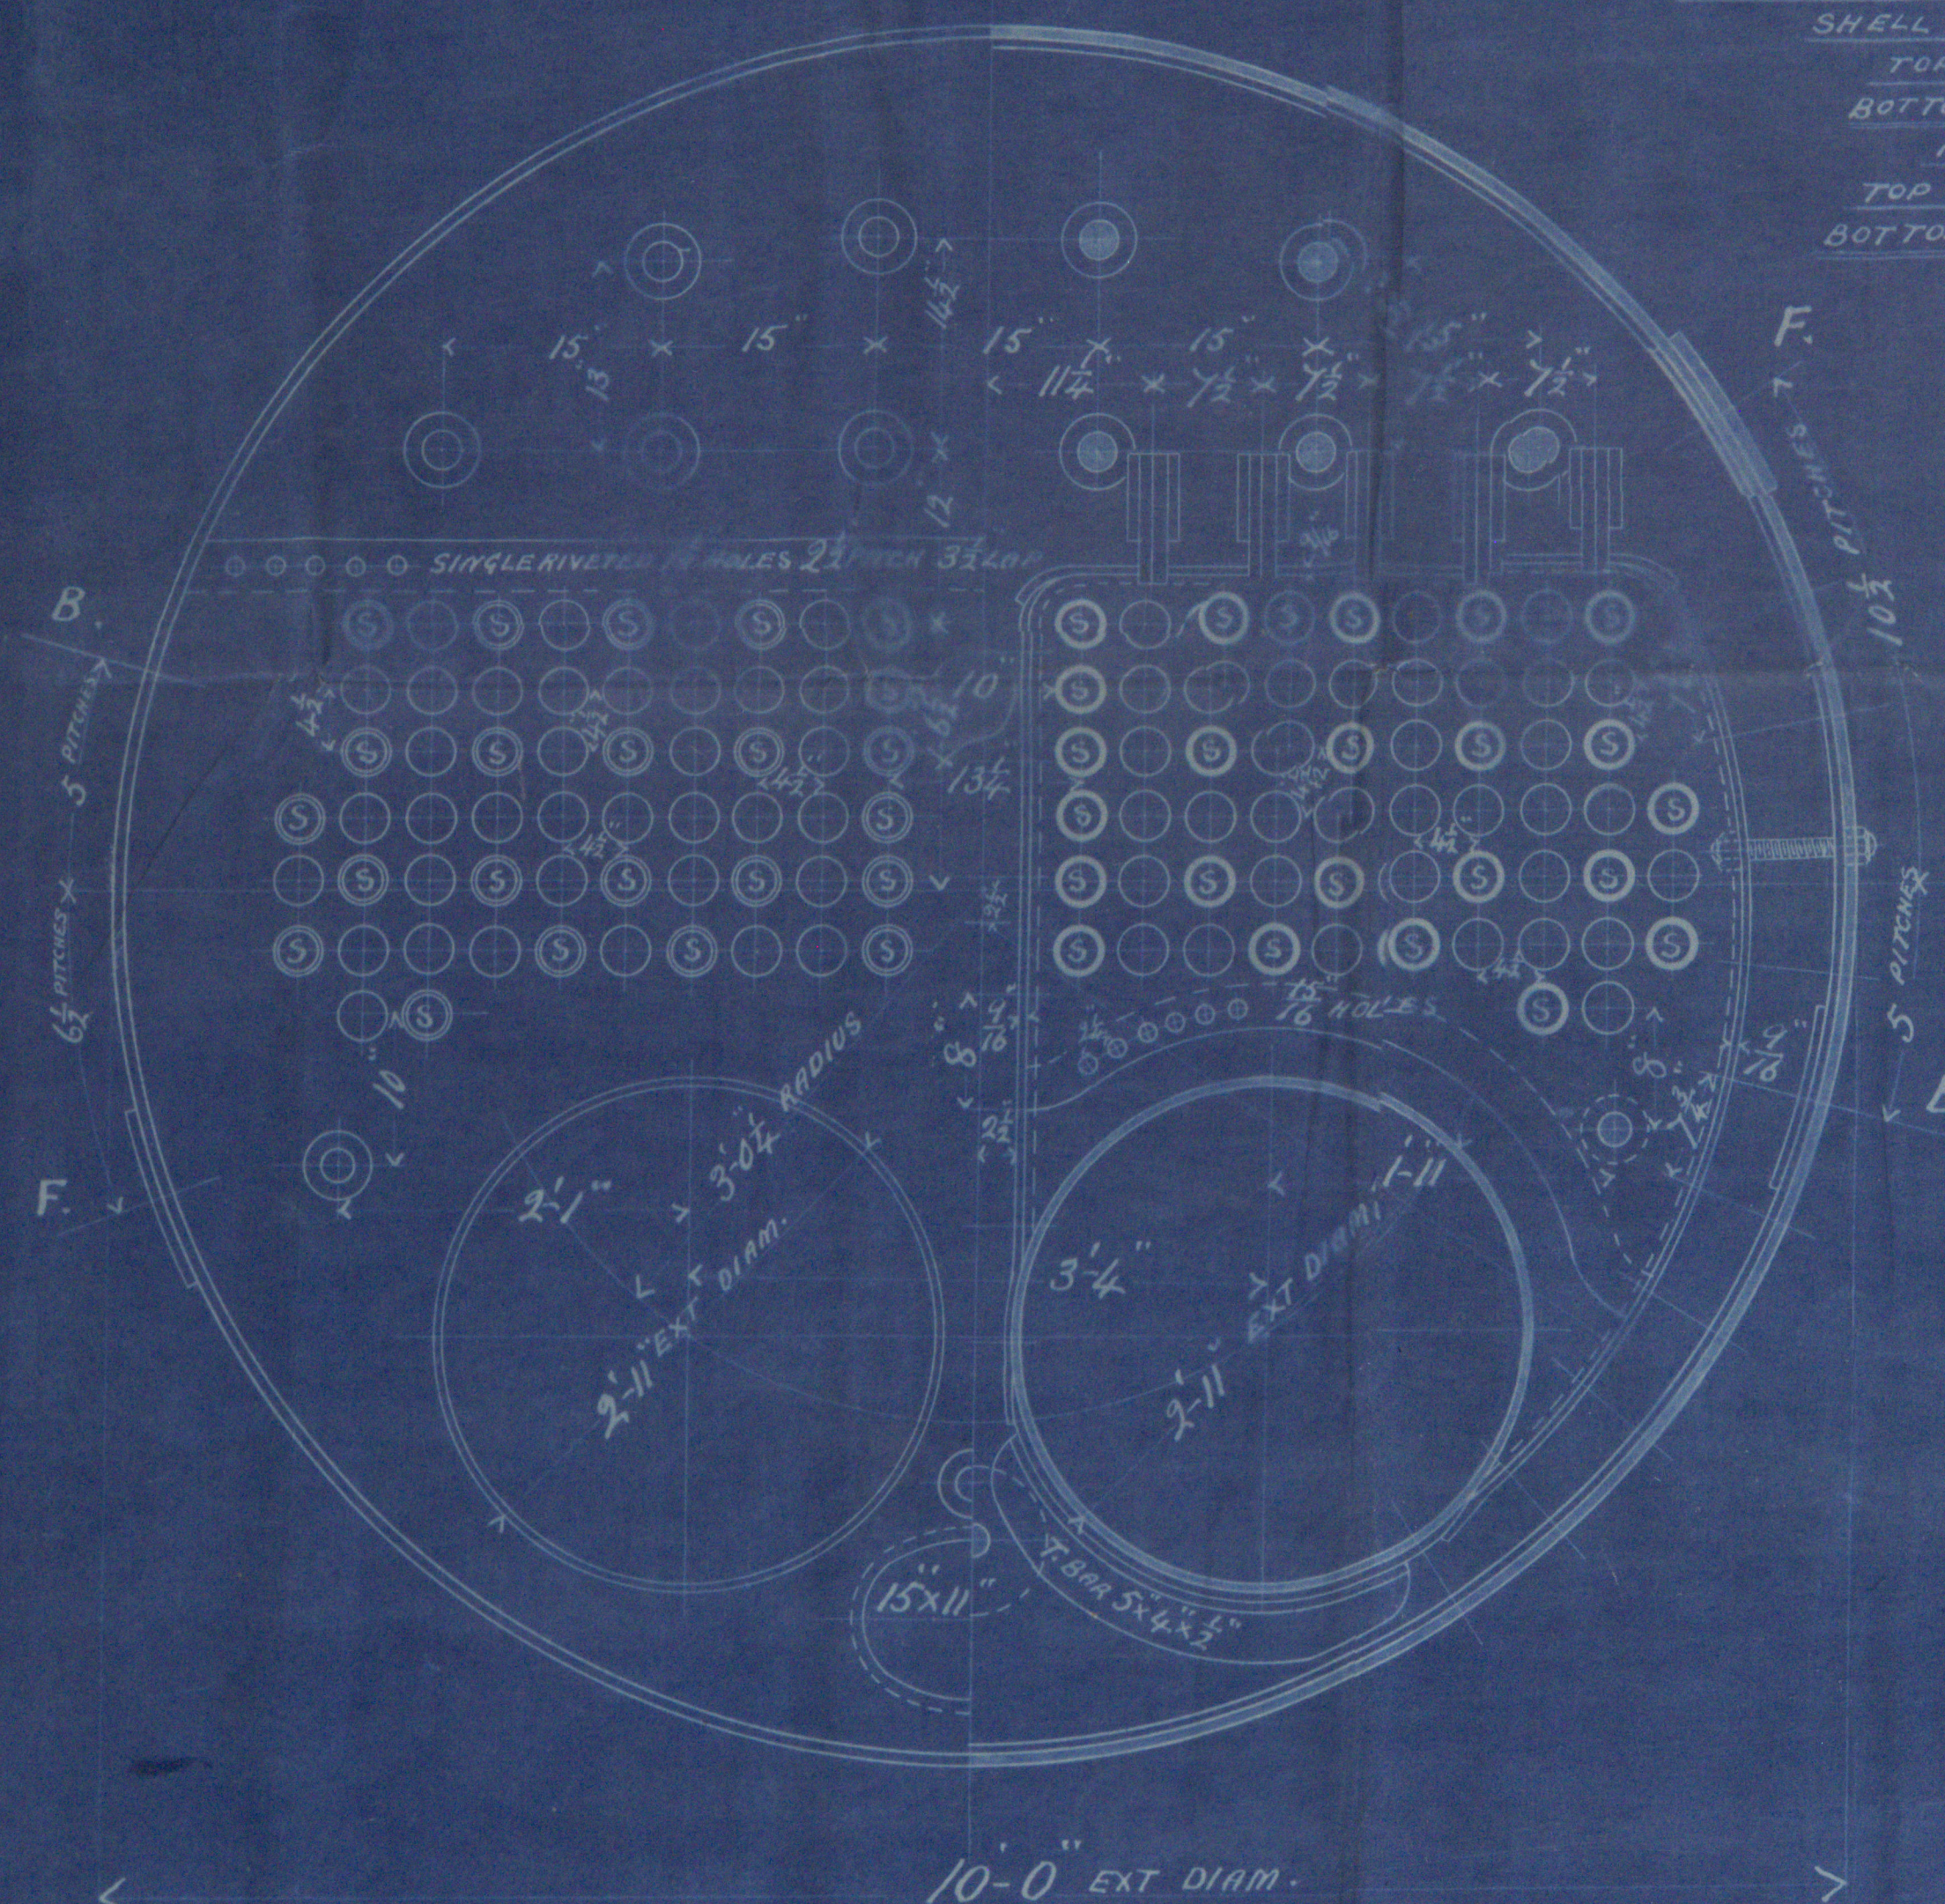
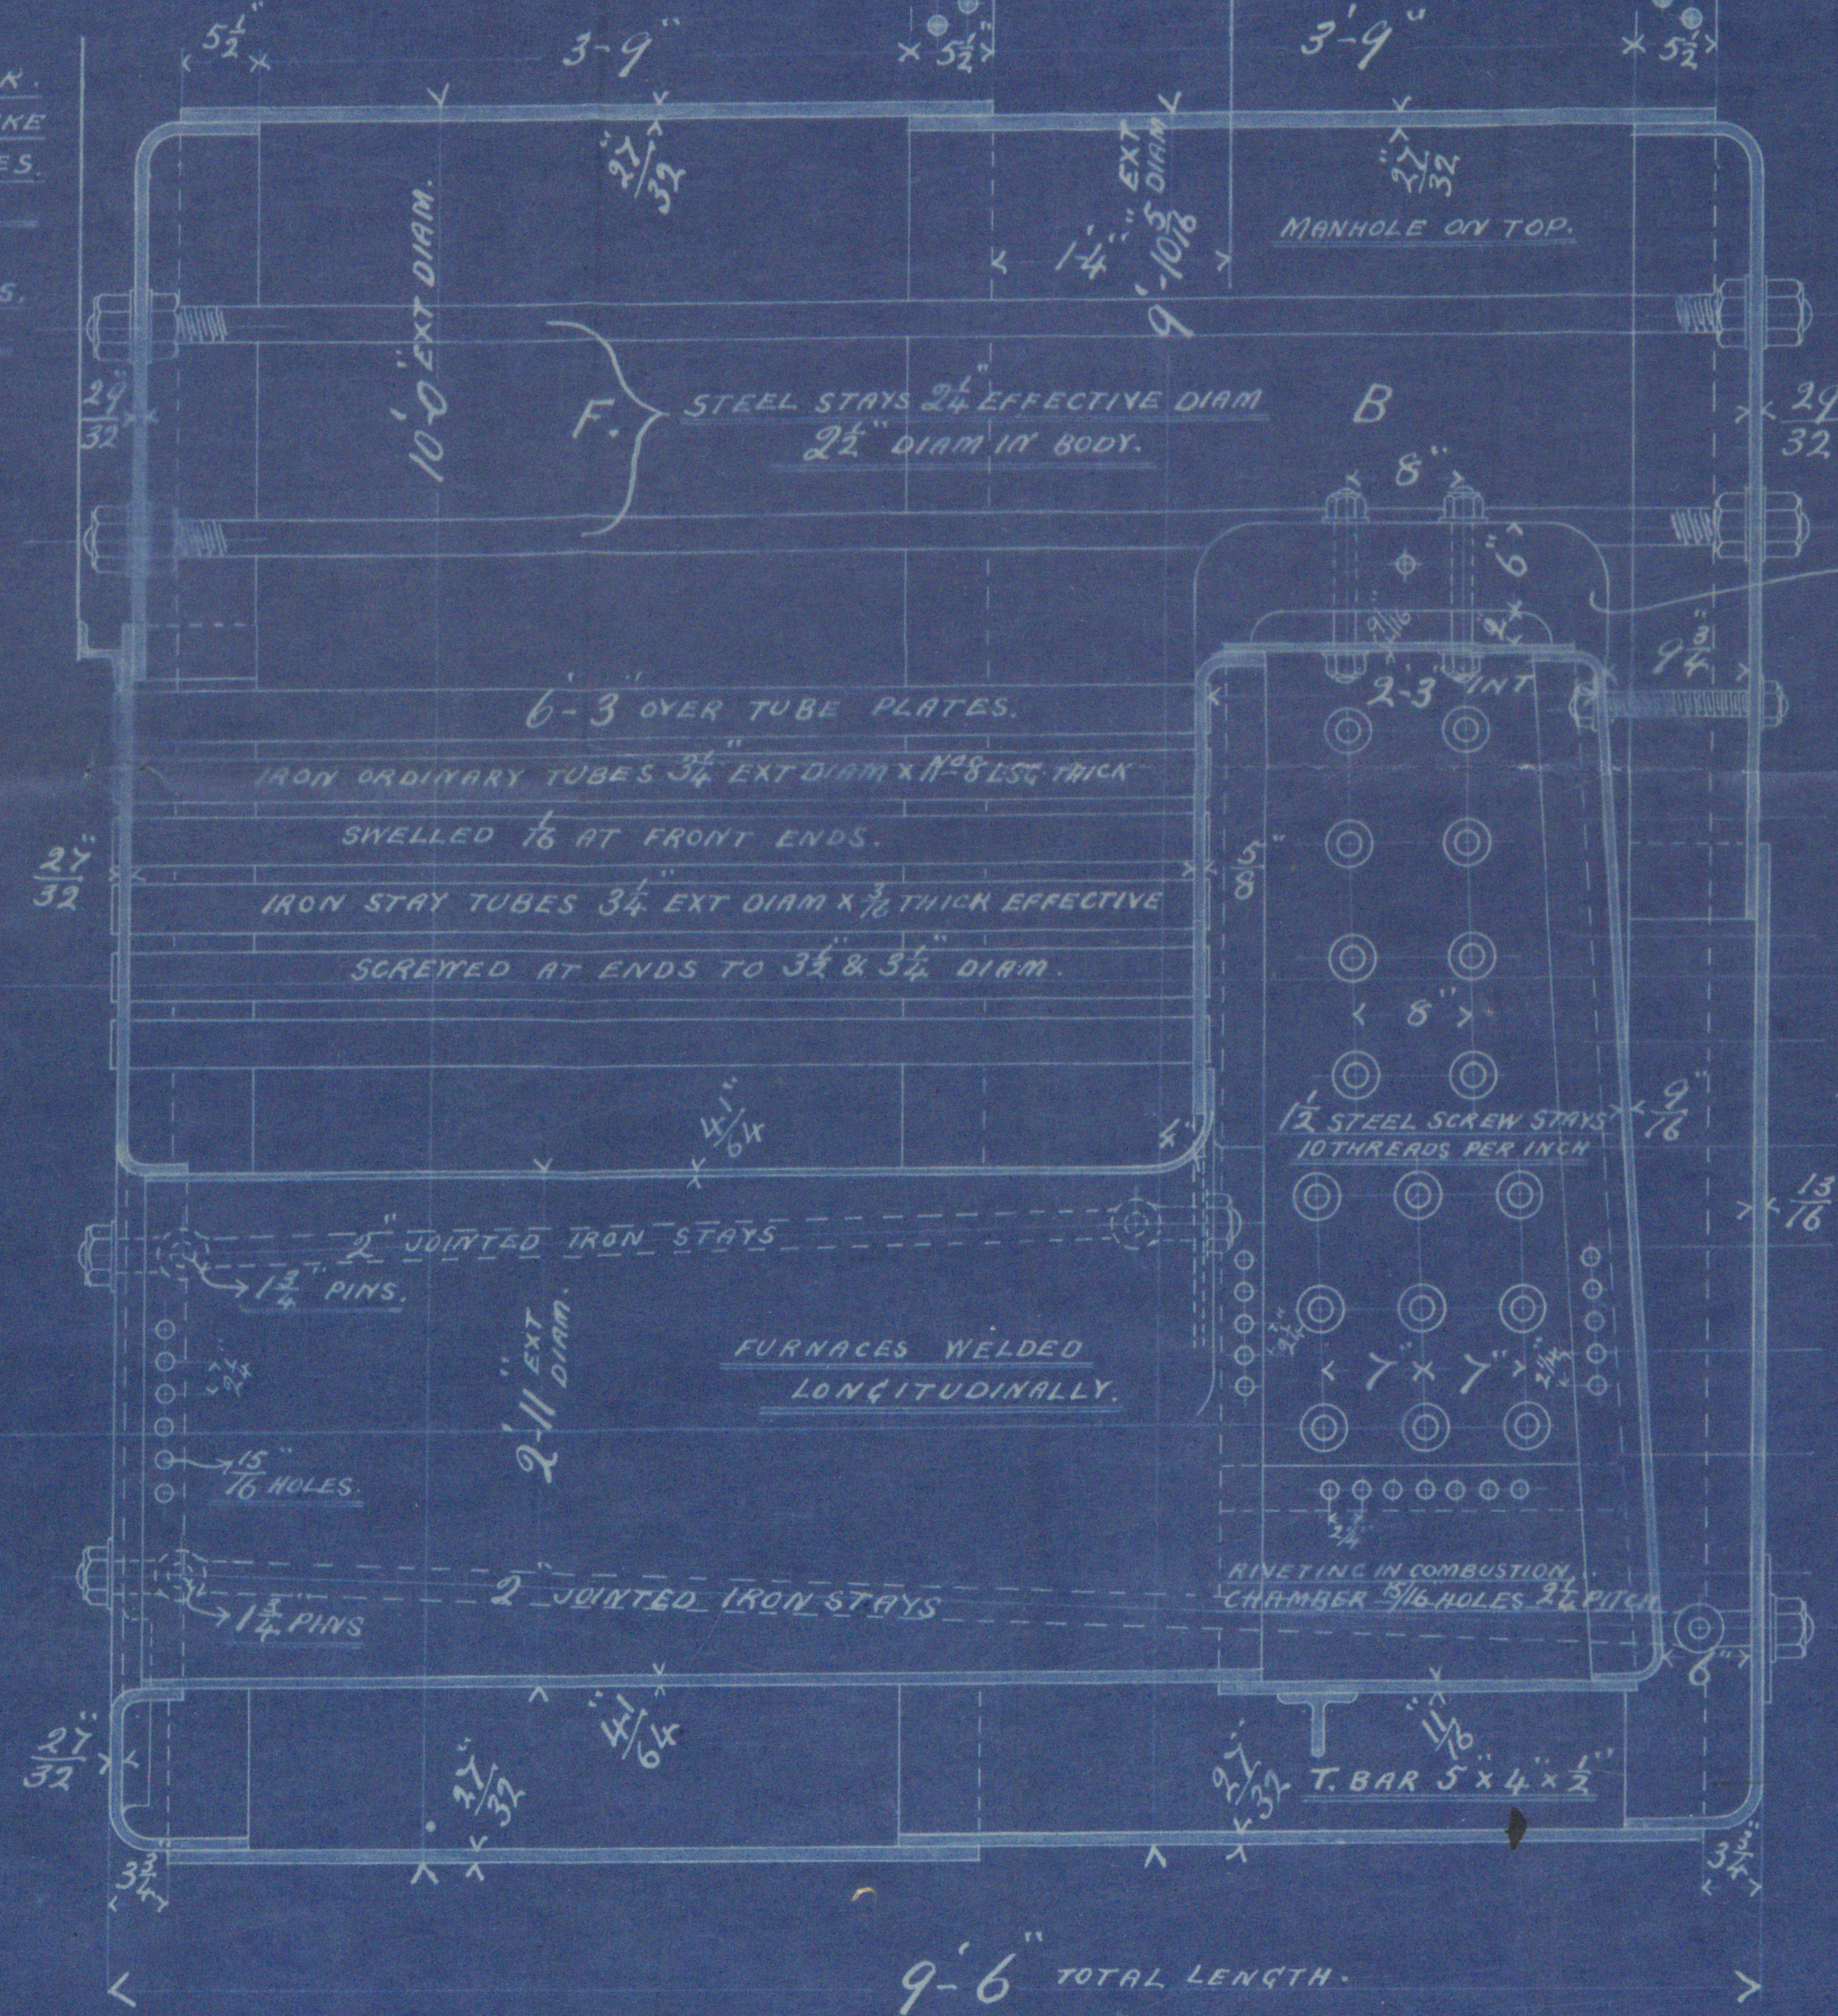
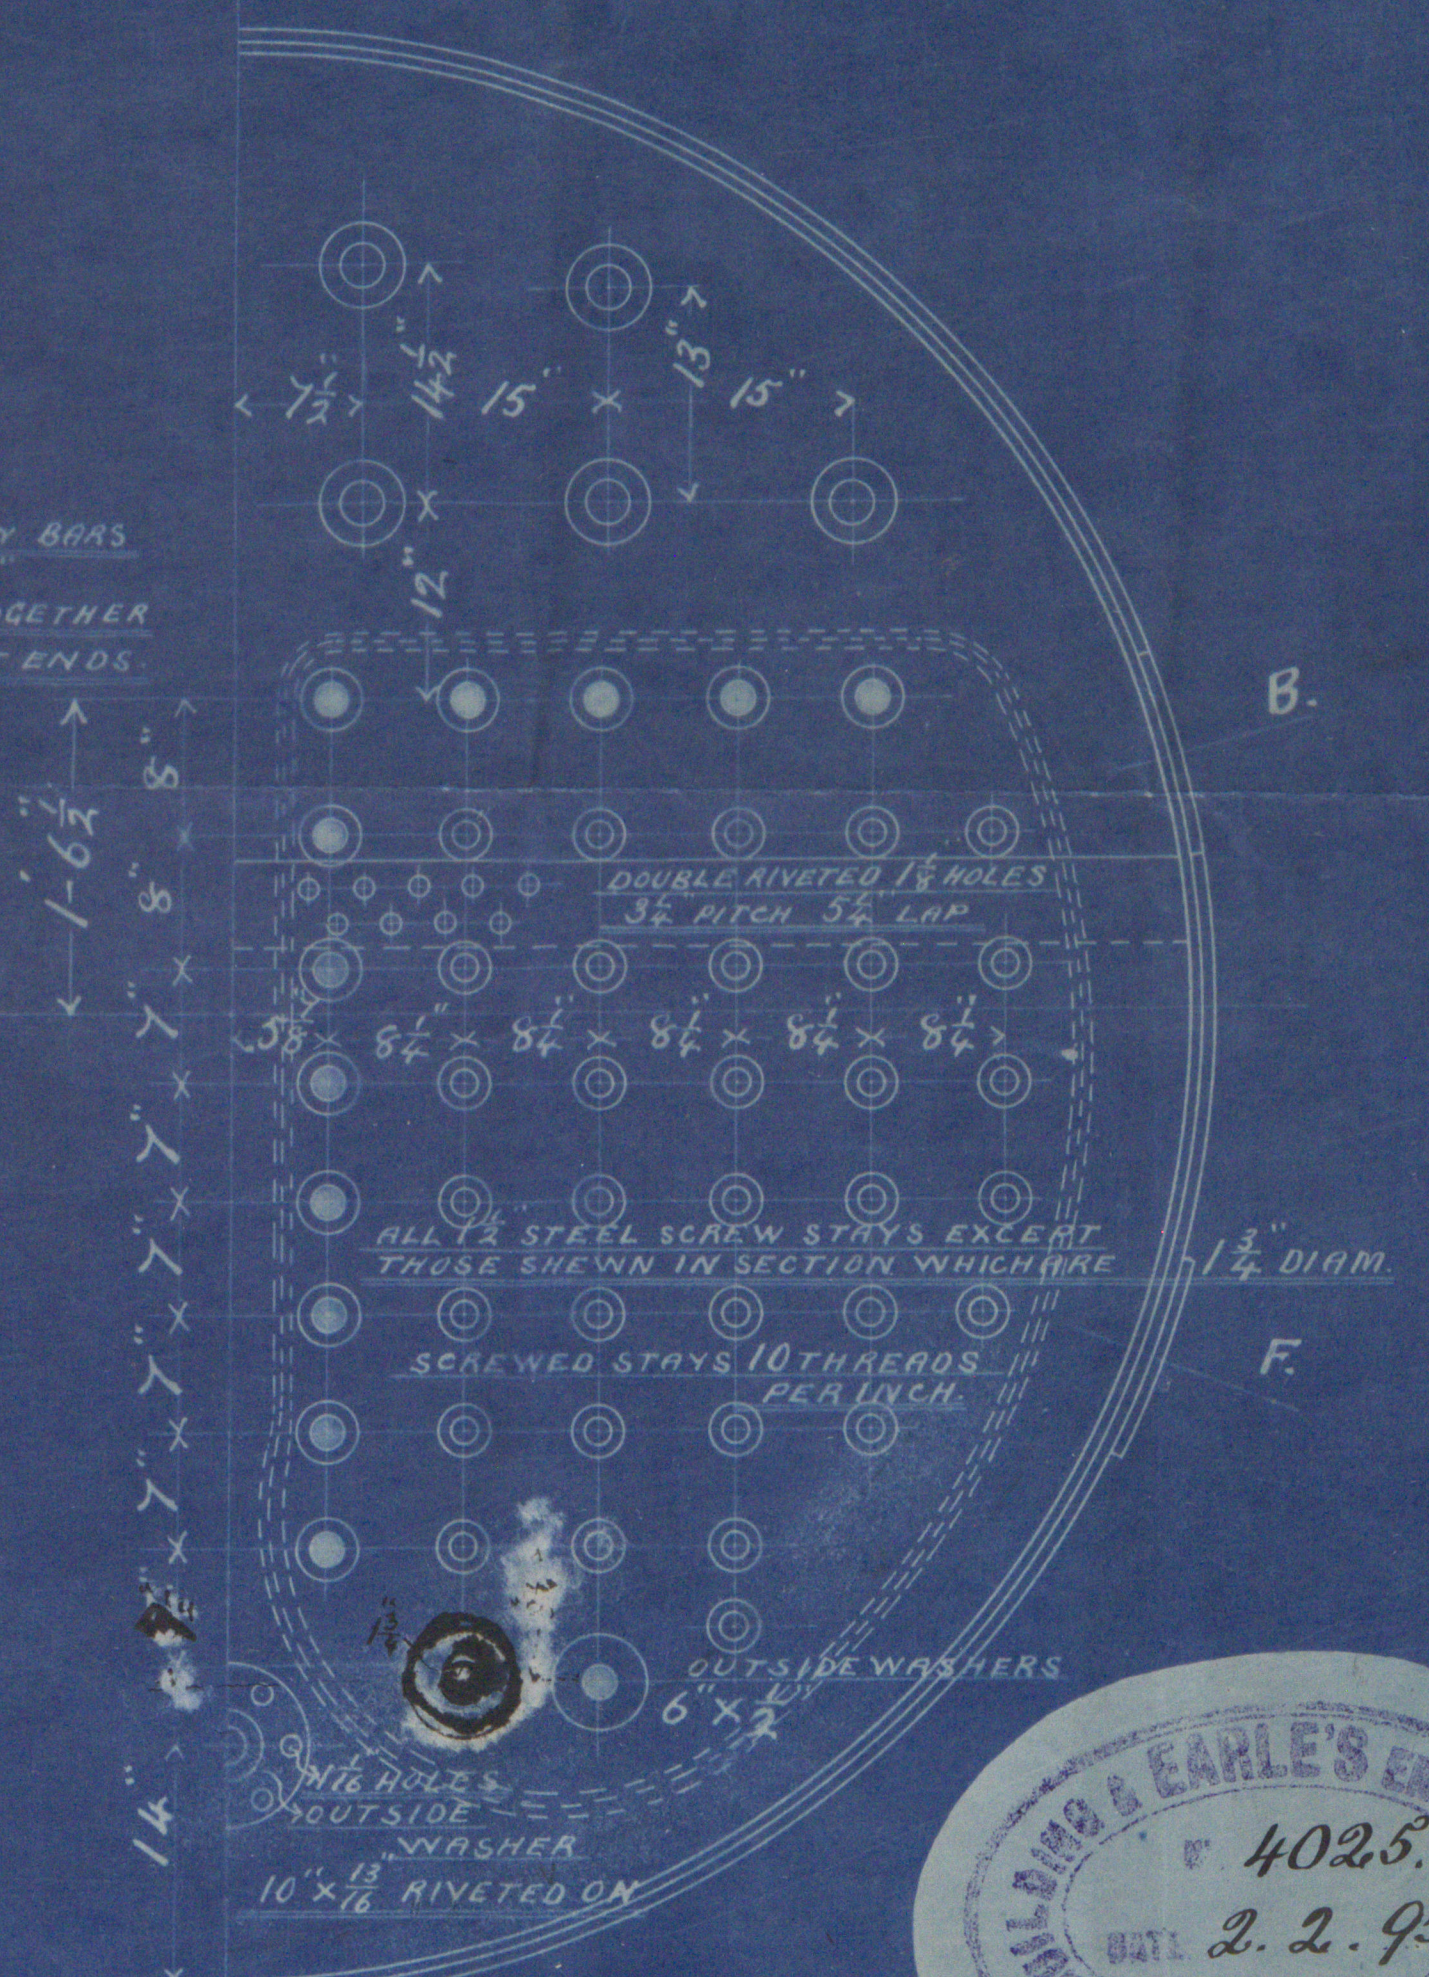
LENGTH OF FIRE BARS	5-0
AREA OF FIRE GRATE	28 sq. ft.
DIAM. OF TUBES OUTSIDE	3 1/4"
LENGTH OF TUBES OVER PLATES	6'-3"
NO. OF TUBES	118
AREA THROUGH TUBES	6 sq. ft.
SURFACE OF TUBES	616 "
TOTAL HEATING SURFACE	800 "
WORKING PRESSURE	160 LBS.
DIAM. OF SAFETY VALVE EACH	2"

SHELL 2 1/32" THICK  
BUTT STRAPS 12 1/4" X 1/4" THICK.  
SHELL PLATES IN F. STRAKE  
TOP PLATE 53 PITCHES.  
BOTTOM " 61 "  
IN B. STRAKE.  
TOP PLATE 57 PITCHES.  
BOTTOM " 57 "
